RF and Phase Noise in IFO Subsystems

RF Noise in ISC Racks

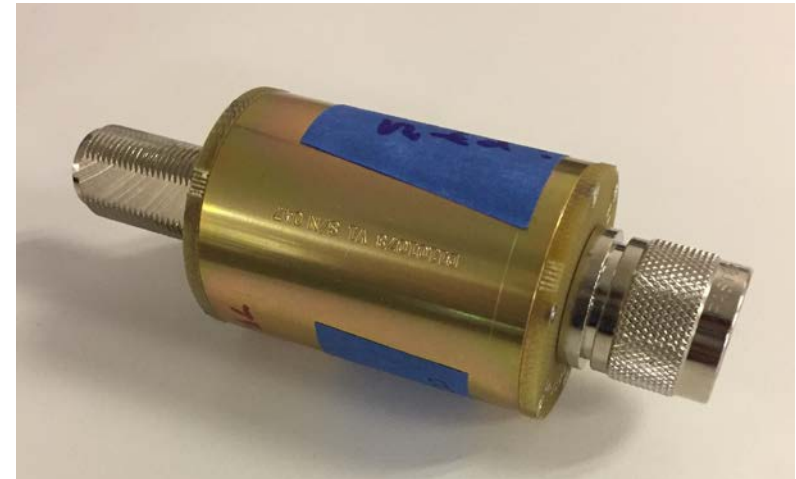
Our Baluns

- We utilize a balun to convert an unbalanced RF signal that is measured relative to ground in the originating rack, to an unbalanced signal relative to ground in the receiving rack.
- This prevents differences in rack grounds from effecting the relative amplitude of the RF signal.
- This type of device is also known as a Ground Isolation Transformer

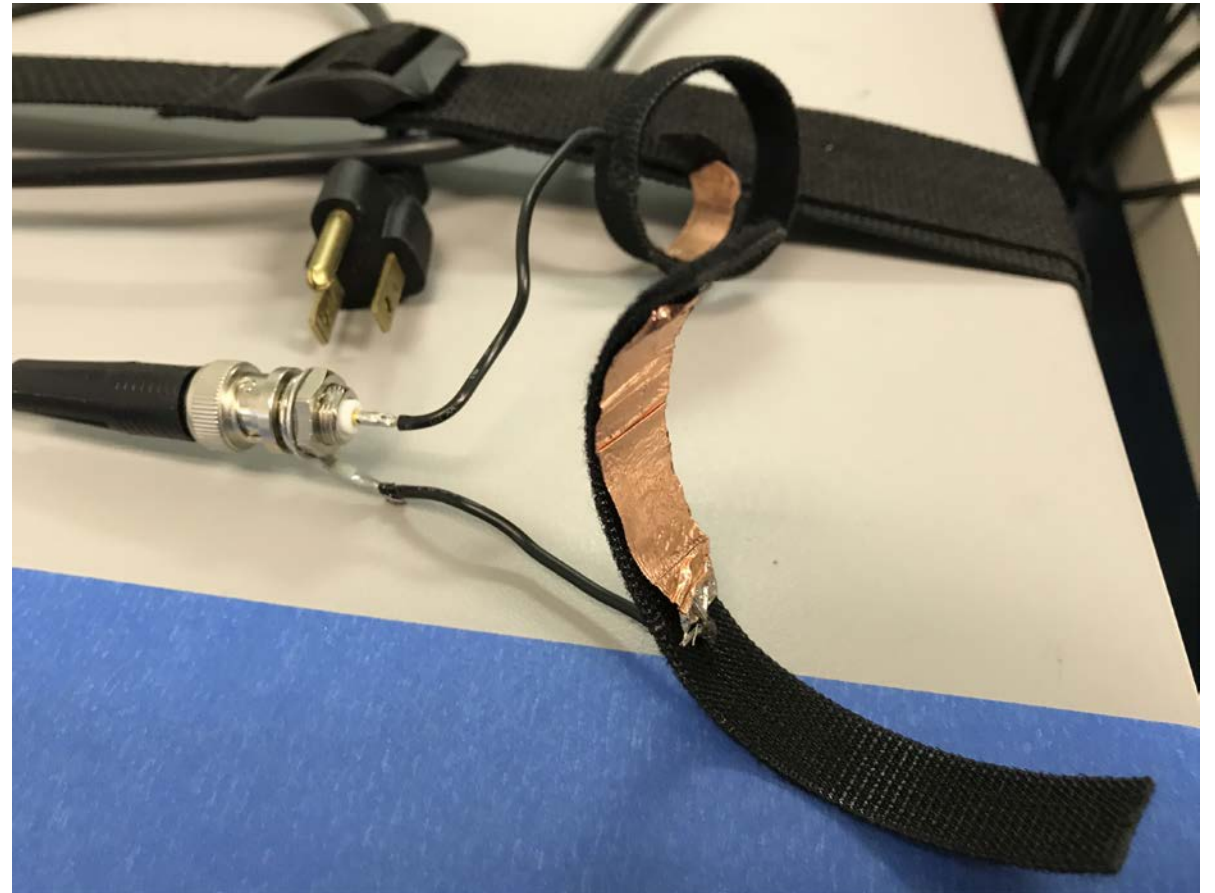
- A custom test lead was fabricated to measure the potential difference between the two ground ends of the balun.
- Since one ground of the balun is connected to chassis ground of the test instrument, a voltage across the lead is a measure of the coupling between the balun and a radiated signal.

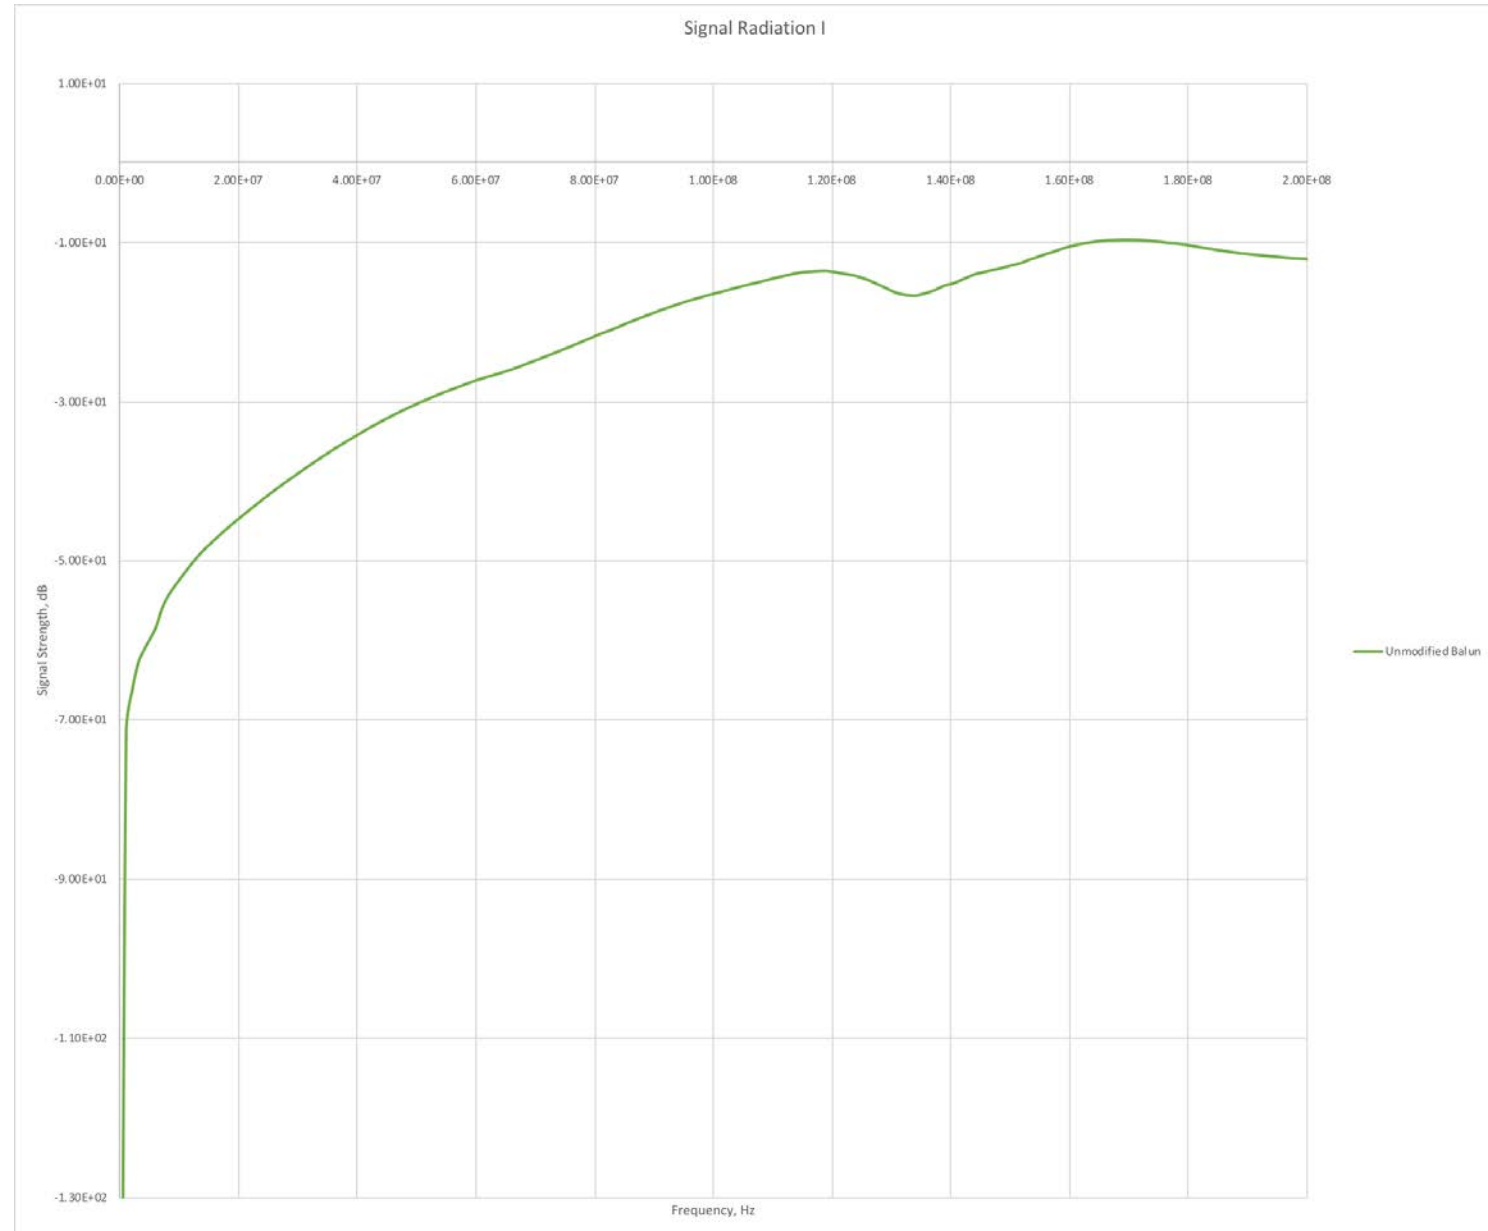
- Using a Network Analyzer we measured signal leakage as a function of frequency.
- The open end of the balun was terminated ($50\ \Omega$).
- Balun connected to RF out of analyzer, test lead to analyzer input.

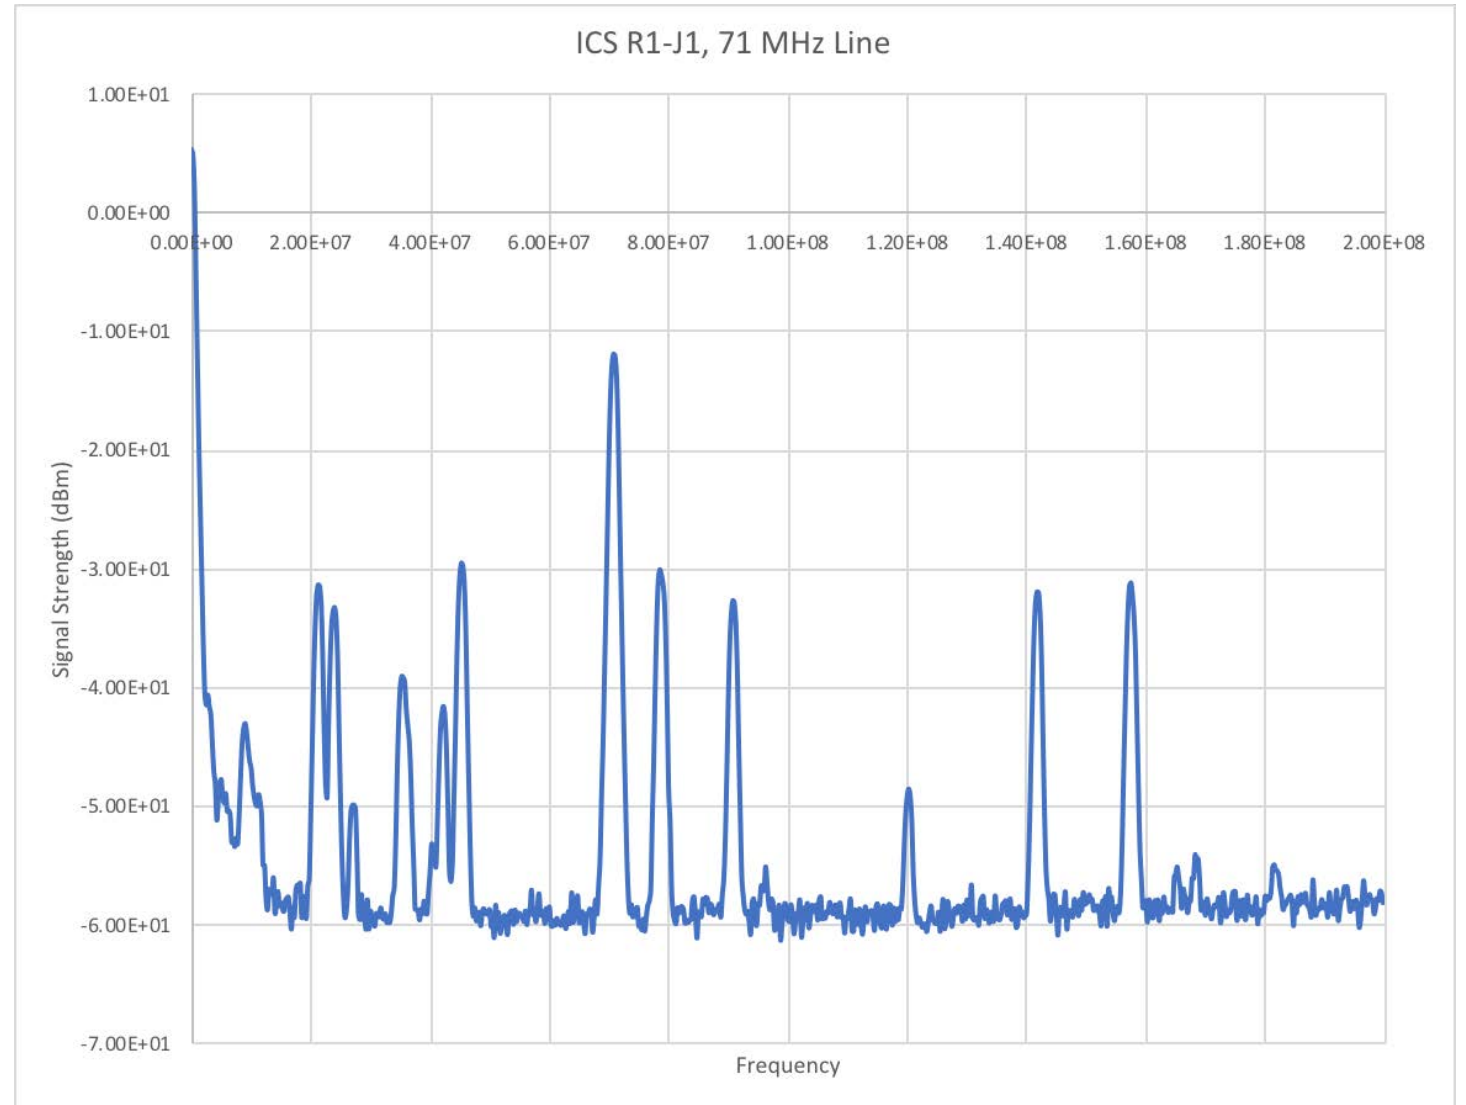
- Inside the LVEA we used a spectrum analyzer to do the same measurement, but with live RF instead of the RF out of the NA.
- We observed peaks due to neighboring signal lines on all baluns.

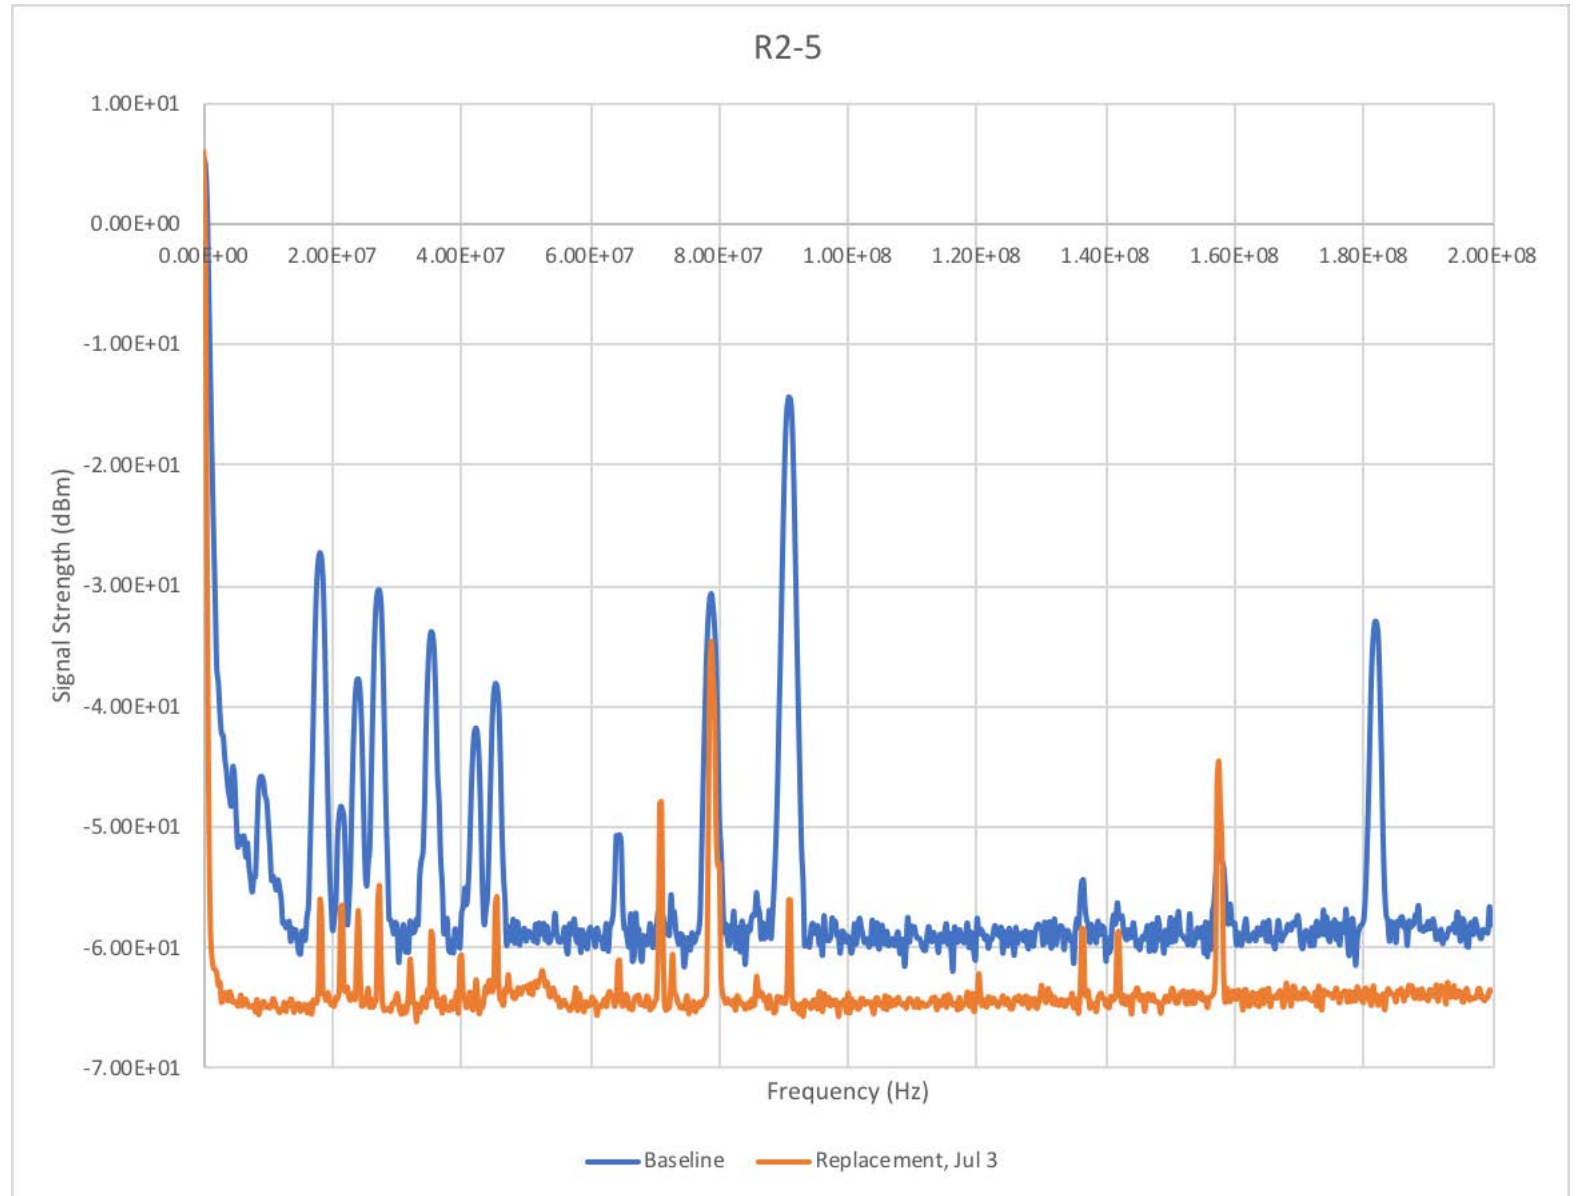
- P1 balun was placed on the 118 MHz line in ISC Rack R2, and leakage was measured before and after replacement.
- 35 - 40 dB attenuation of radiated signal.

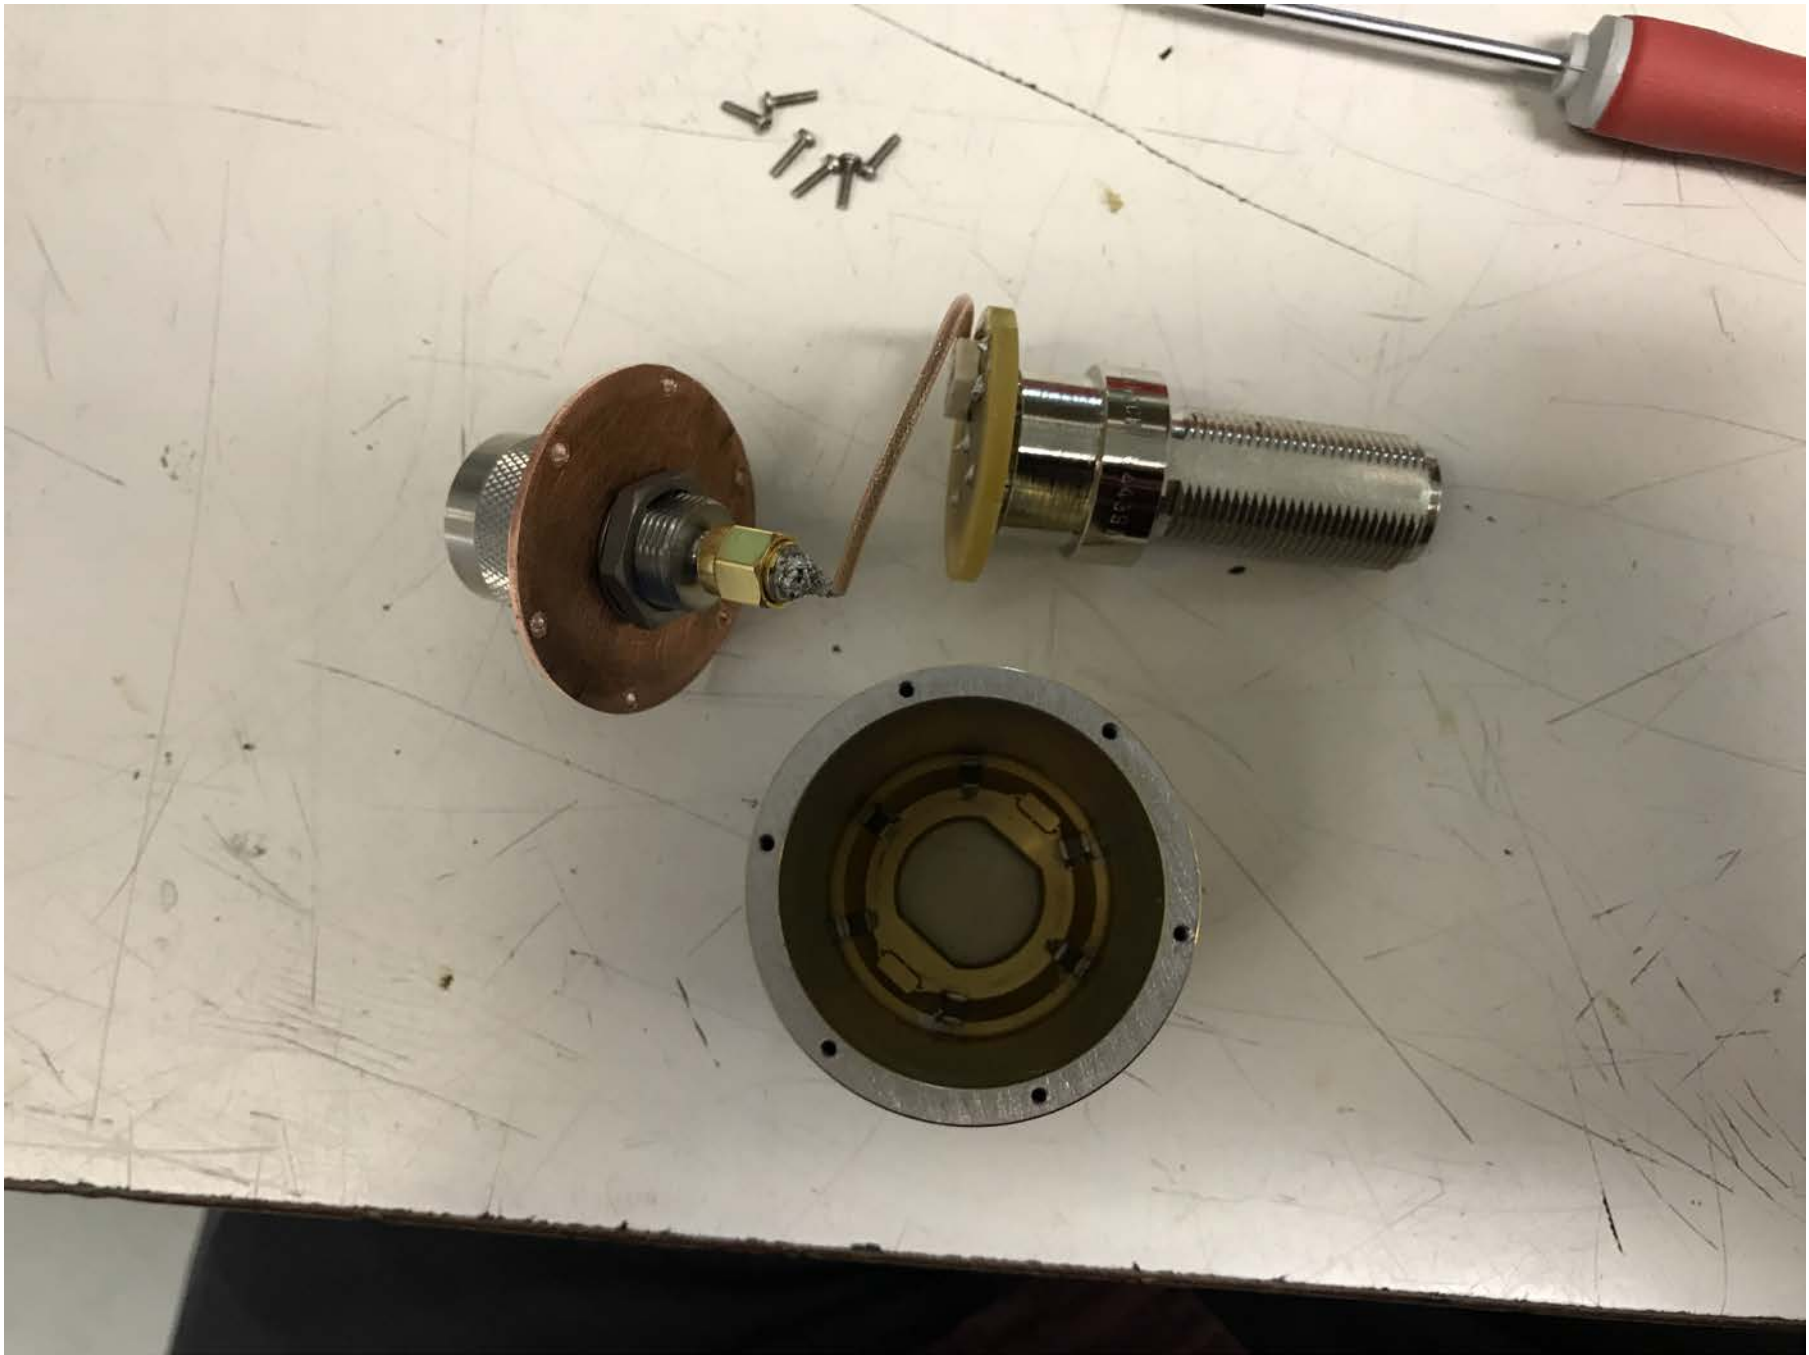
- The second prototype (P2)
 - Installed capacitors and copper end piece as in (P1)
 - Moved transformer on interior PCB and placed UMCC (Ultra Miniature Coaxial Connector) jack on board.
 - Replaced Male N-type solder cup connector with Male N – Female SMA adapter.
 - Replaced wires with RG-178 coax

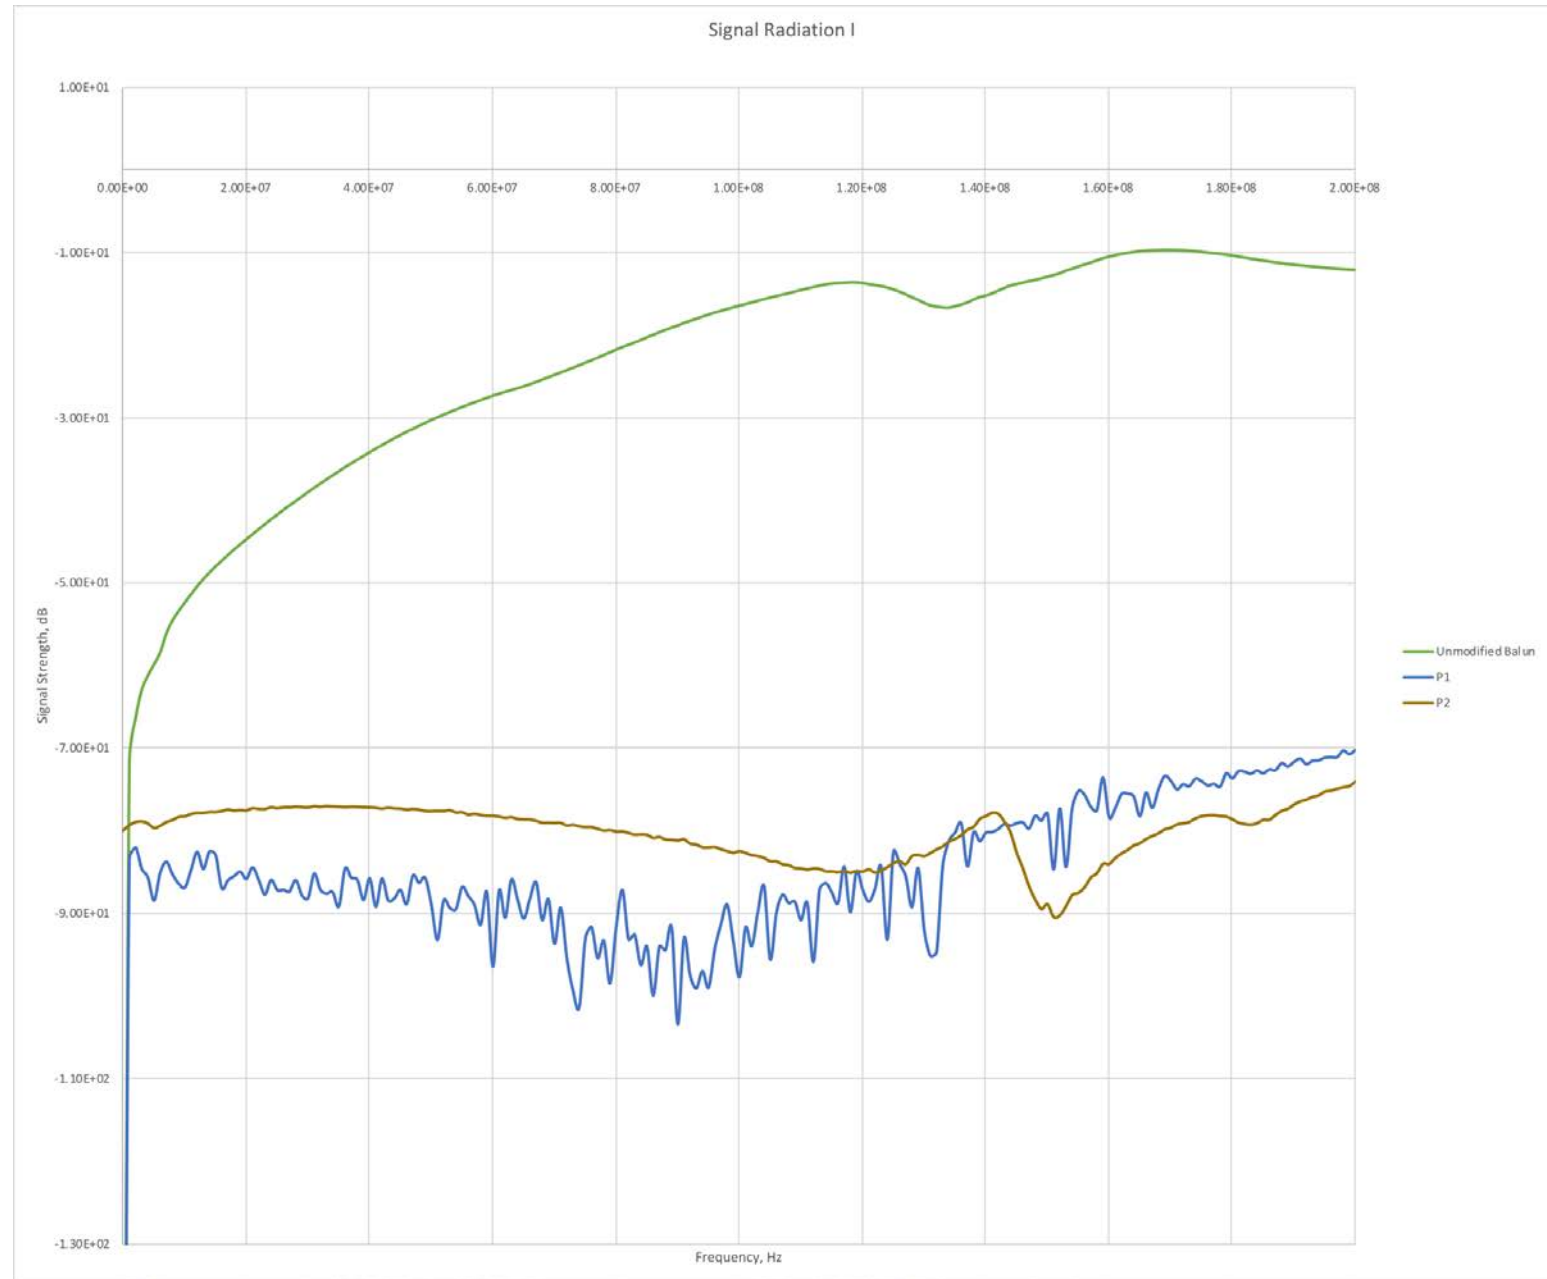
- P2 was a test of a possible board redesign for the internal board.
- Similar attenuation as P1 but more repeatable

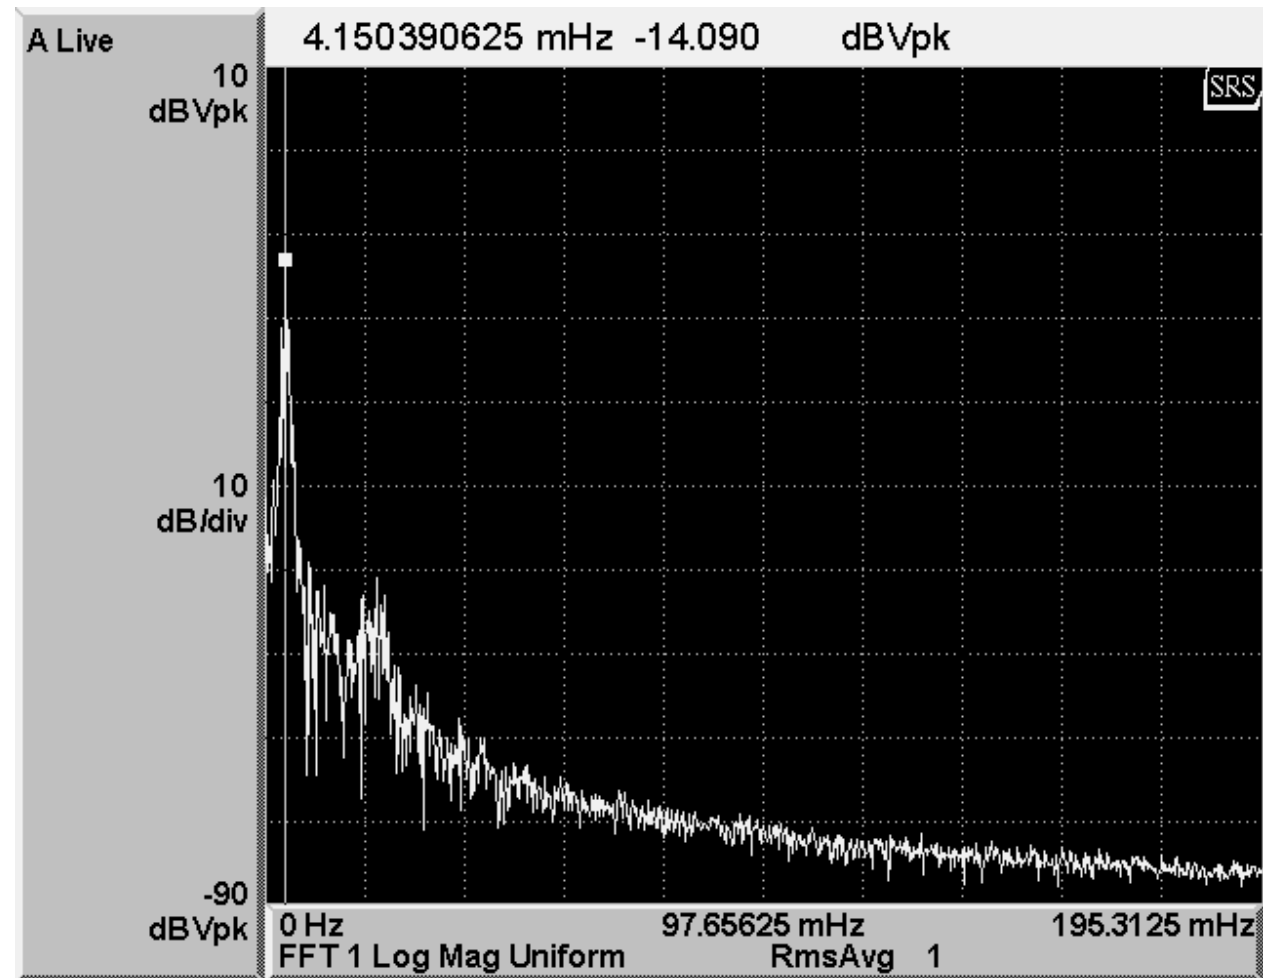
- A 1 Hz Comb was present in the IFO output data
- Possible candidate: phase adjustments of the GPS 1 pps Disciplined Oscillators
- We mixed 10 MHz atomic clock with the 10 MHz GPS disciplined oscillator.
- No comb was found and very little phase noise was observed.
