# Mitigating Laser Damage in LIGO Optics

Jasmine Terrones  
Mechanical Engineering '22

# Laser Interferometer Gravitational-Wave Observatory

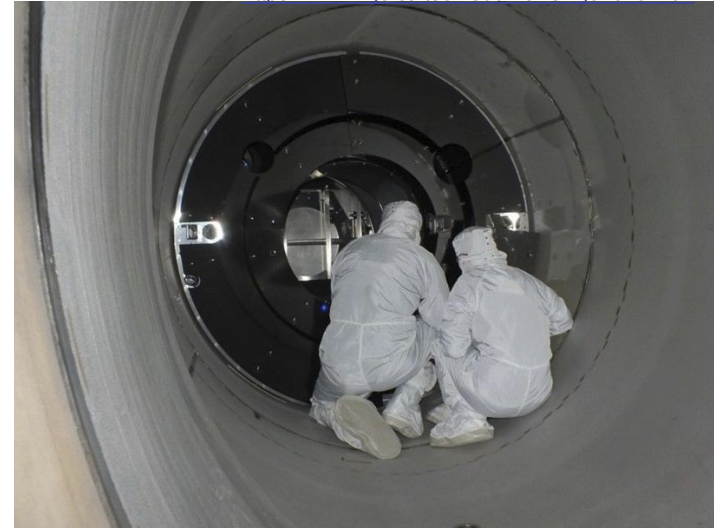
DLC coated SSTL baffle  
installation

- Beam dumps and baffles absorb scattered infrared light
- Black glass used in critical areas
  - Very low reflectivity compared to other materials
  - Extremely fragile and difficult to install
  - Overheats at high power
- Different materials used at higher power
- Search for better materials and coatings ongoing

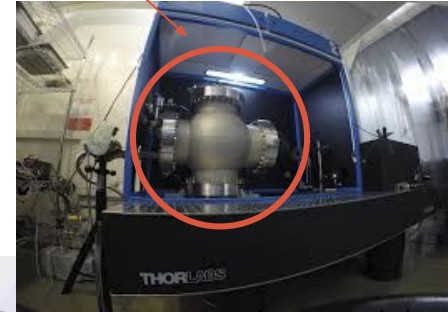
Vacuum system

- In vacuum and in air testing capabilities
- Testing intensities ranging from 50 mW/mm<sup>2</sup> to 1 kW/W/mm<sup>2</sup>
- Equipped with XY translation stages for raster scans
- Damage captured with Nikon Scanning Darkfield microscope
- Higher power laser needed for contamination tests (and more resistant filters, beam dumps, etc.)
