Attack of Stainless Steel Beam Line

Microbially- Induced Corrosion

Daniel P. Henkel, Ph.D., P.E.

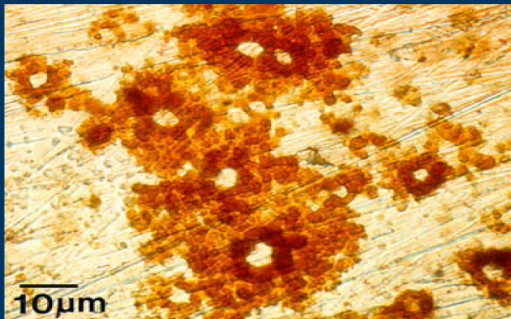
Exterior Wall

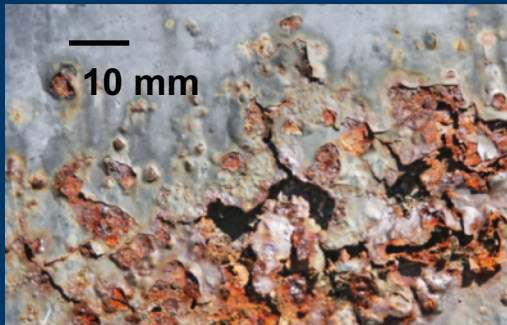
Interior Wall

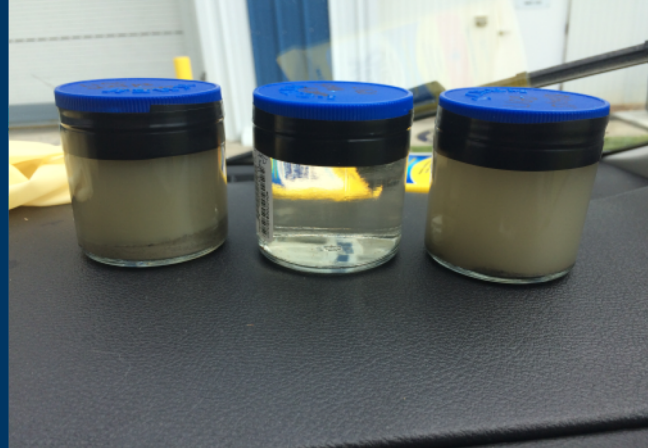
Bacteria in Local Waters

Iron Related Bacteria	Positive, enteric, iron-reducing bacteria 9,000 CFU/mL (High)
Acid Producing Bacteria	Positive 1,500 CFU/mL (Moderate)
Sulfate-Reducing Bacteria	Negative

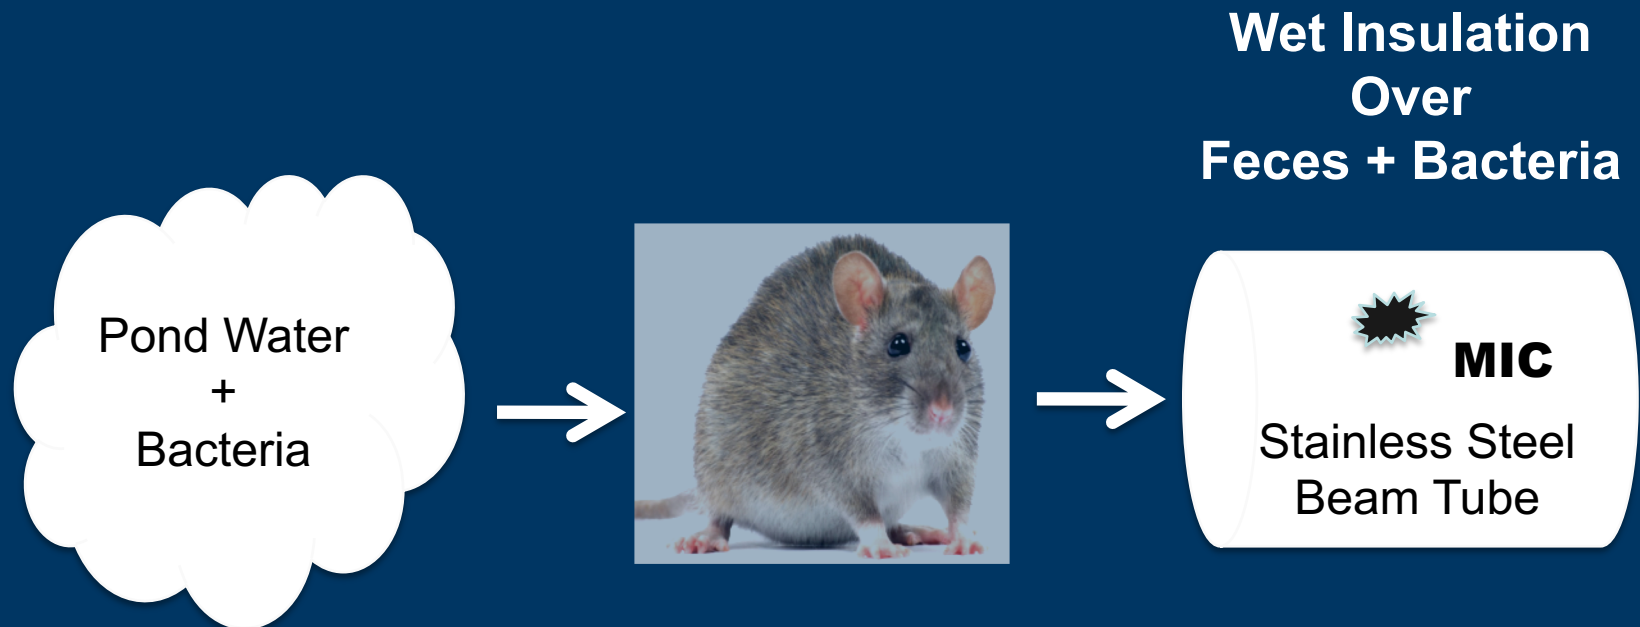
Bacterial Transfer to Insulated Beam Tube

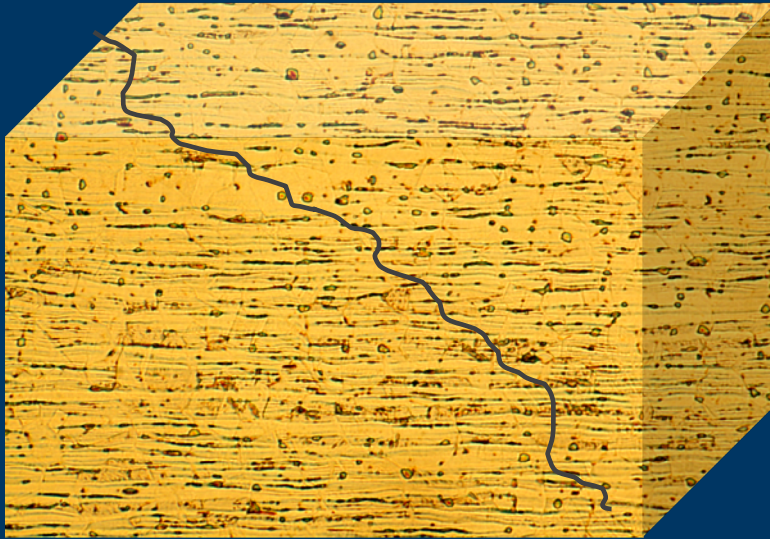
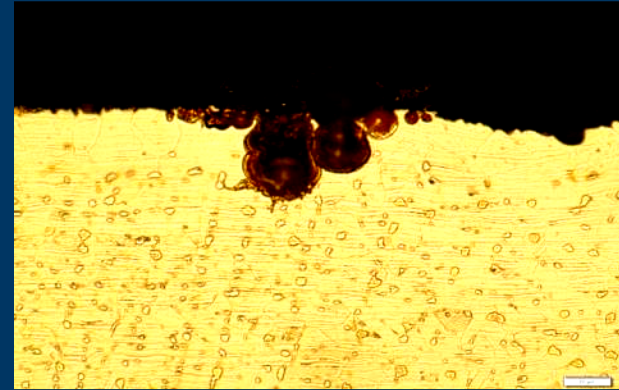
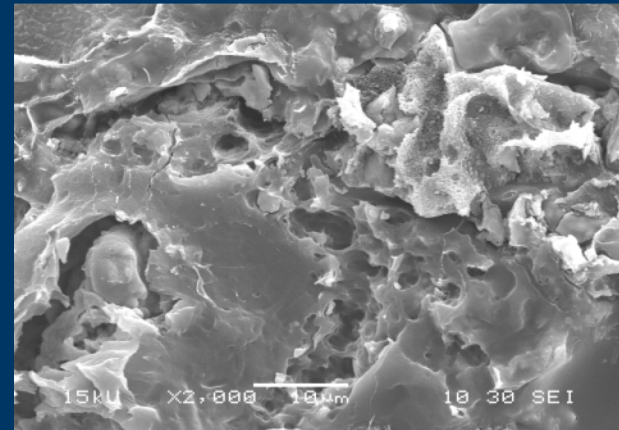
Surface Pitting and Leak Path

- Dry brush to remove any insect debris
- Do not rinse stainless tubes
- No chlorinated solvents inside tunnels
- Maintain less than 60% humidity
- Seal any leaks or drips onto beam tubes

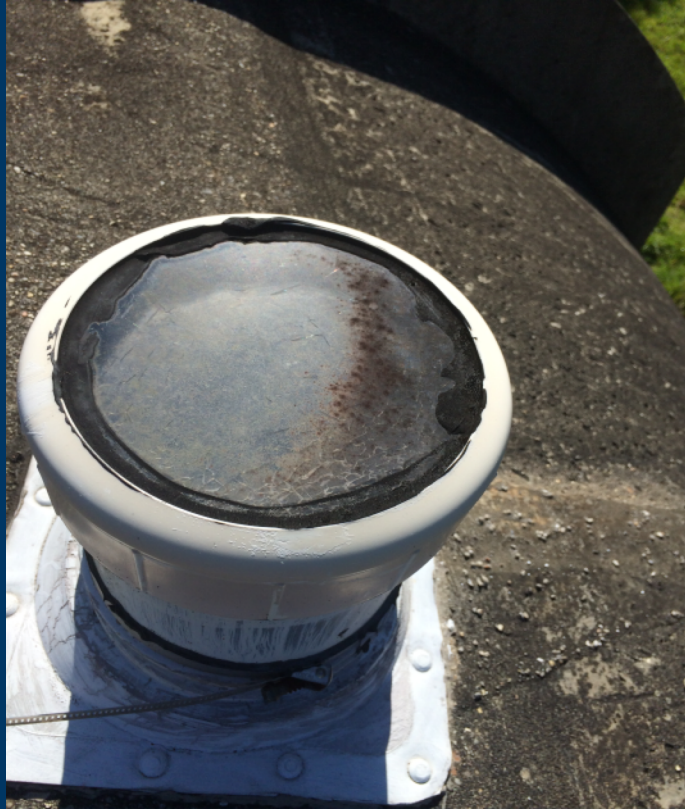
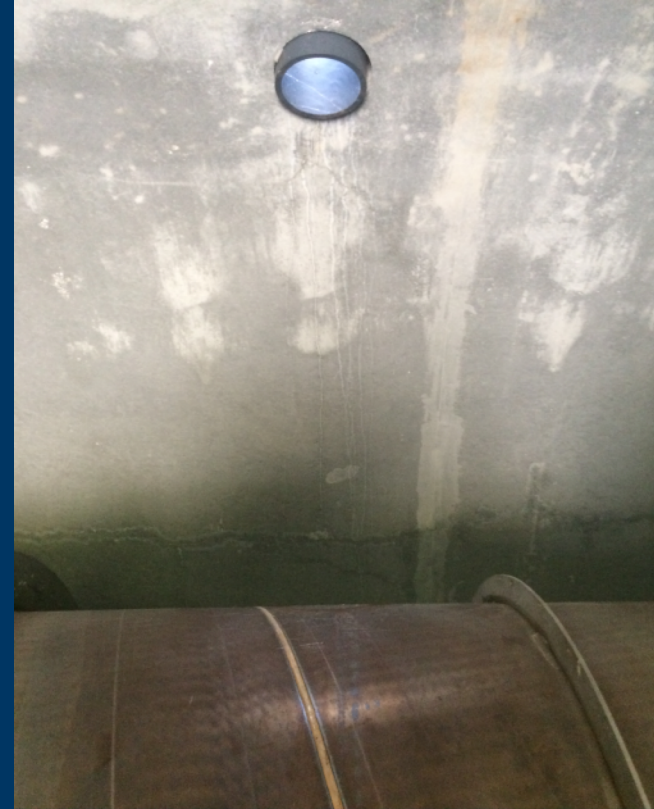
MIC on Un-Insulated Beam Tube Under GPS Outlets

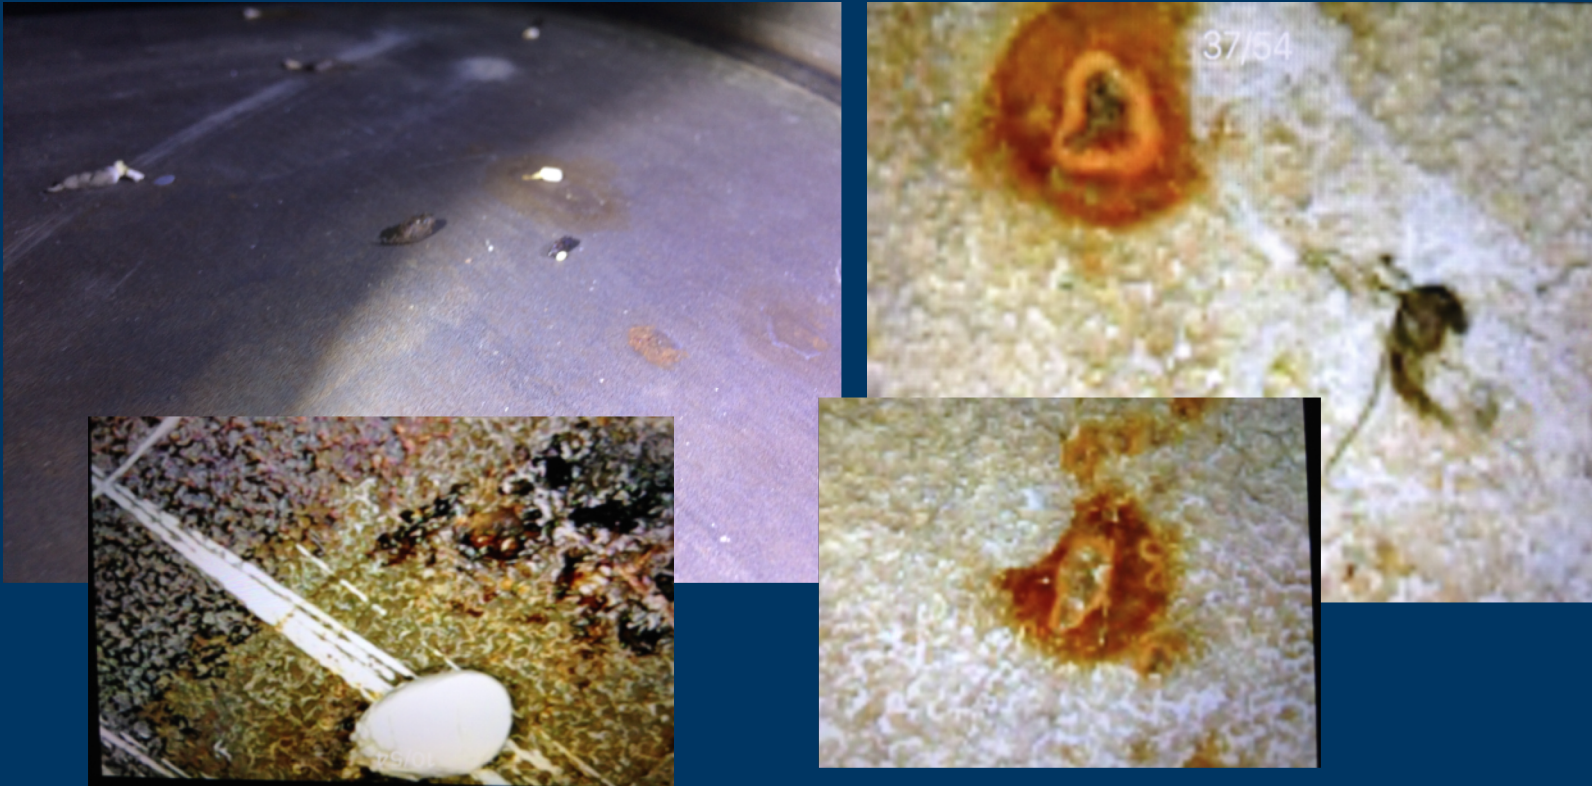
Active Corrosion Under Insect Debris

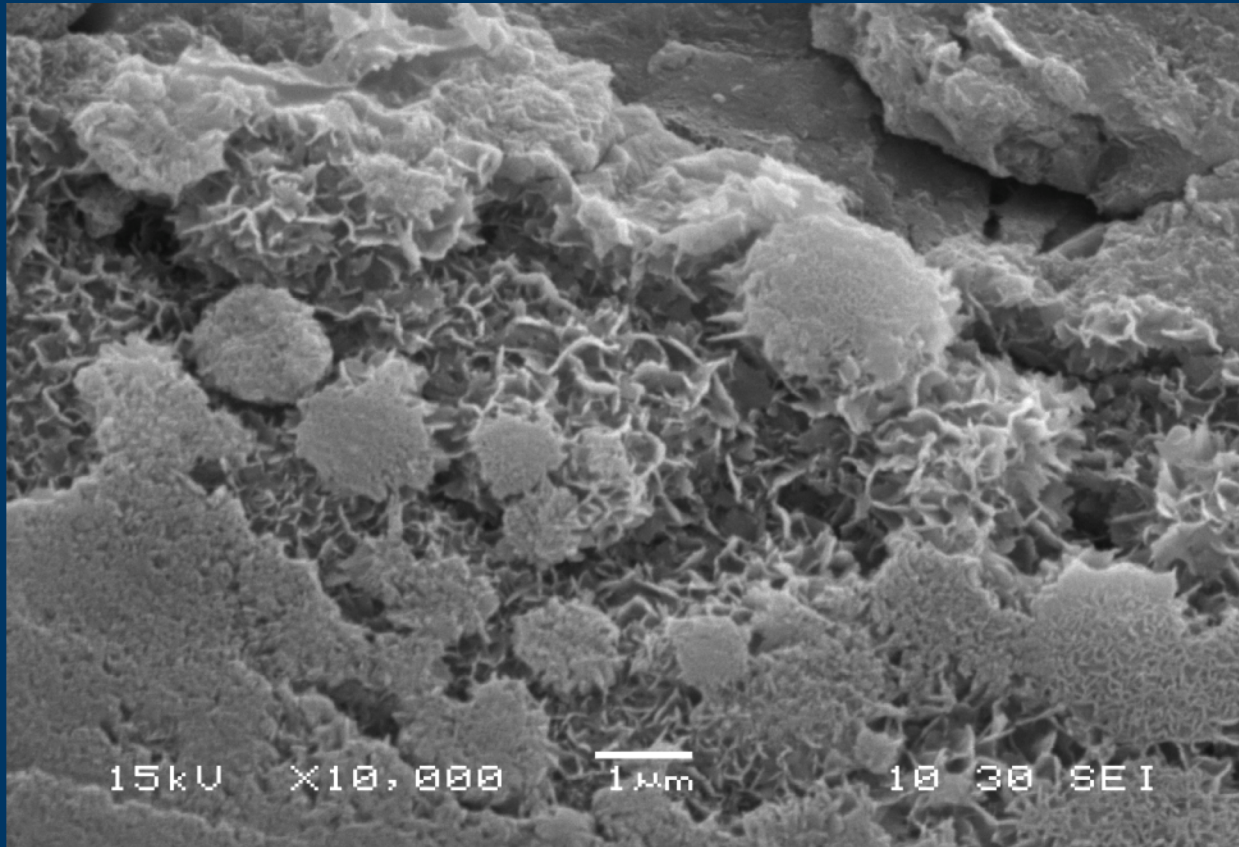
Bacteria Producing Rust

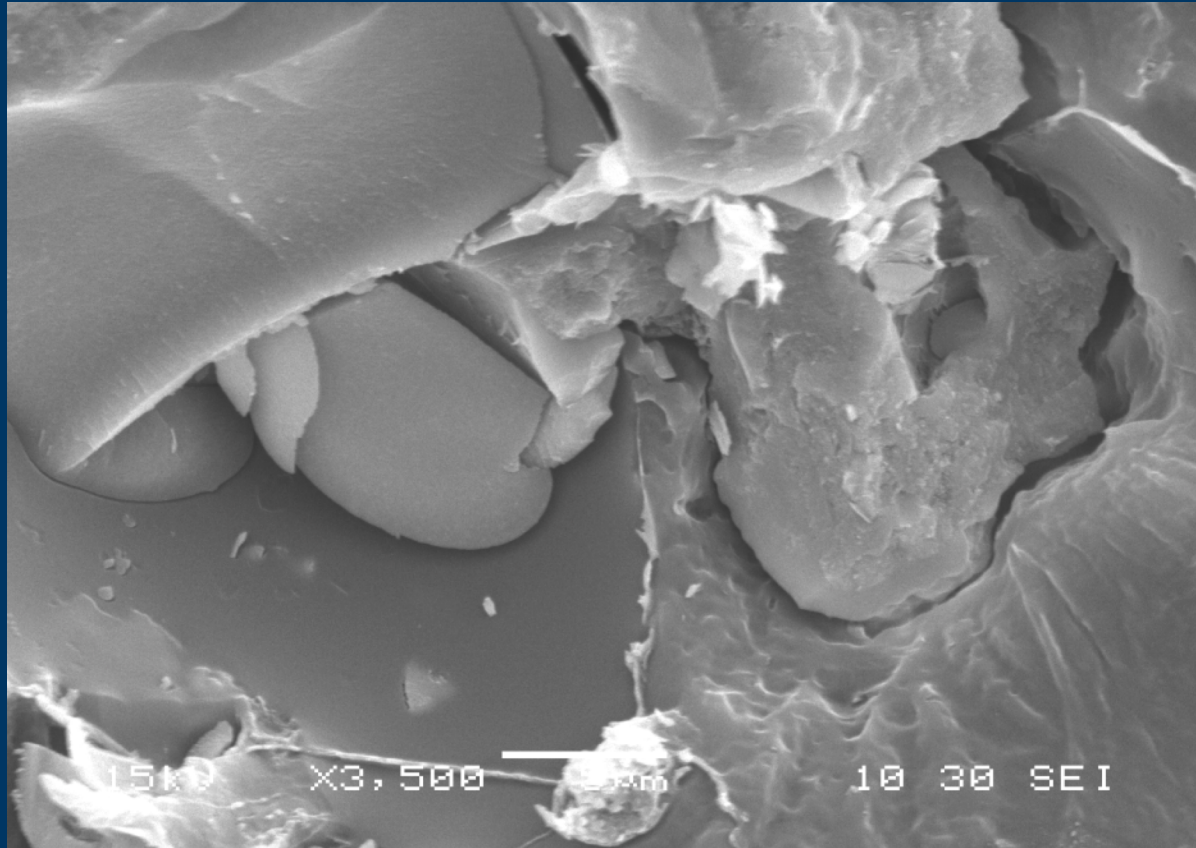
High Mag Image of Bacteria Attack
