LASER INTERFEROMETER GRAVITATIONAL WAVE OBSERVATORY

LIGO-E2500134-v1

## Report: UF Ring Heater (RH) Reliability Testing at 40m

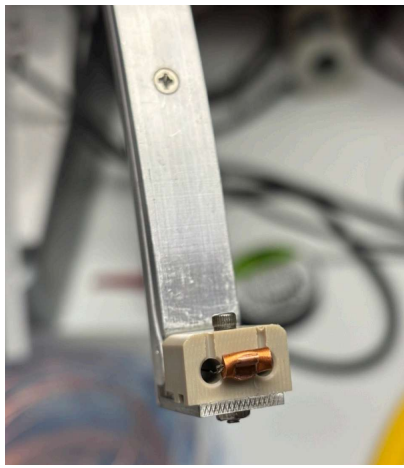
**Figure 2.1-2** Crimping of NiCr outside the PEEK endpiece to close the current loop

The first thing completed was replacing the old NiCr wire. The new wire was measured (Figure 2.1-1) and crimped in a closed loop through the PEEK endpiece (Figure 2.1-2). The NiCr was threaded through the other endpiece and crimped to a copper conducting wire (Figure 2.1-3), which was installed into selected pins of the feedthrough connector (Figure 2.1-4). Assembly was verified in an open-air room before disassembling the breadboard and RH in preparation for cleaning (Figure 2.1-5).

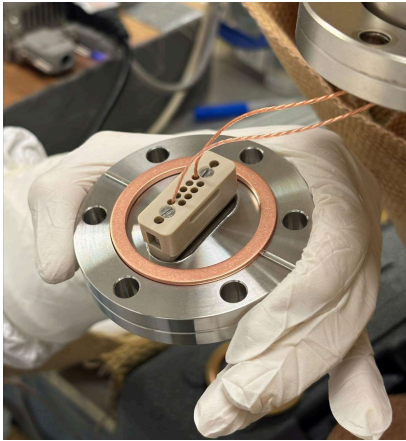
**Figure 2.3-2 In-vac feedthrough port**

The heater needed a current run-through while under vacuum, so a feedthrough port was installed on the Tee with a pressure gauge on the rear chamber door (Figures 2.3-2 through 2.3-4).

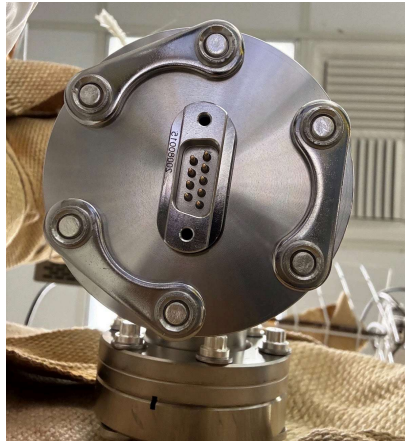
**Figure 2.3-3 Underside view of feedthrough exposed to room air**

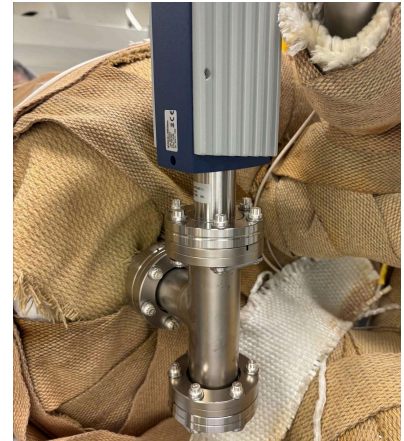
**Figure 2.3-5 Tee-assembly of feedthrough and pressure gauge**
