LIGO Laboratory / LIGO Scientific Collaboration

LIGO- E1000312 *LIGO* January, 2011

aLIGO HAM-ISI, Pre-integration Test Report, Phase I,

LHO Unit 3 – HAM10 (post-assembly, before storage, after replacement of faulty parts)

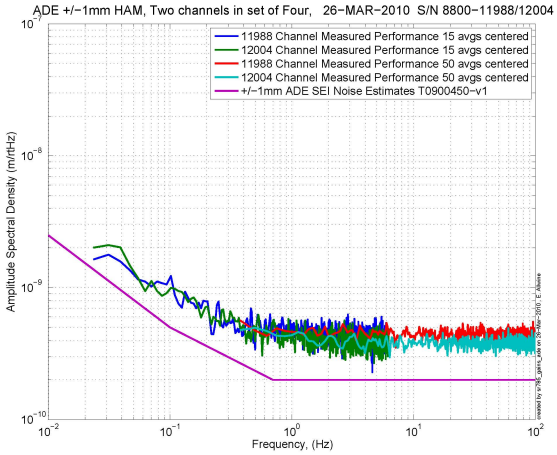
Figure - H1 and V1 sensor noise

Issues/difficulties/comments regarding this test:
- Values of sensor gaps and zeroing were not recorded. Waived for this unit.
- BNC feedthrough connectors have been diagnosed defective and replaced. *Voltage after zeroing post brake* was not recorded since then. Previous results can still be found in DCC document E100237-V2, *Capacitive Position Sensor Testing*.

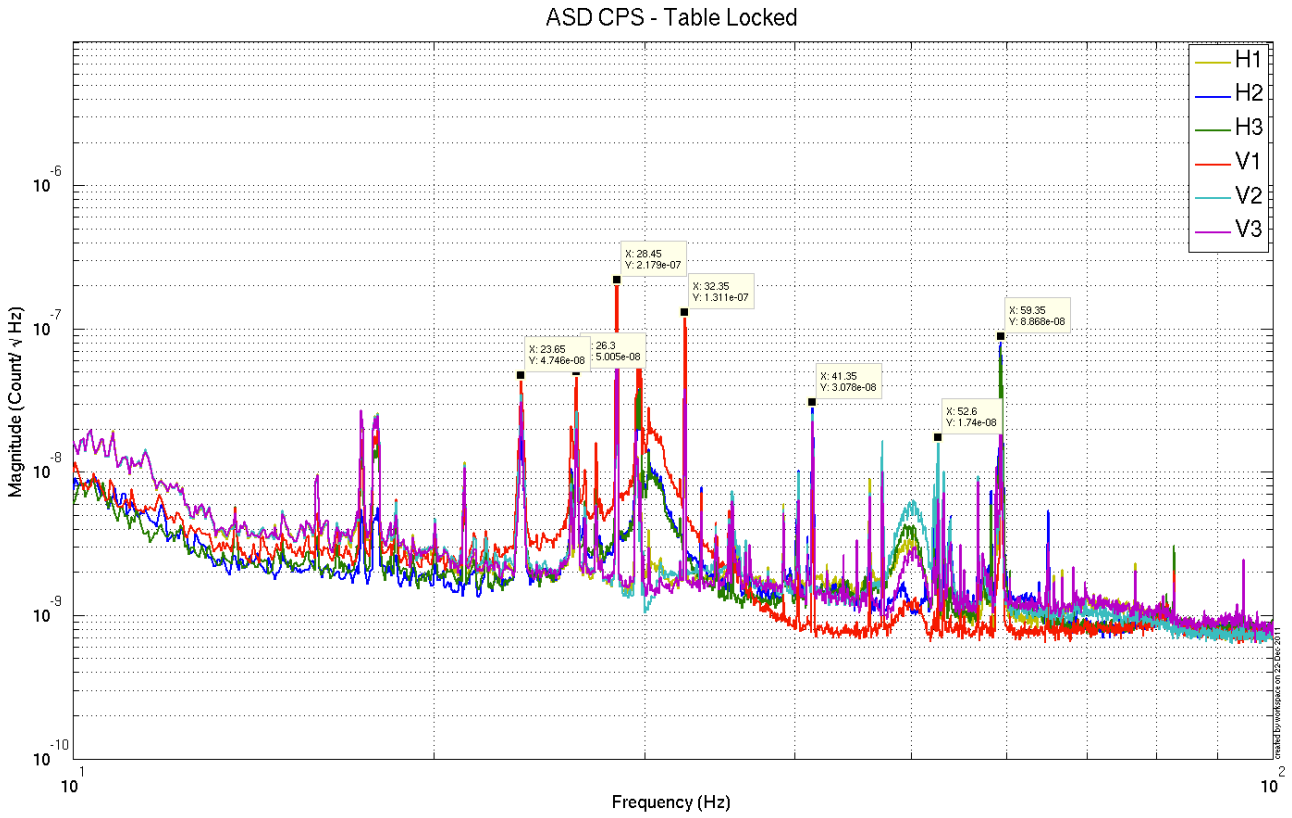
Figure –ASD CPS on locked HAM-ISIs

Subject of investigation:
After measuring few amplitude spectral densities of CPS and GS13 on the HAM-ISI, we were surprised by the high density of narrow peaks between 10Hz and 100Hz (cf figure *ASD CPS on locked HAM-ISI*). Since these peaks are less visible on GS13 spectra (cf step 6, GS13 ASD figure), we thought that electronic noise could create the high Q peaks on the CPSs. Since measurements are taken with the HAM-ISI in the so-called "locked" position, we should not see any stage 0 to stage 1 relative motion. Hence, we got concerned by the grounding of the new shielding installed on the CPS cables.

Extra tests:
We took measurements in different configurations to find the source of the peaks:
- CPS spectra fans ON vs fans OFF: We only saw minor differences

The two spectra (shield not grounded, and shield grounded) are identical and without any features in the 10-100Hz bandwidth (Noise floor at 5e-10 m/sqrt Hz). It confirms that CPSs are not picking up electric noise but are actually seeing a real motion.

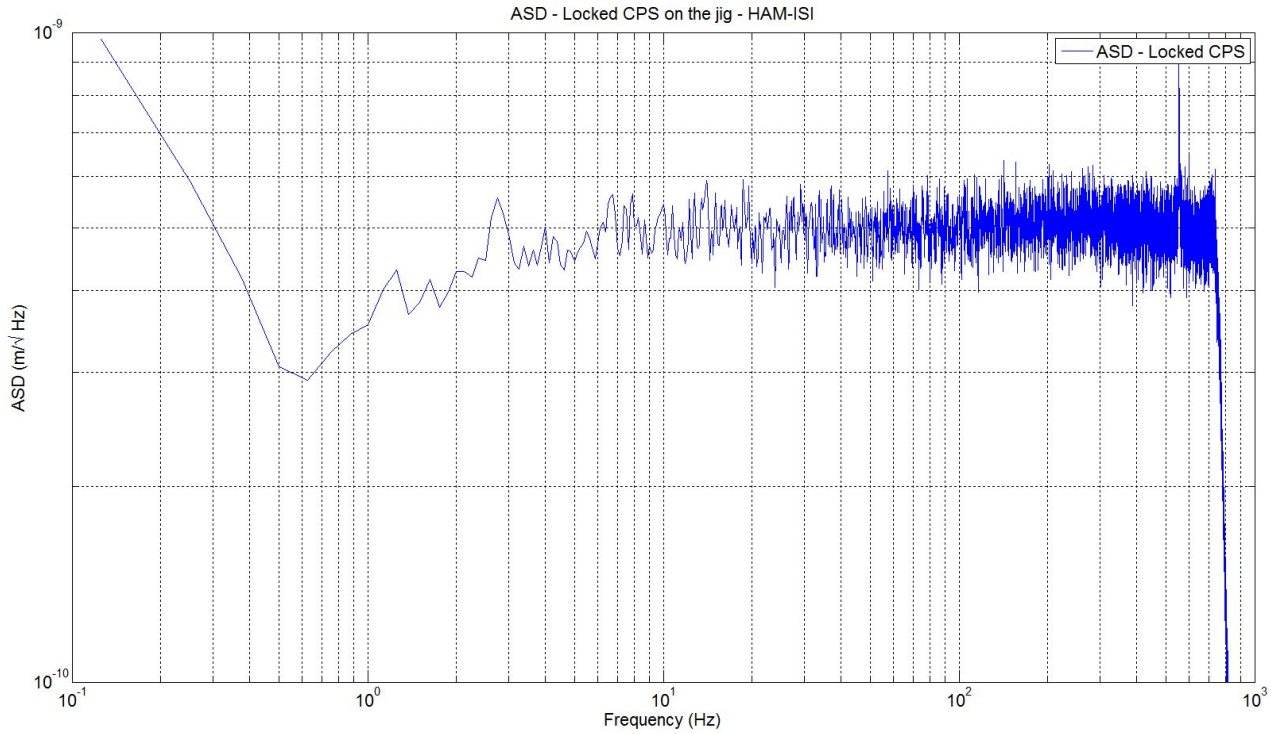
Figure –ASD locked CPS on the jig

The figure below is the calibrated ASD of the CPS on the jig.

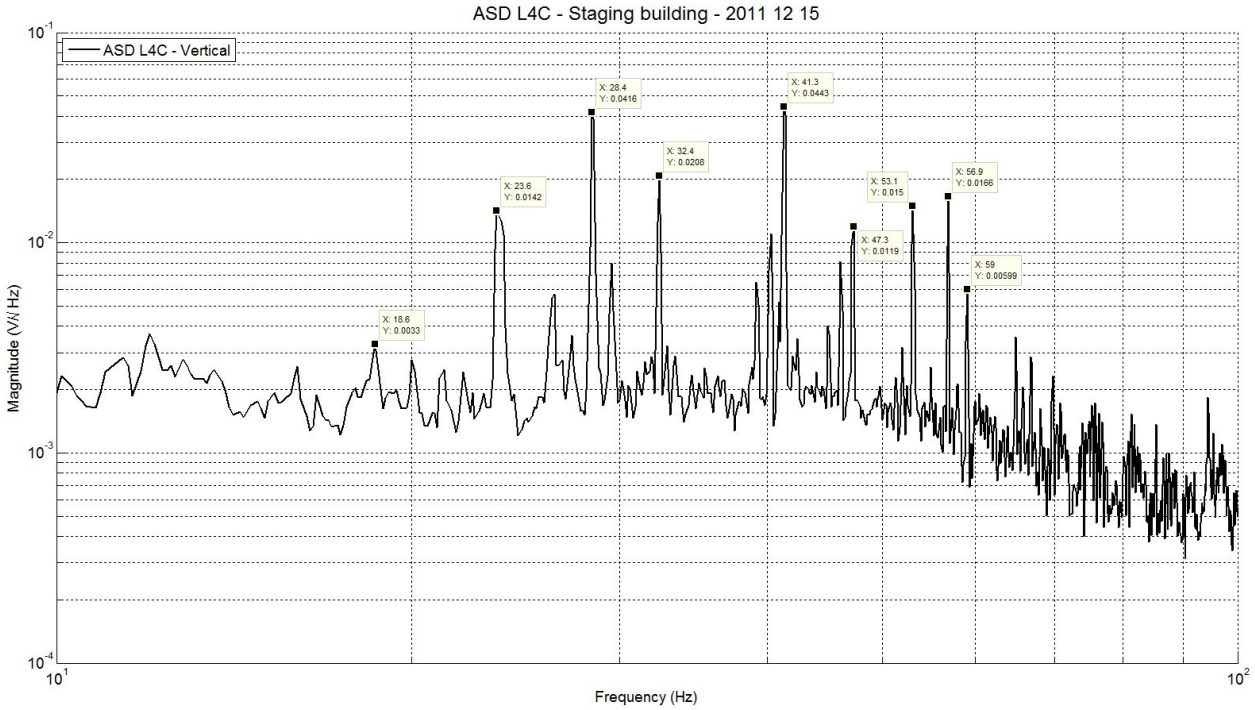
Figure – ASD of L4C on the ground in LHO staging building

A L4C was set on the ground to confirm that the peaks seen on HAM-ISI CPS ASD, in the so-called "locked" position, comes from ground motion itself. Due to the passive isolation provided by the ISI above 1Hz, amplitudes of the narrow peaks (probably motors) are reduced on GS13 (in the unlocked and the so-called locked configurations).

Narrow peaks agree with ASD of CPS in "locked configuration"

Conclusions regarding this test:
This last measurement confirms that the peaks seen on the ASD of the CPS when the HAM-ISI is locked are due to ground motion.

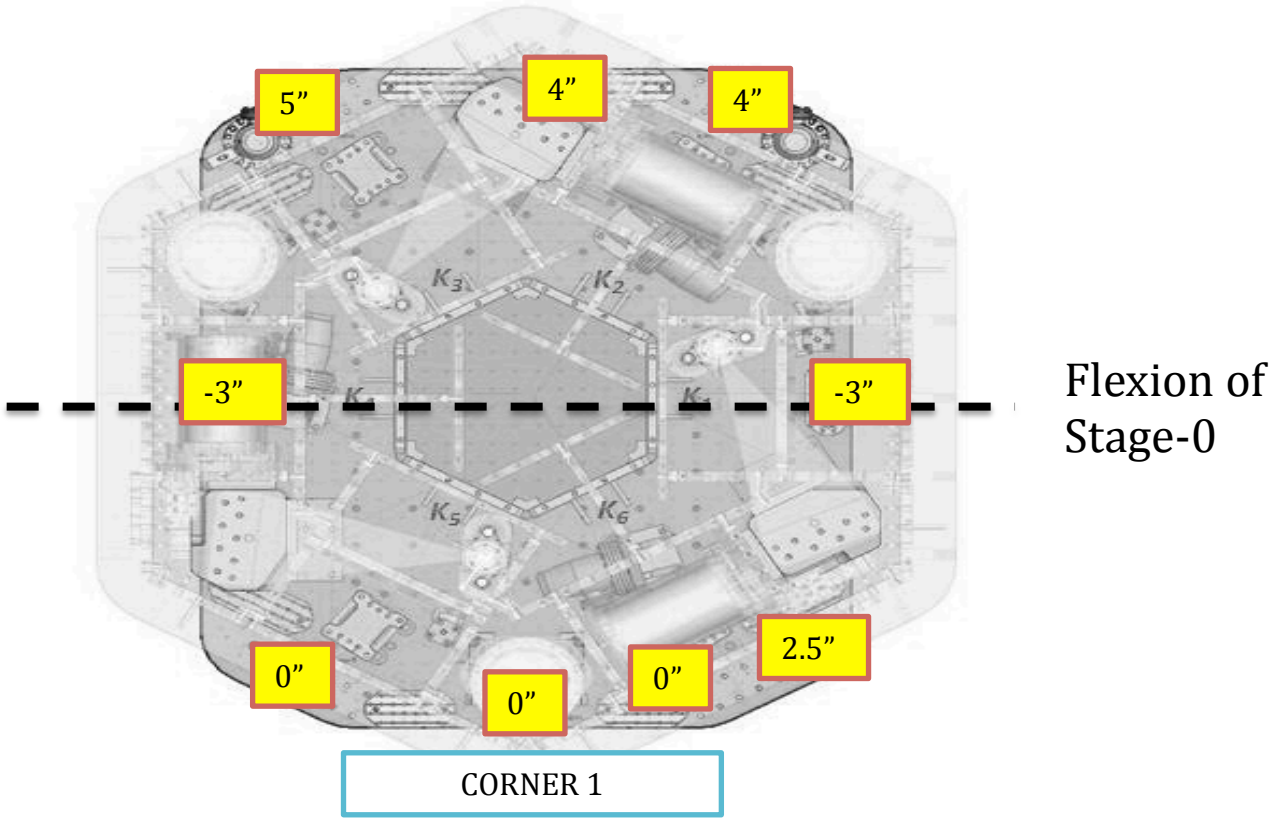
Figure – Level measured on Stage 0

Issues/difficulties/comments regarding this test:
Stage 0 appears to be flexing along the median line which is facing corner 1.

Max angle=(0.005)/(72/2)= 141µrad

Test result: **Passed:** ____ **Failed:** __X__

Note:
This test doesn't meet our stringent requirement, however this leveling value is sufficient for all the tests being performed.

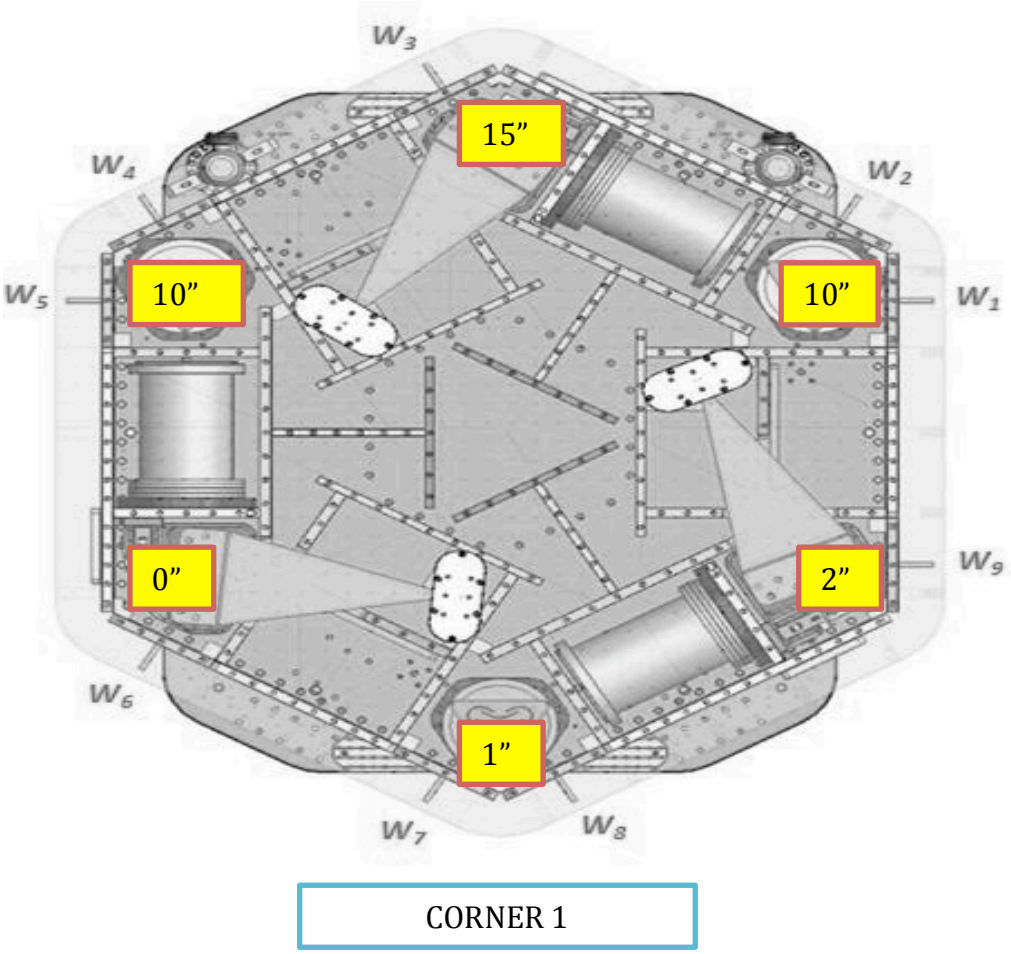
Figure – Level measured on Stage 1

Issues/difficulties/comments regarding this test:
The optical table appears tilted with corner 1 the lower point.

Max angle = (0.014)/85.59 = 164 µrad

Max angle $_{\text{stage 0 inclination removed from recorded values}}$ **= (0.014-0.005)/85.59 = 105 µrad**

Test result: **Passed:** ____ **Failed:** X

Note:
This test doesn't meet our stringent requirement, however this leveling value is sufficient for all the tests being performed.

Issues/difficulties/comments regarding this test:
Shims could be used to adjust stage-1 level previously measured out of spec.

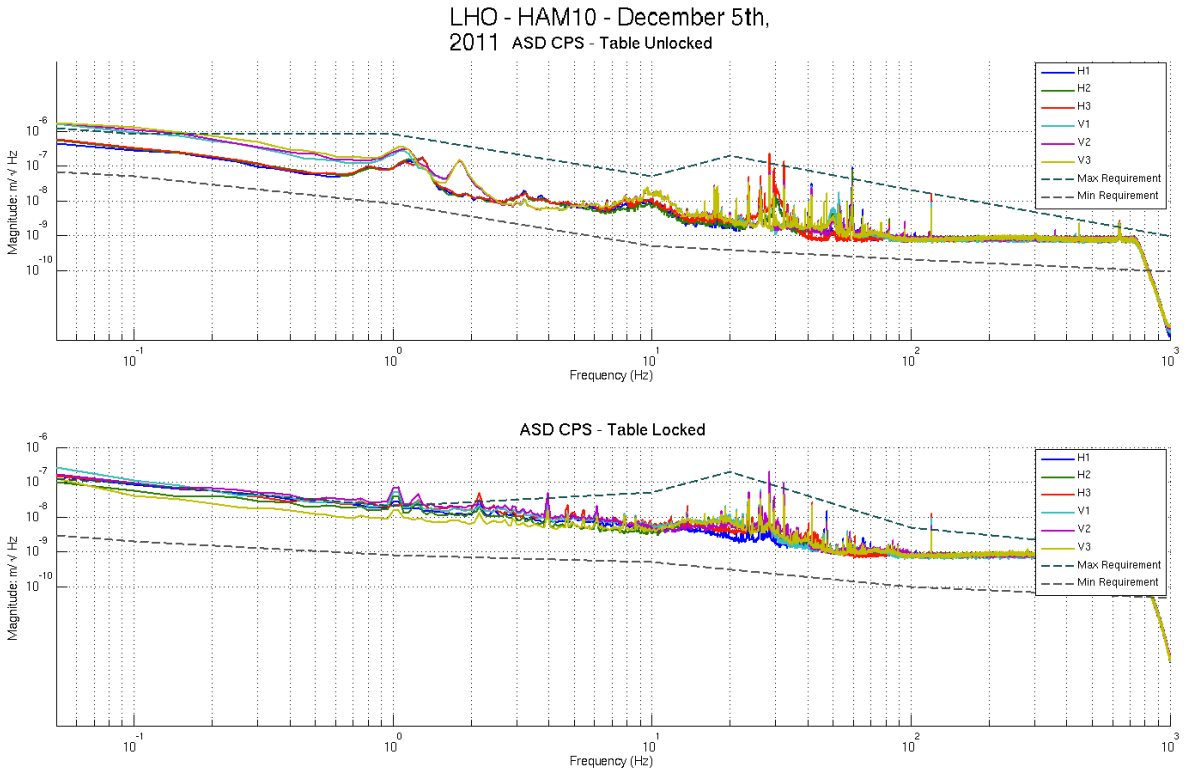
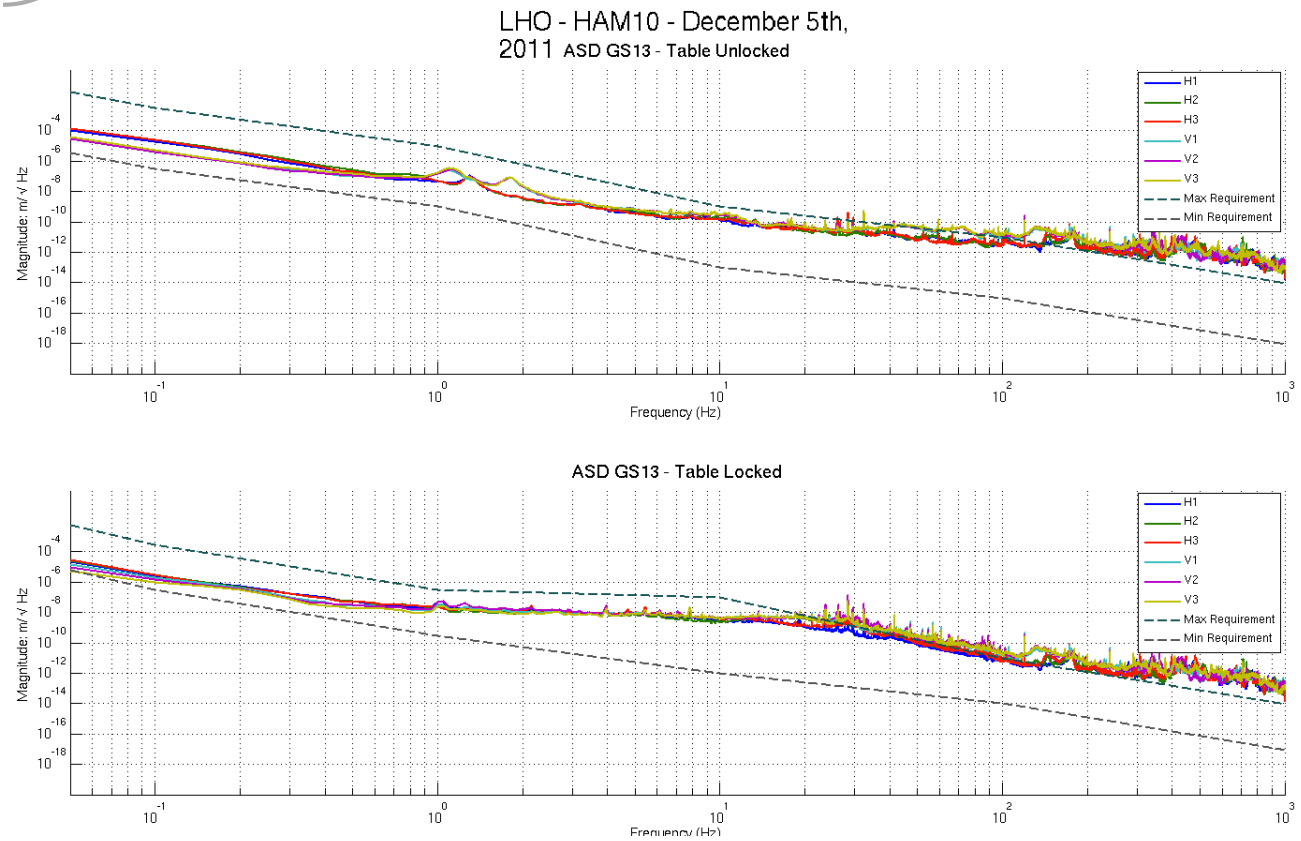
Figure - Calibrated CPS power spectrum

Figure – Power spectrum Calibrated GS13

Issues/difficulties/comments regarding this test:
10Hz-100Hz peaks investigated above in Part 1, last step: *capacitive position sensor investigation*.

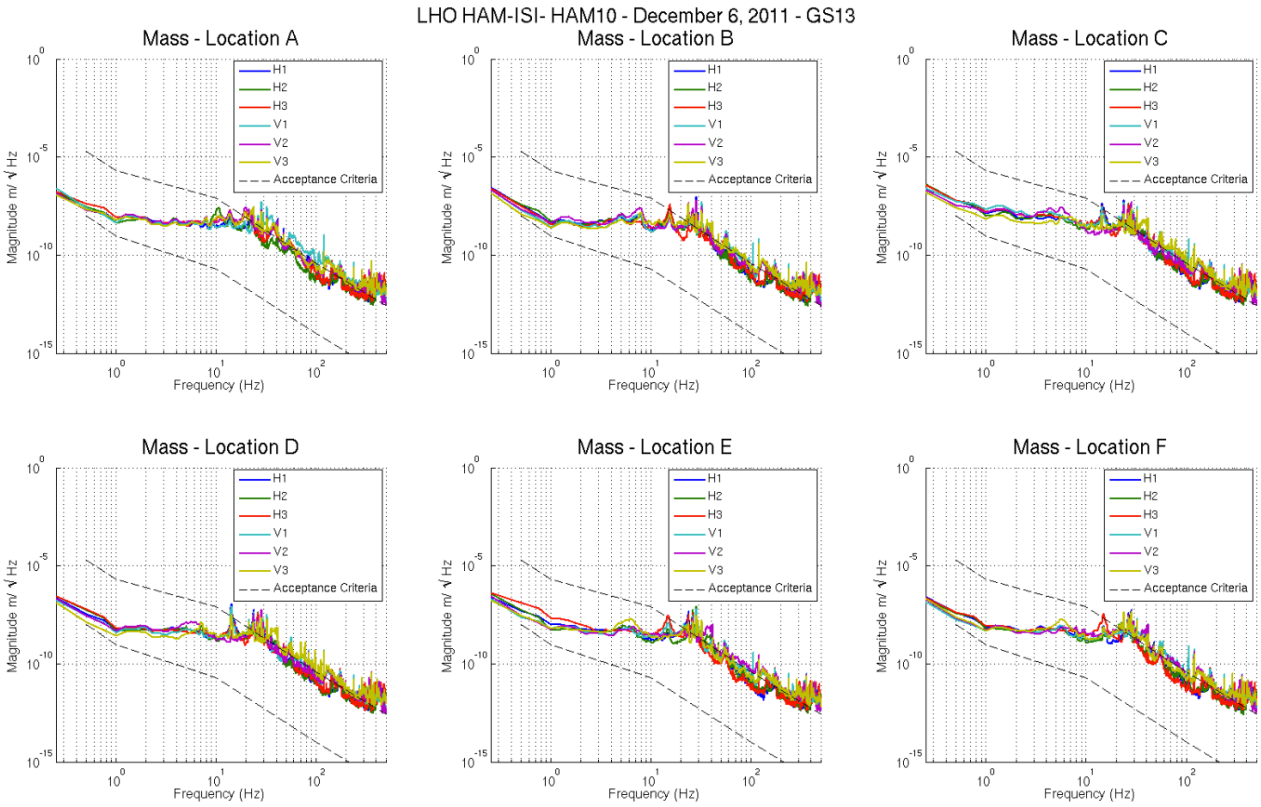
Figure – Power spectrum Calibrated GS13 with mass at corners A to F

Issues/difficulties/comments regarding this test:
Test GS13 are used, so borderline values are acceptable.

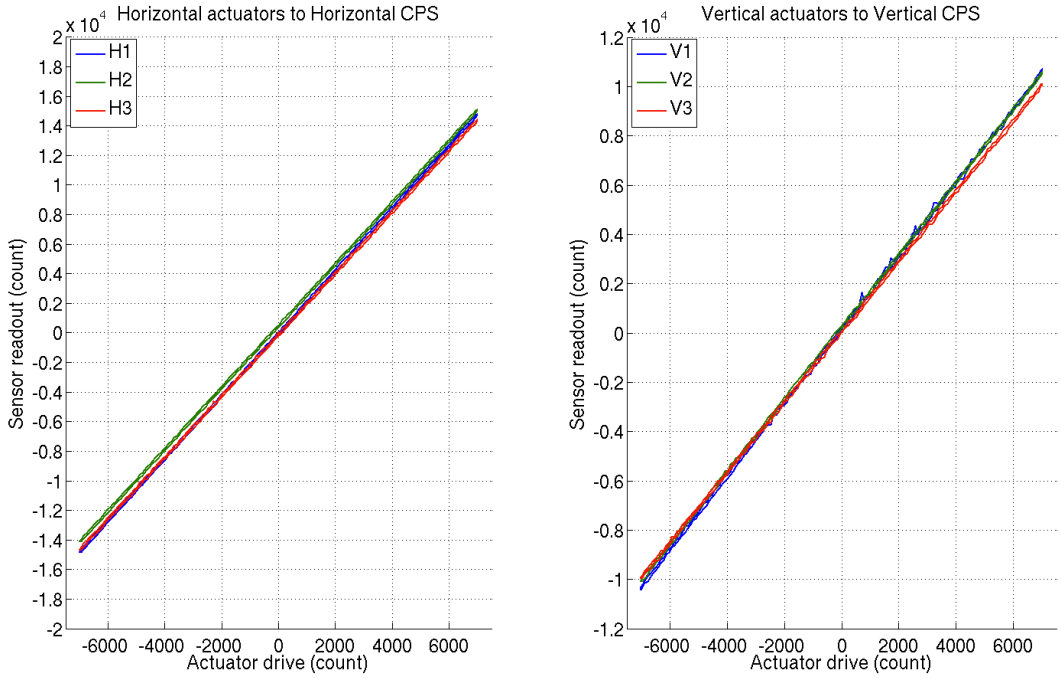
Figure - Linearity test on the triplet 'actuators - HAM-ISI – sensors' in both Horizontal and vertical directions

- A cable was rubbing initially and caused V1 and V3 to be 5% off average.
- No cable rubbing anymore. Still, we observe 2% off average for these sensors.
- Cables lengths vary from one corner to another. They are:
  - Corner 1: 26ft
  - Corner 2: 42ft
  - Corner 3: 48ft

Test result: **Passed: ___** **Failed: __X__**

Step I.2: Test GS13 will be replaced with permanent ones. S/N should be recorded then.
Step III.14: Deviation from average slope out of spec. However this is associated with cable length. Make sure that linearity test results correlate with the final filed cables.

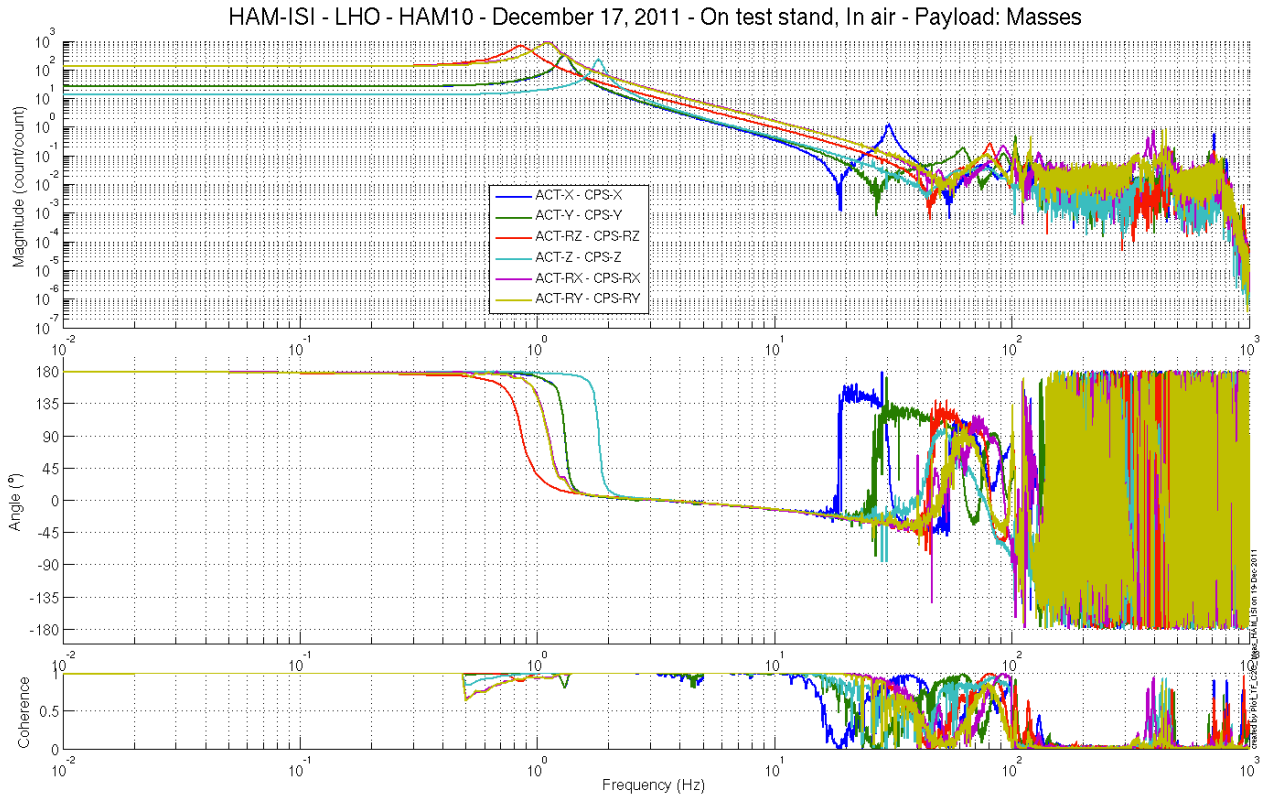
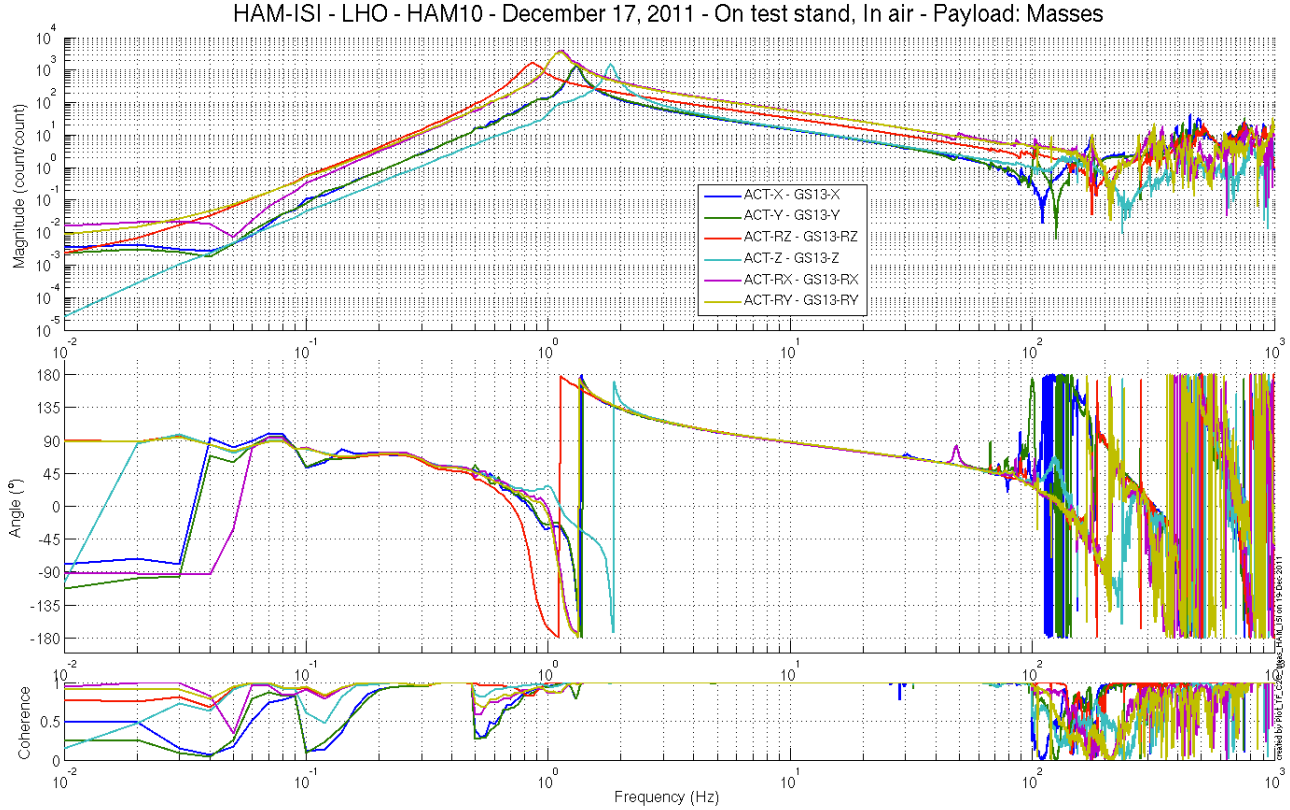
Issues/difficulties/comments regarding this test:
Damp gain set on -1 during measurements causing phase not starting at 0 degrees.

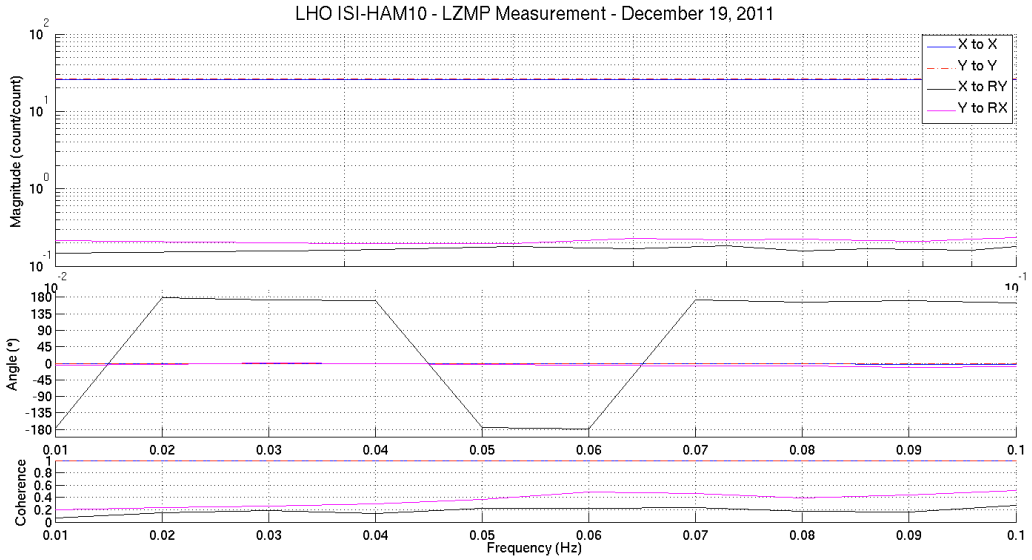
Figure - Lower Zero Moment Plane – Main and cross couplings at low frequency

Issues/difficulties/comments regarding this test:
Increasing the number of averages from 200 to 300 did not affect results.

LMZP Offset X - mm
1.1906
LMZP Offset Y - mm
1.5215
