LIGO- E1100304	*LIGO*	August 13th, 2012

aLIGO BSC-ISI, Pre-integration Testing report,

Phase I (post-assembly)

This document presents the series of tests (Phase I) performed on the ISI-BSC2 (ITMY) in the High Bay before its move to the LVEA (Teststand). Tests were done during March 2012.

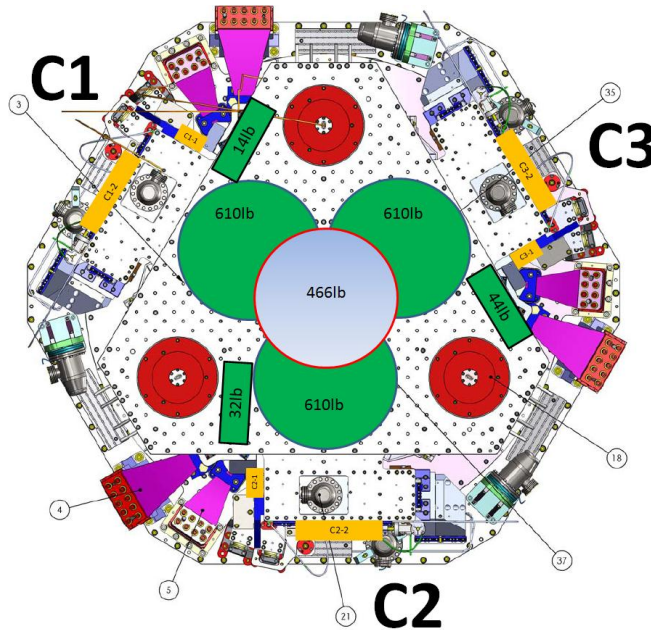
Figure - Masses distribution

The figure below presents the location of the masses on both stages.

Nominal payload: 108.9Kg – 240lb
Added masses are 73Kg – 160lb lighter than expected.
Total mass of stage 1=912Kg - 2010lb

Nominal payload: 1185Kg – 2612lb
The added masses is 106Kg lighter than expected.

Total nominal mass of Stage 2: 2830Kg – 6239lb
Error on the nominal overall mass of stage 2: 106/2830=3.7%

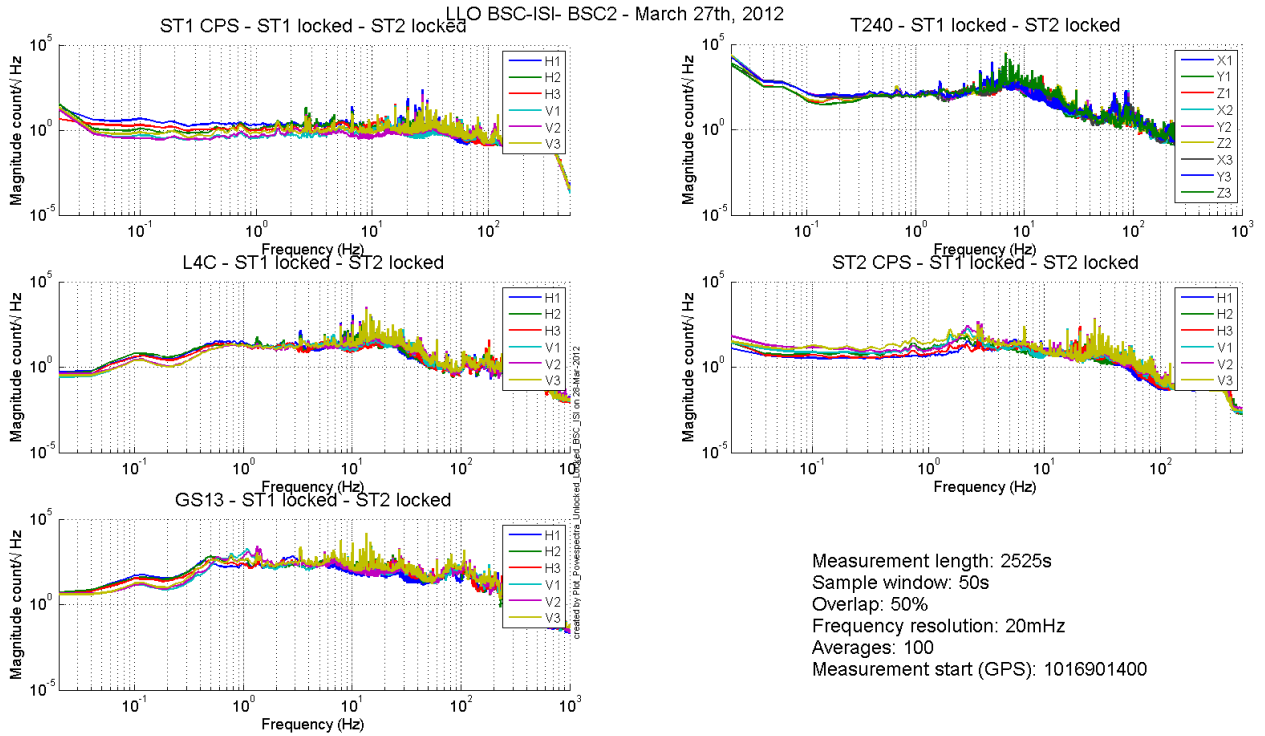
Figure 1: Spectra Stage 1 Locked Stage 2 Locked

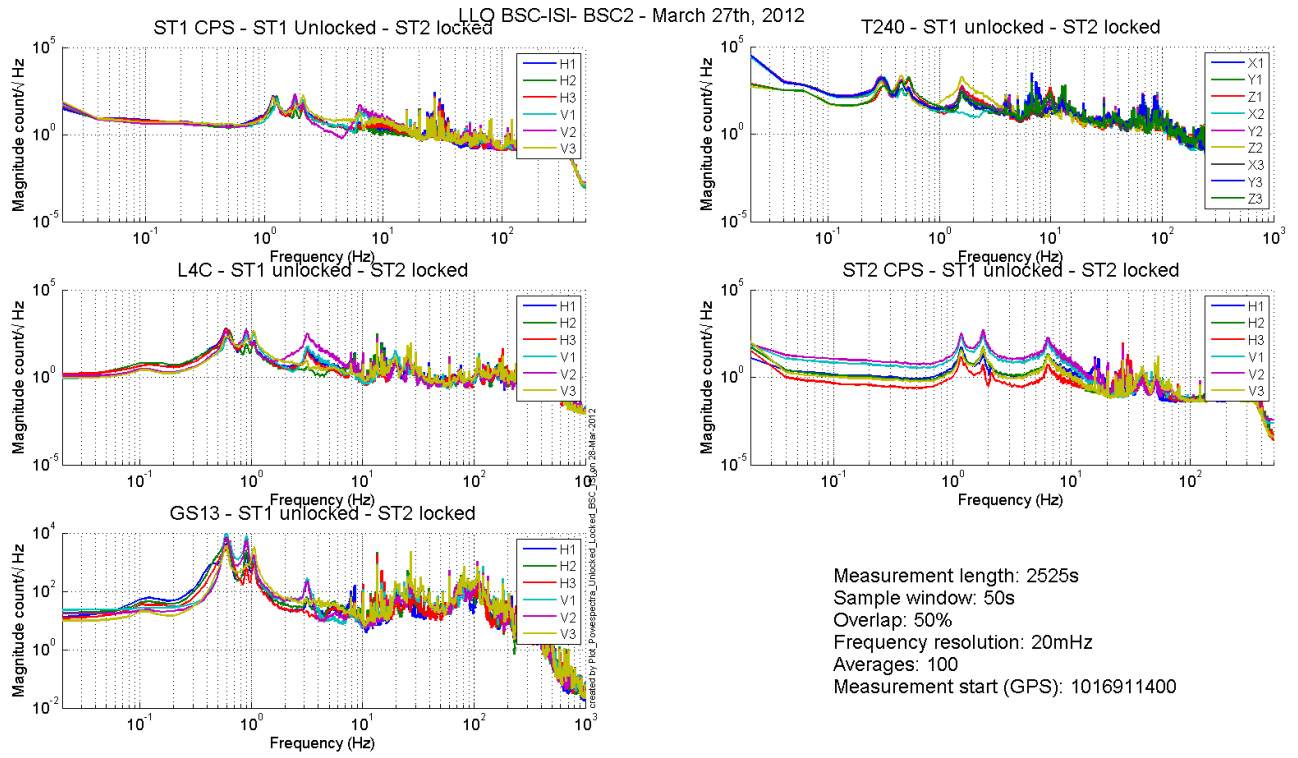
Figure 2: Spectra Stage 1 Unlocked Stage 2 Locked

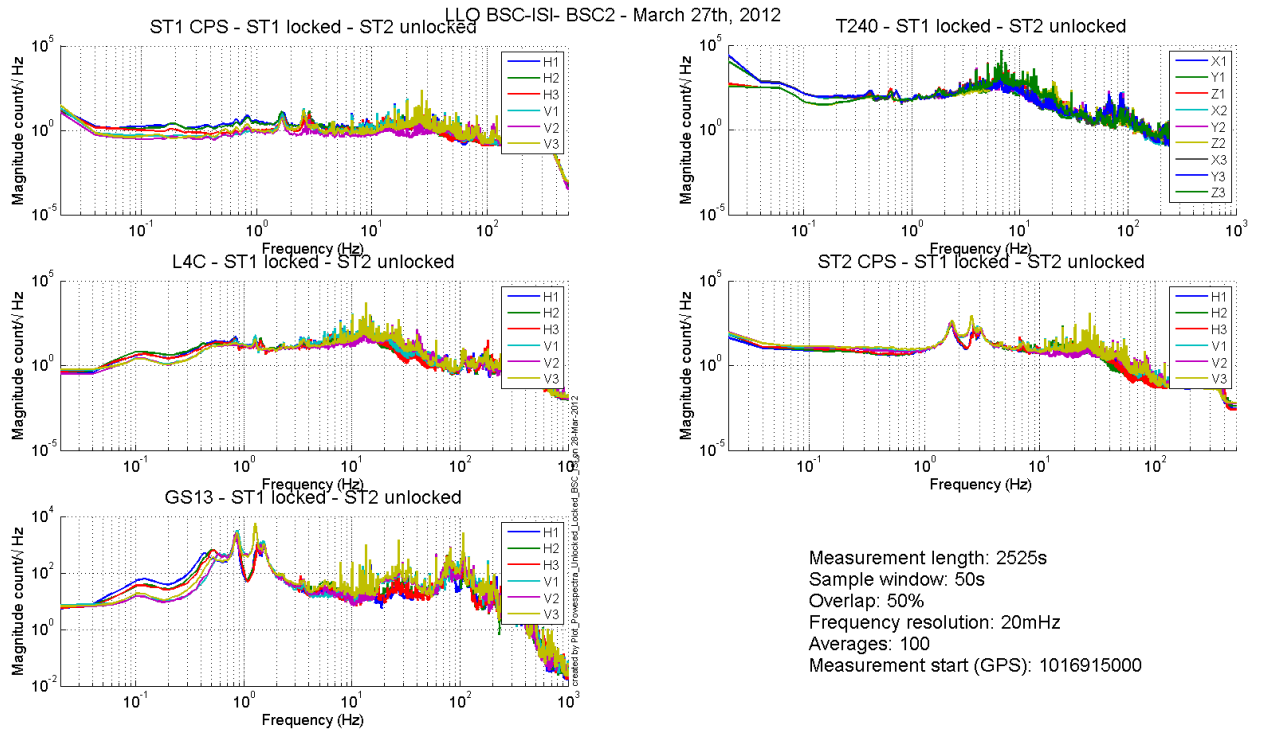
Figure 3: Spectra Stage 1 Locked Stage 2 Unlocked

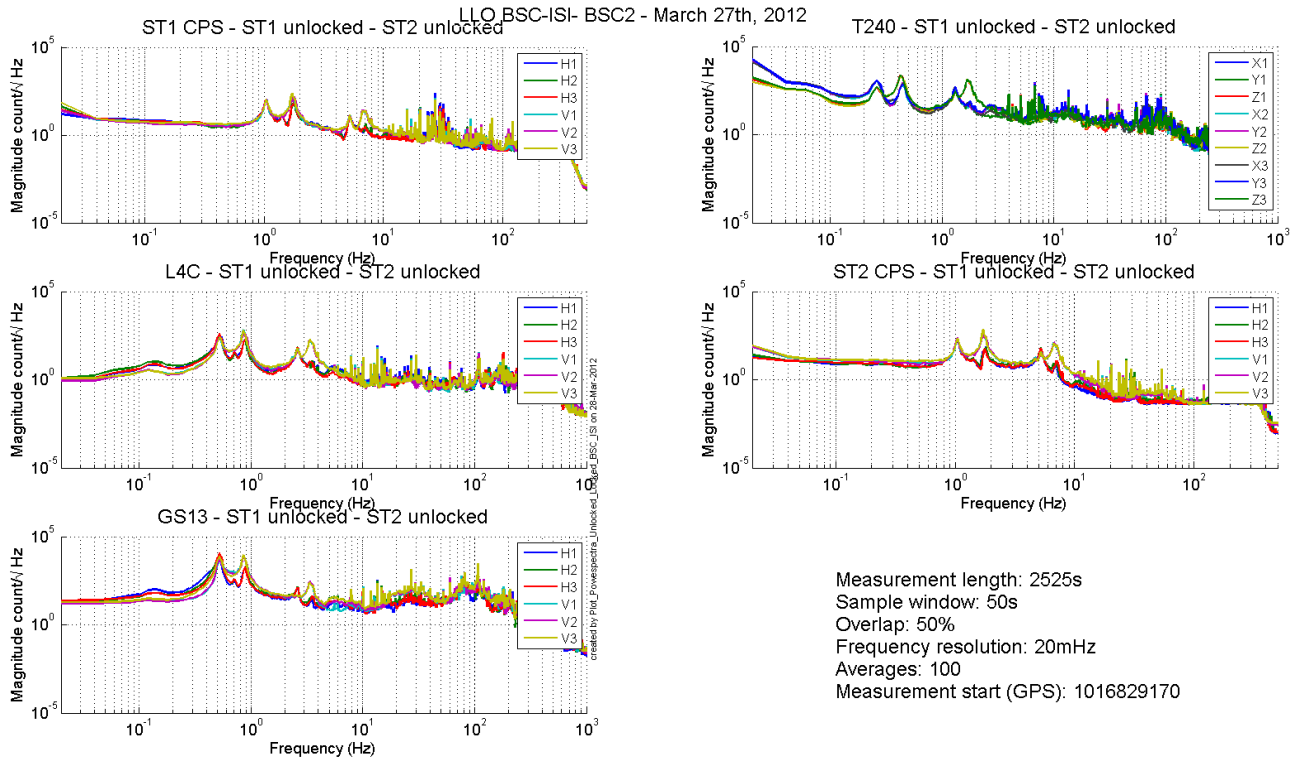
Figure 4: Spectra Stage 1 Unlocked Stage 2 Unlocked

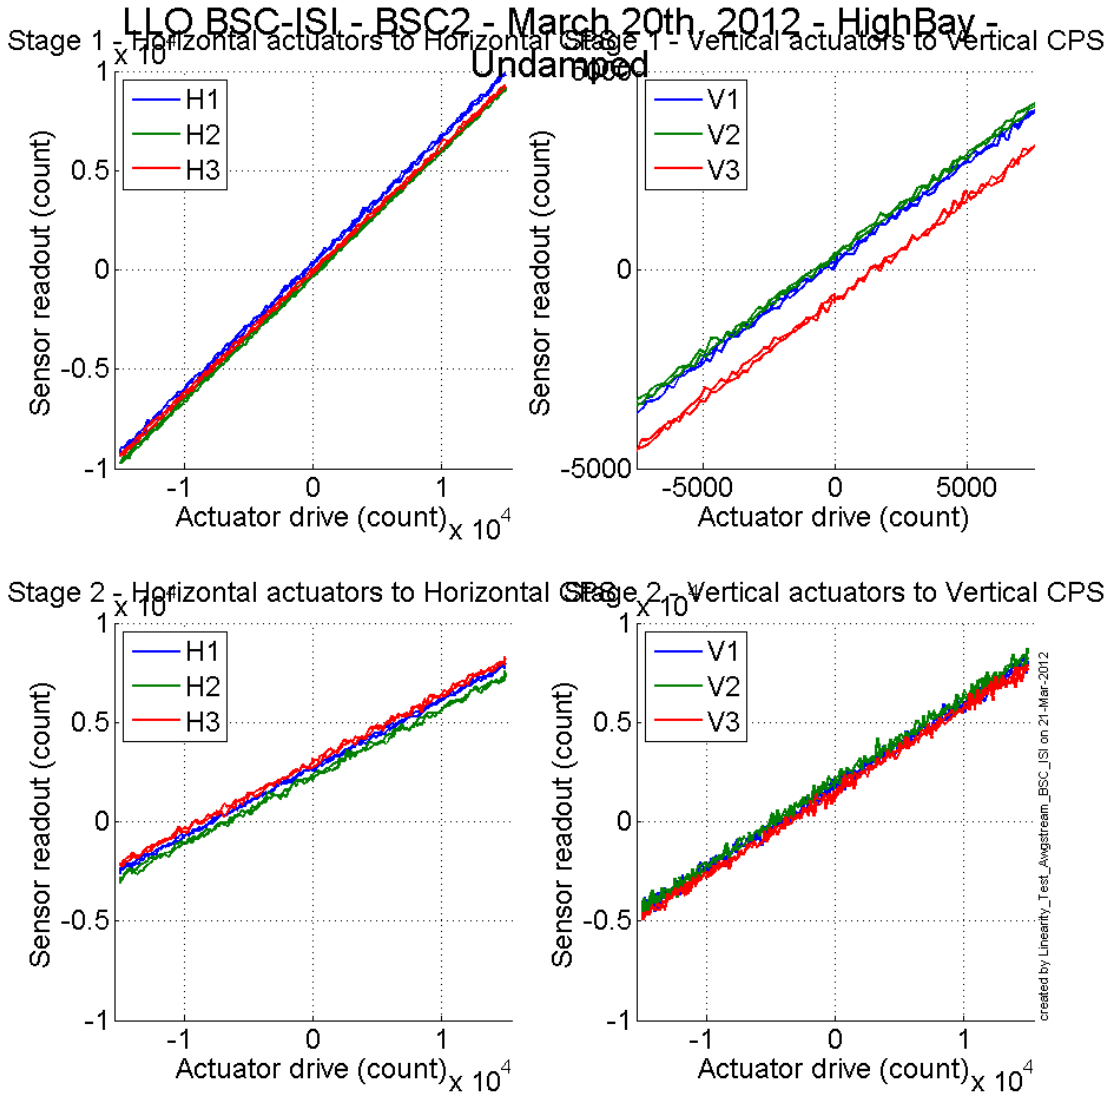
Figure 7 - Linearity Test

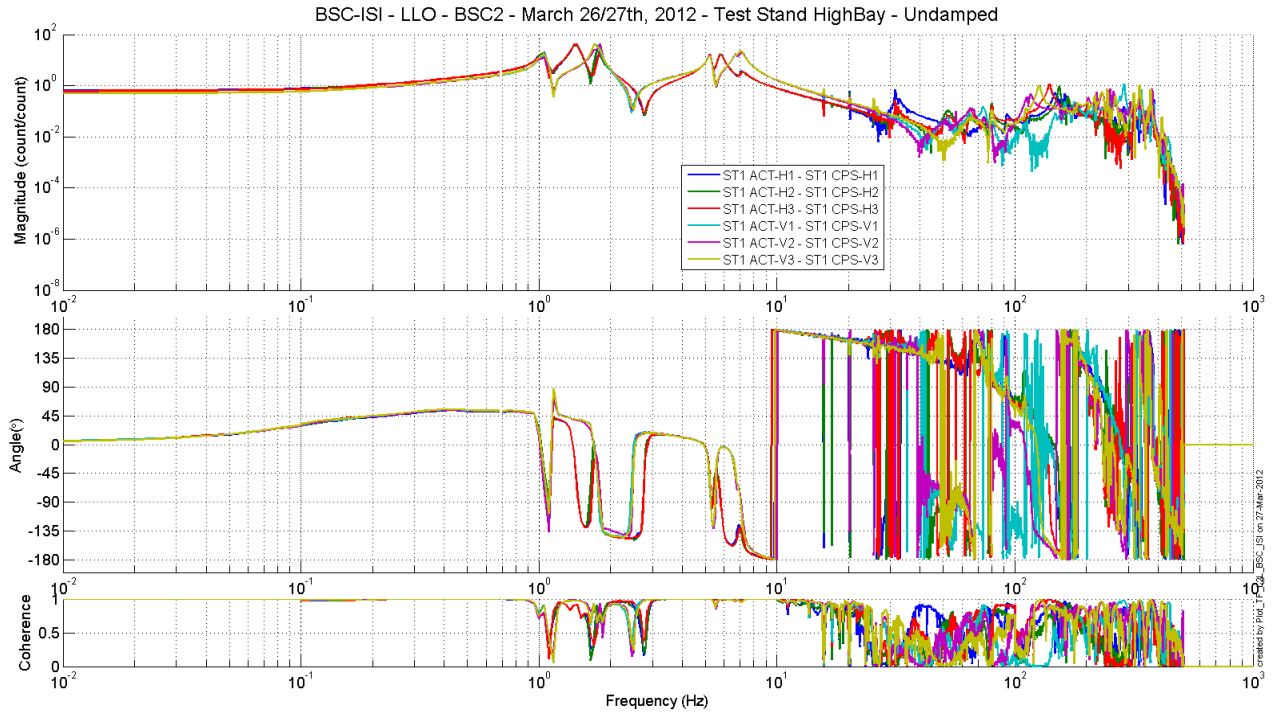
Figure 8 - TF L2L Raw - ST1 Act to ST1 CPS

Note 3: The resonance observed at 33Hz on Stage 1 CPS is the resonance of the test stand. When the transfer functions will be measured in the LVEA, this resonance should be observed at lower frequency (19Hz). The High Bay test stand has short feet in comparison with the LVEA test stand (some comparison plots will be presented the testing report – phase II).

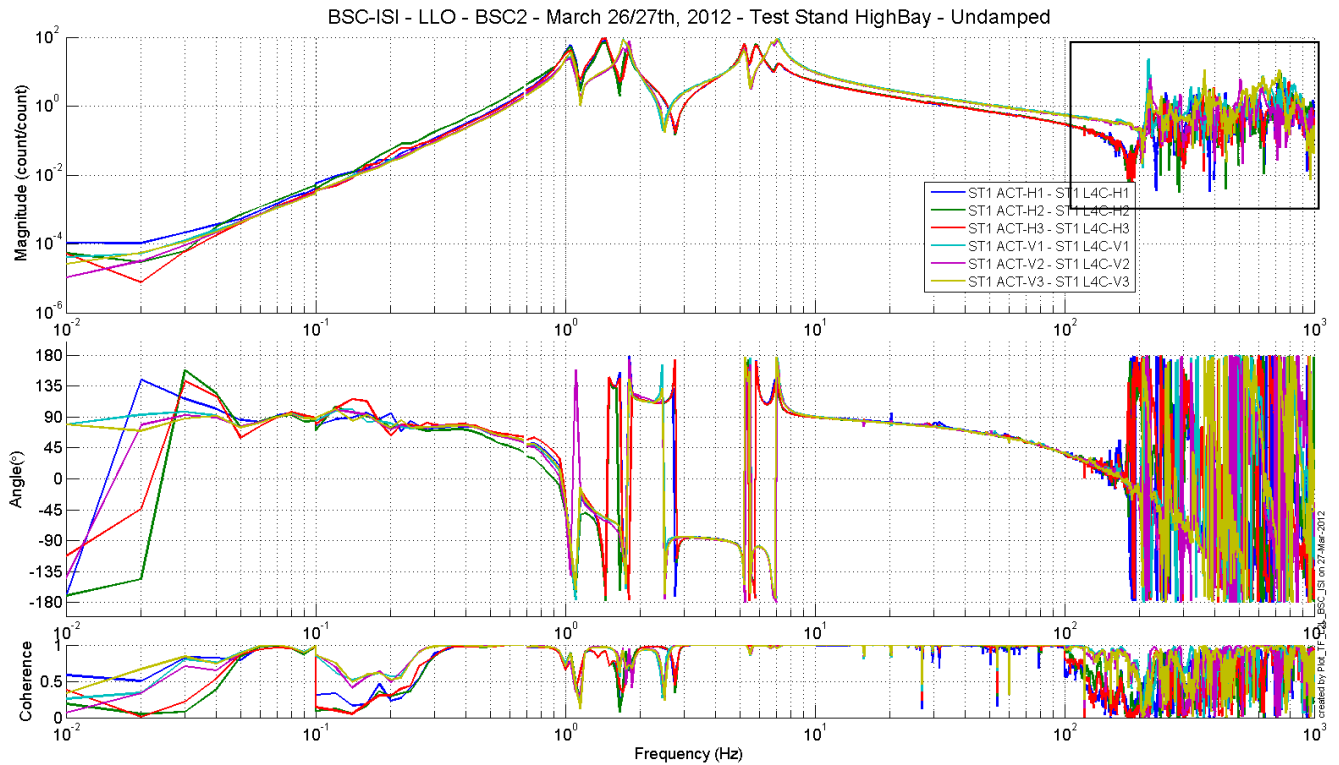
Figure 9 - TF L2L Raw - ST1 Act to ST1 L4C

Note 4: The first high frequency resonance observed on stage 1 by the L4C is at 216Hz. The next resonance is observed at 244Hz. The first mode of the blade has been measured at ~250Hz at LASTI.

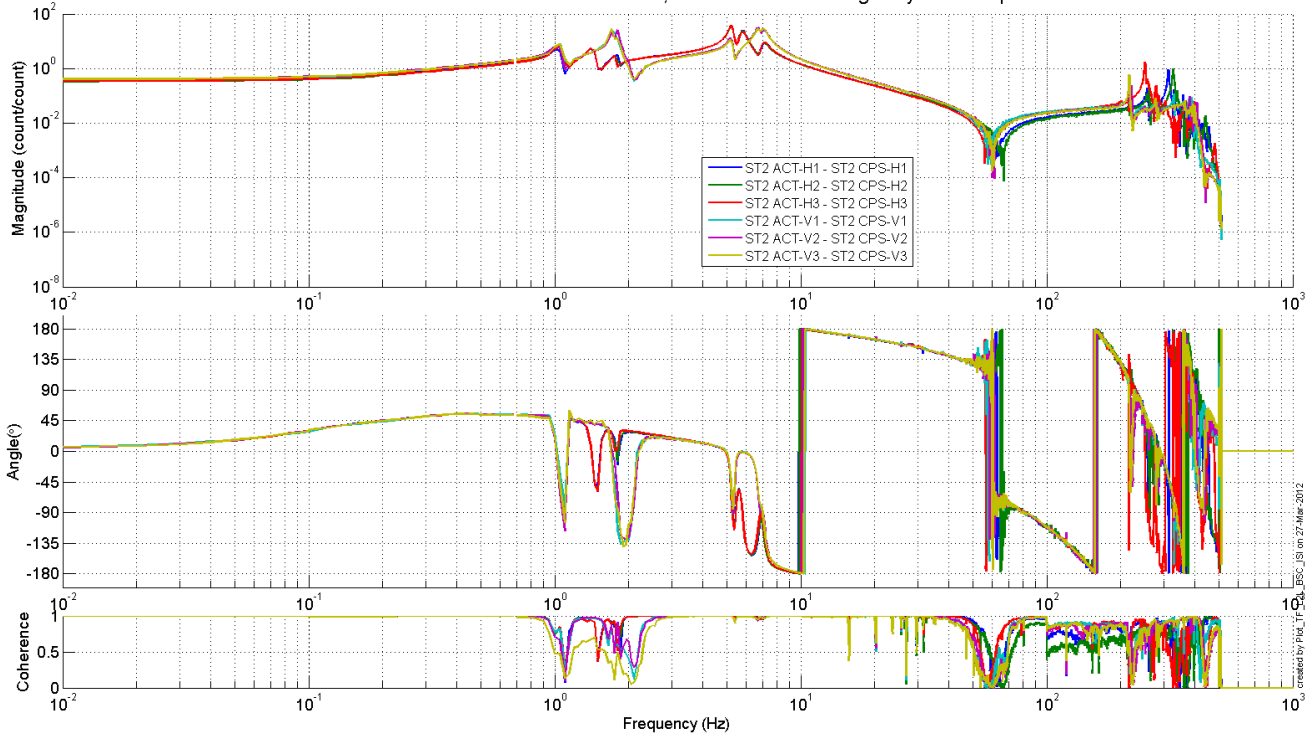
Figure 10 - TF L2L Raw - ST2 Act to ST2 CPS

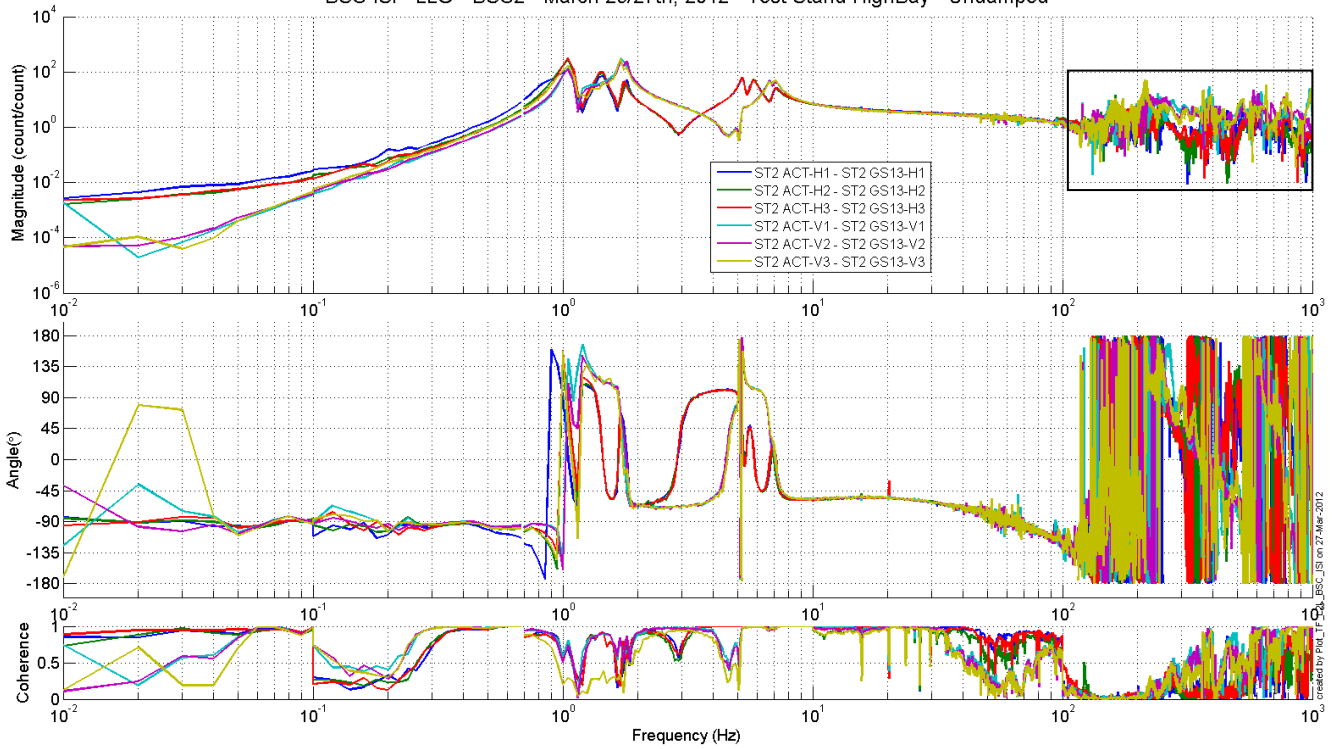
Figure 11 - TF L2L Raw - ST2 Act to ST2 GS13

Note 5: There is a poor coherence on the GS13 transfer functions. It can be explained by the weak drive of the fine actuators. Moreover, the stage 2 of the ISI is strongly excited by the fans of the clean rooms. These two factors strongly affect the quality of the measurements. Also, we might have an issue with the GS-13 gain because they were saturating a lot, which can also explain the poor quality of the signal.

Note 6: On the ST2-ACT to ST2-GS13 transfer functions, the first high frequency resonances are observed at 120Hz and 162Hz.
