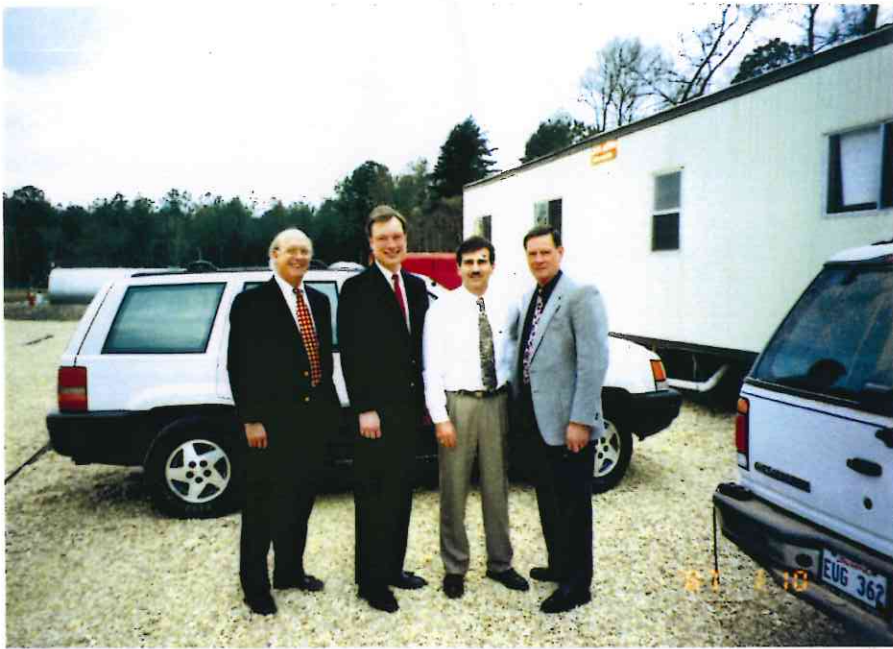
G960024-01-O-P

1. Site visit by Congressman Richard Baker from left to right, Skip Smart, Congressman Baker, Mayor Dale Erdey & Bo Garrison, former head of the State Police
