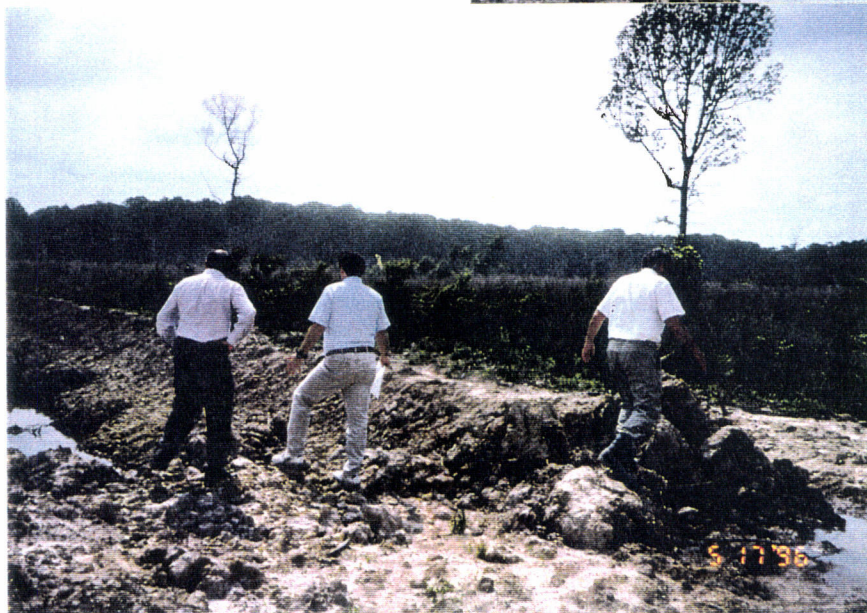
G960142-12 -O-PV

12. Southwest arm at station 109+00 HO team reviewing site progress, left to right , Fred Asiri, John Blasius, & Otto Matherny.
