LASER INTERFEROMETER GRAVITATIONAL WAVE OBSERVATORY

LIGO-T1200551-v2

Feb. 1, 2013

## Optical-lever installation interferences at LHO

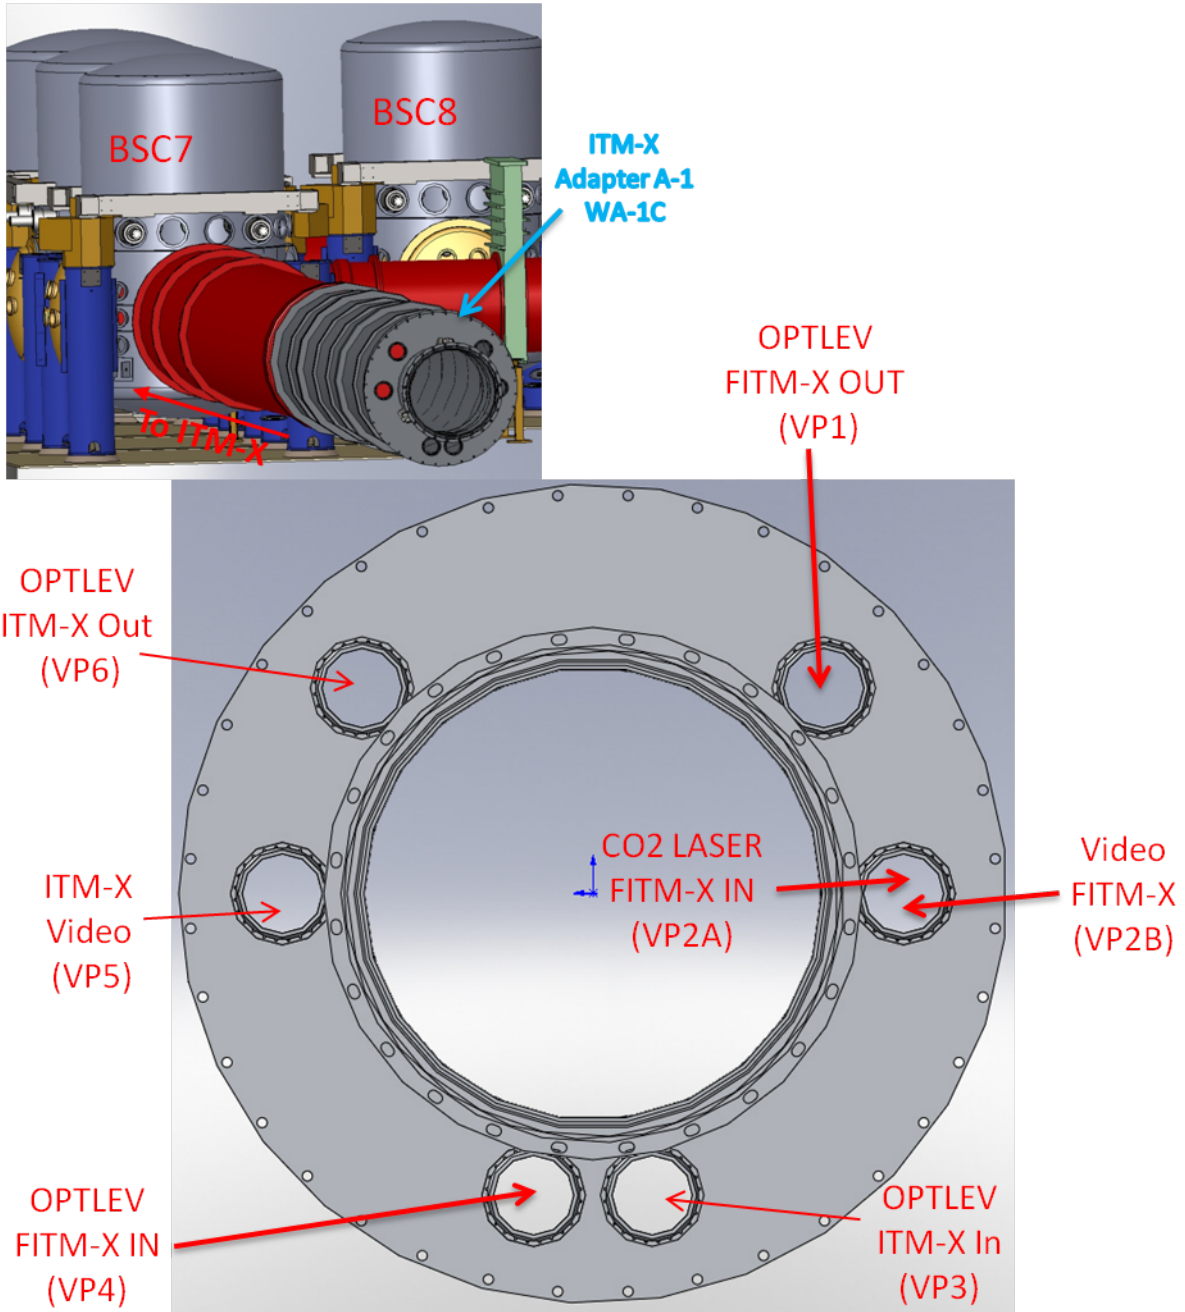
Figure 7: Viewport configuration for ITMX, from Figure 41 of T1000746, Viewport Final Design. We are concerned only with ITMX IN (VP3) and ITMX OUT (VP6). "FITM" refers to H2 and is no longer relevant.

Recommendation: Re-route or remove interfering pipes. Mount initial-alignment monument LV7 on leaner’s baseplate. Translate leaner parallel to beam axis as needed.

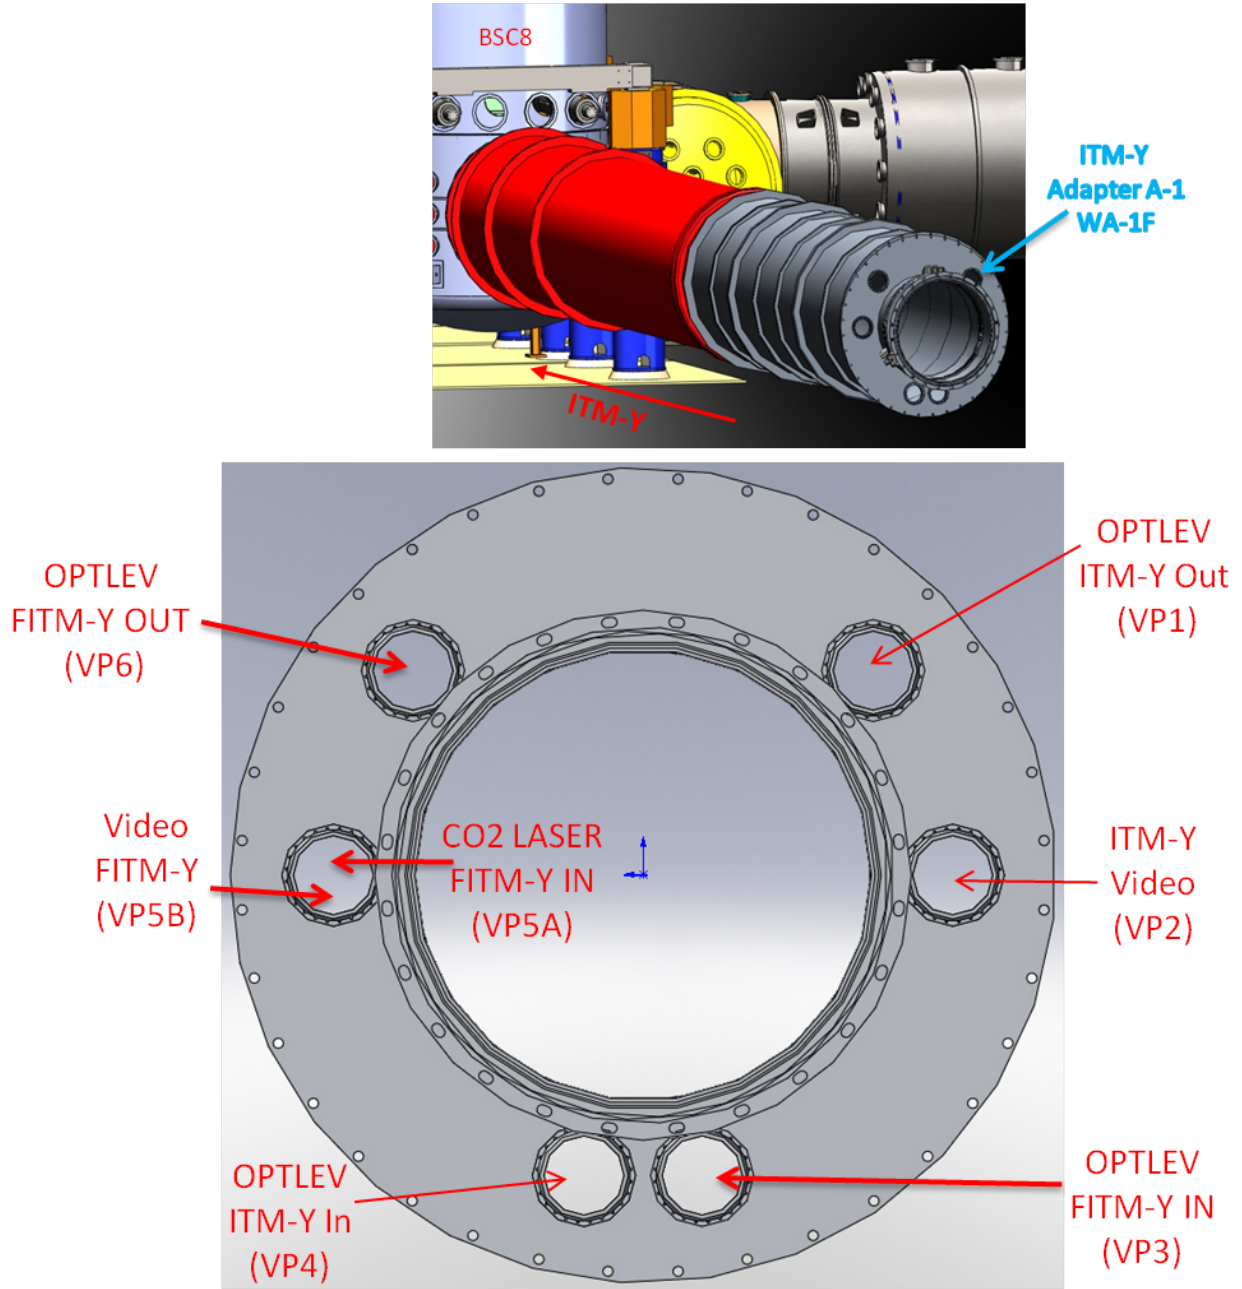
Notes: Installed, but occludes initial-alignment monuments LV17, LV18, and LV19.

**Figure 9: Viewport configuration for ITMY. We are only concerned with ITMY, not FITMY, and thus restrict our attention to VP4 and VP1.**

Recommendation: Mount initial-alignment monuments on pylon baseplates. Adjust pylon positions along beam axis and rotate transmitter by  $180^\circ$  as necessary.

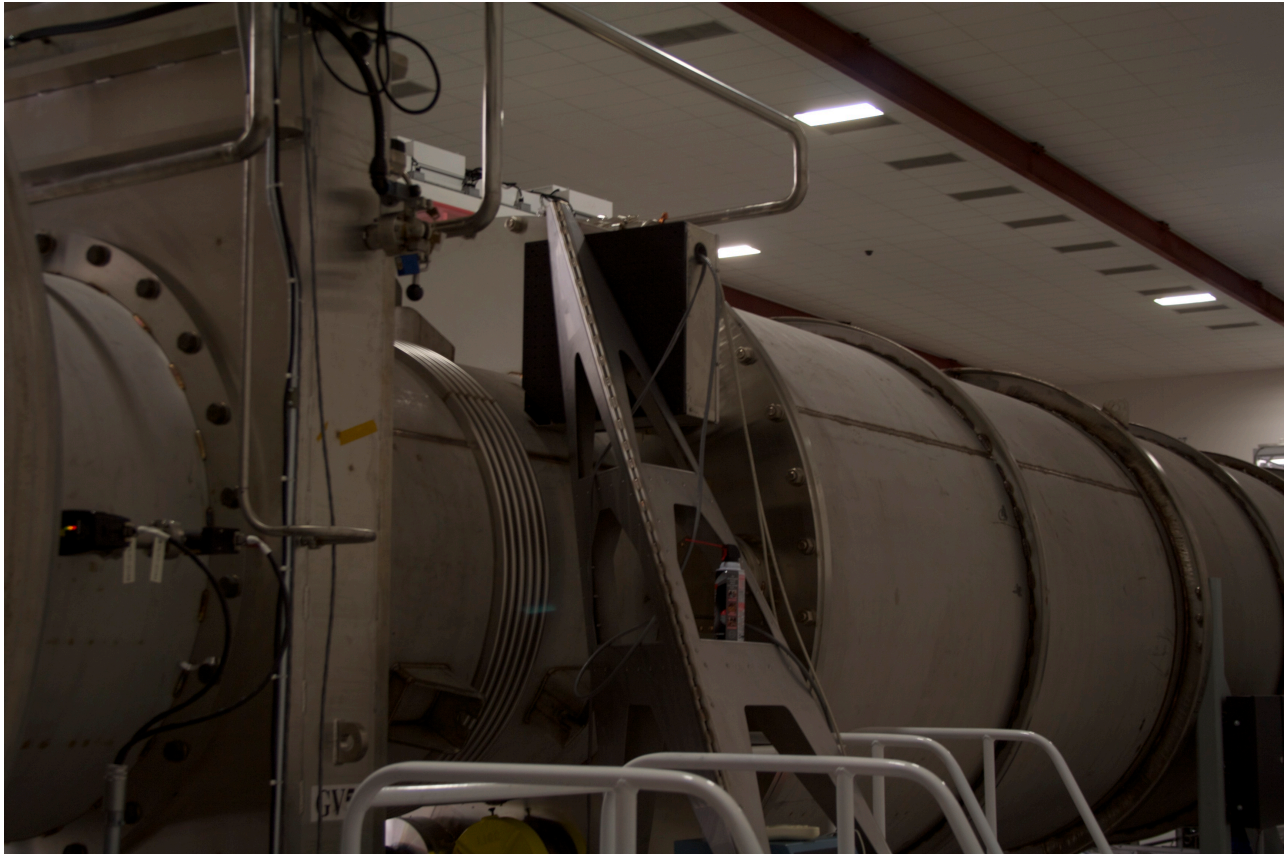
**Figure 12: ITMY receiver (leaner) looking into VP1.**

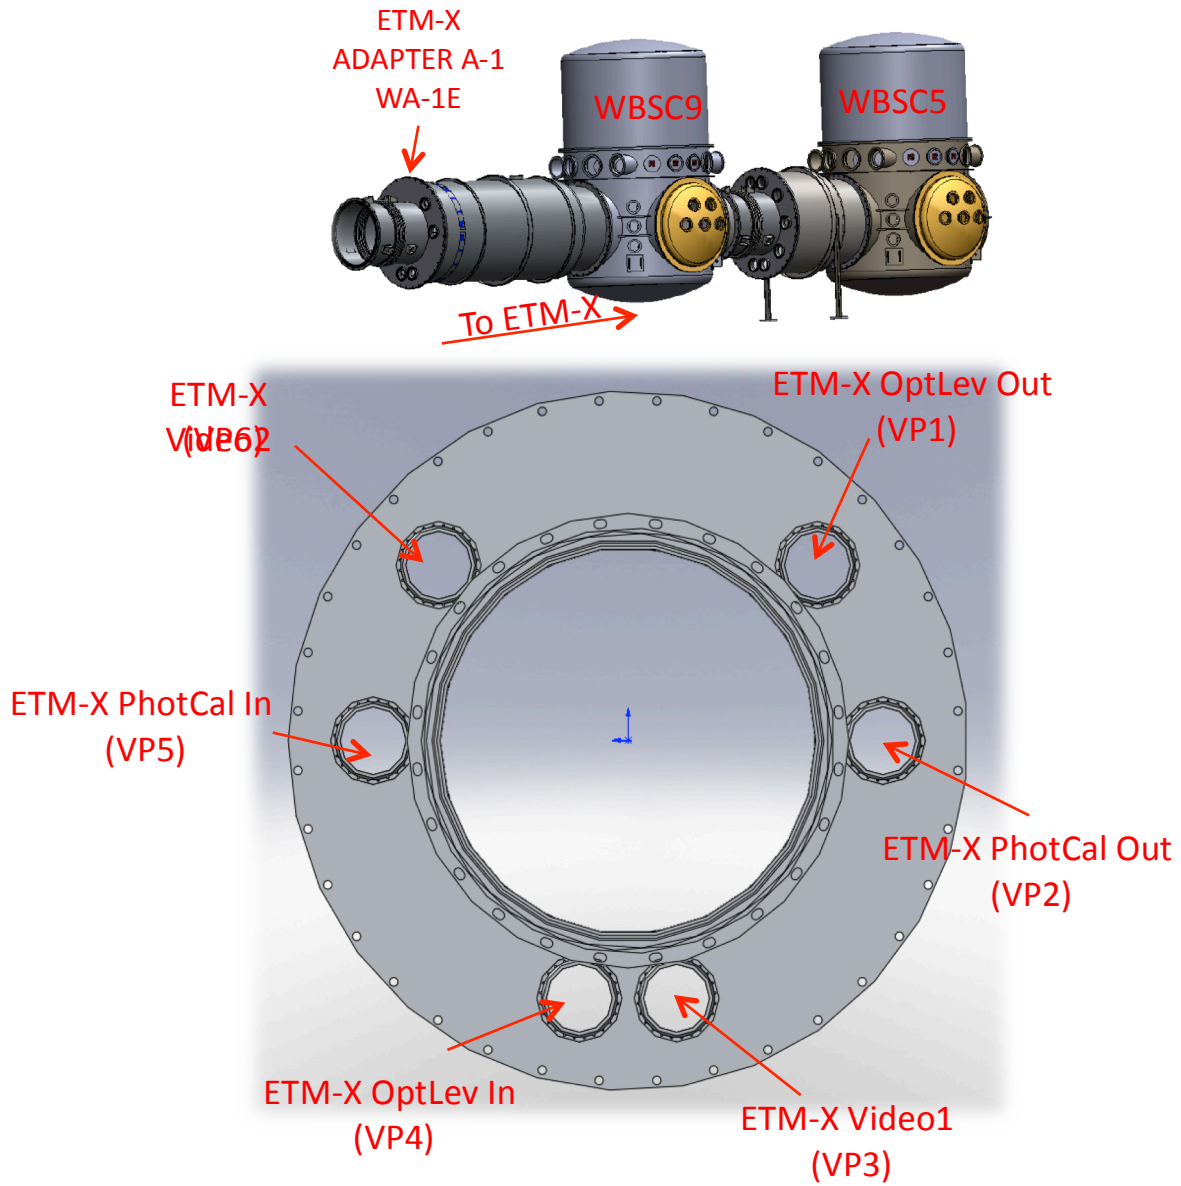
Notes: Significant interference here for both the transmitter and receiver. There is a turbo pump in the way of the leaner, and the dwarf will probably occlude a survey monument used for initial alignment.

Figure 14: Viewport configuration for ETMX, taken from Figure 45 of T1000746, Viewport Final Design.

Recommendation: Re-position AUX cart to clear space for leaner. Translate launching pylon back ~3.5" and mount monument inside baseplate.
