T2000526 Ink and First Contact Damage test

[Sample SN 0919](#)

Zhang, Billingsley

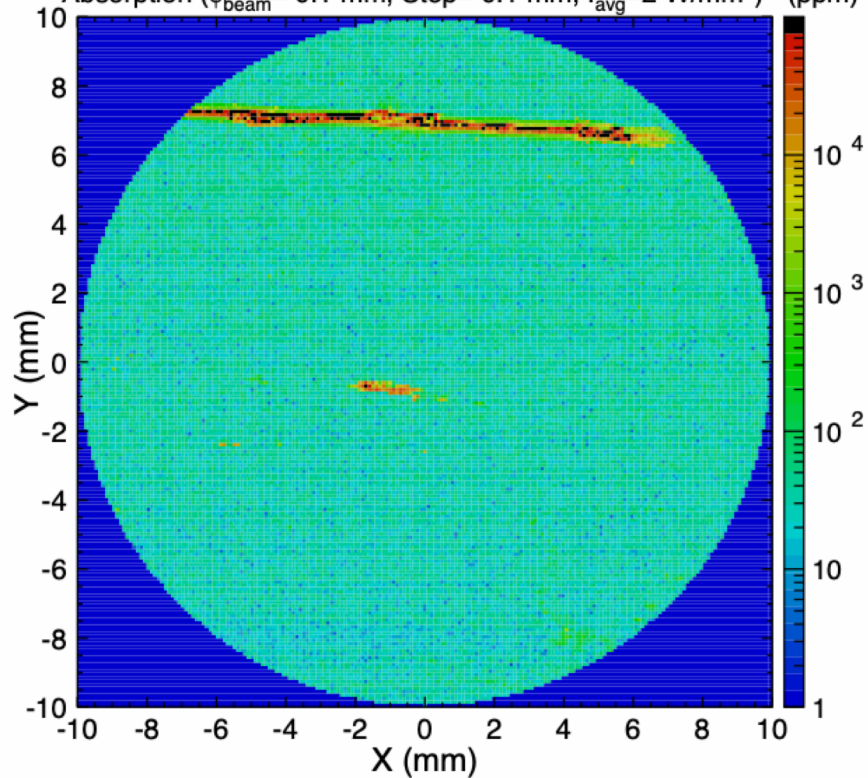
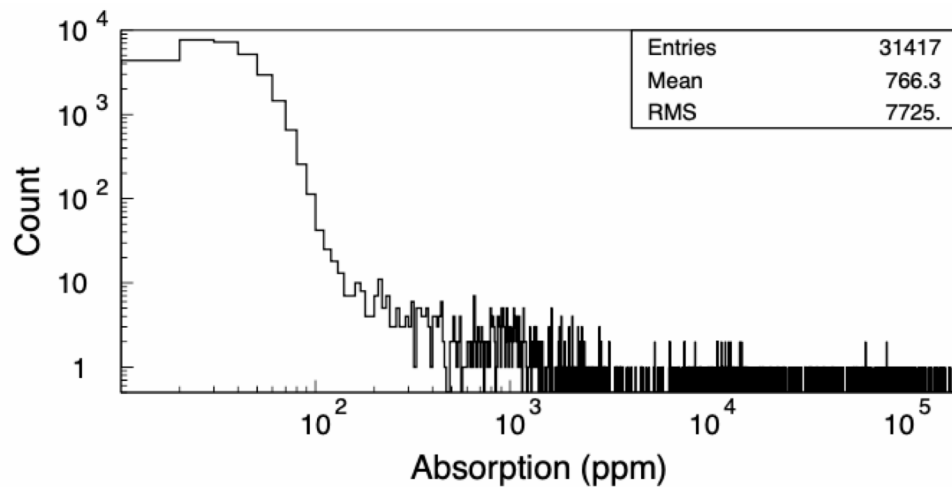
Scan at 2 W/mm²

Absorption ($\phi_{\text{beam}} = 0.1 \text{ mm}$, Step= 0.1 mm, $I_{\text{avg}} = 2 \text{ W/mm}^2$) (ppm)

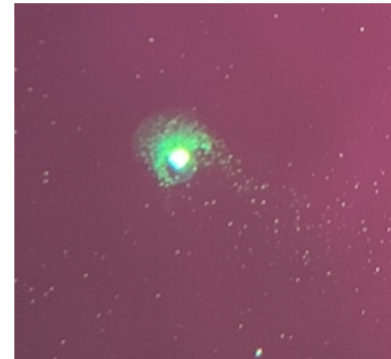
Perhaps one damage site that was not on a line? We usually clean before this type of test, but the sample is getting quite dirty. (below)

No damage in line 1,

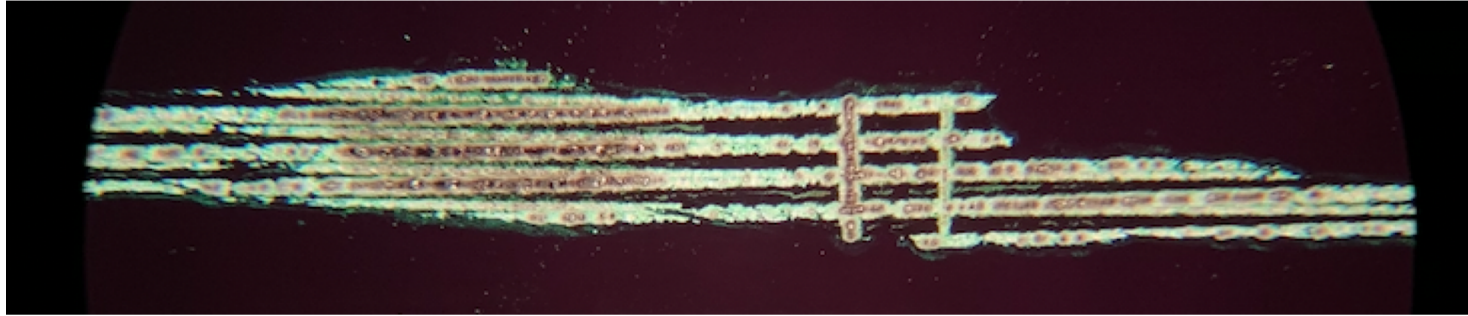
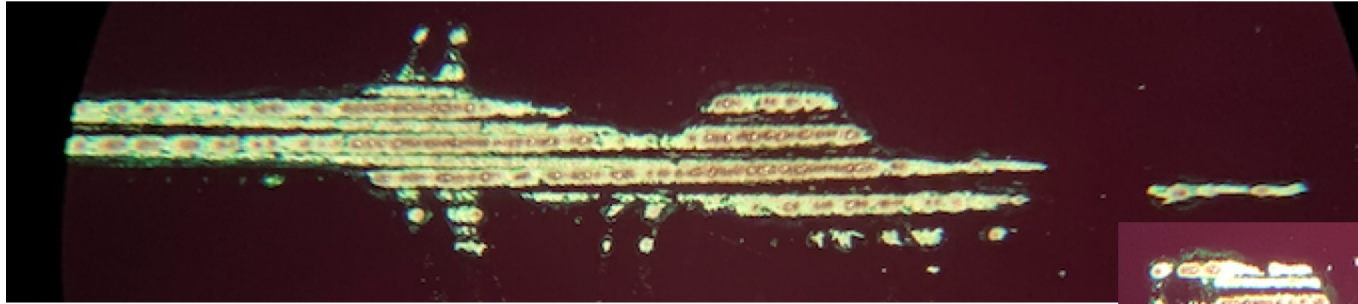
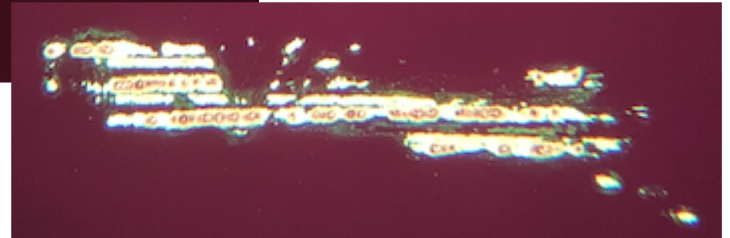
Inspection after 200 W/mm² - Optic now cleaned

All lines are at least partially visible, even with the high background from the mount and the damage

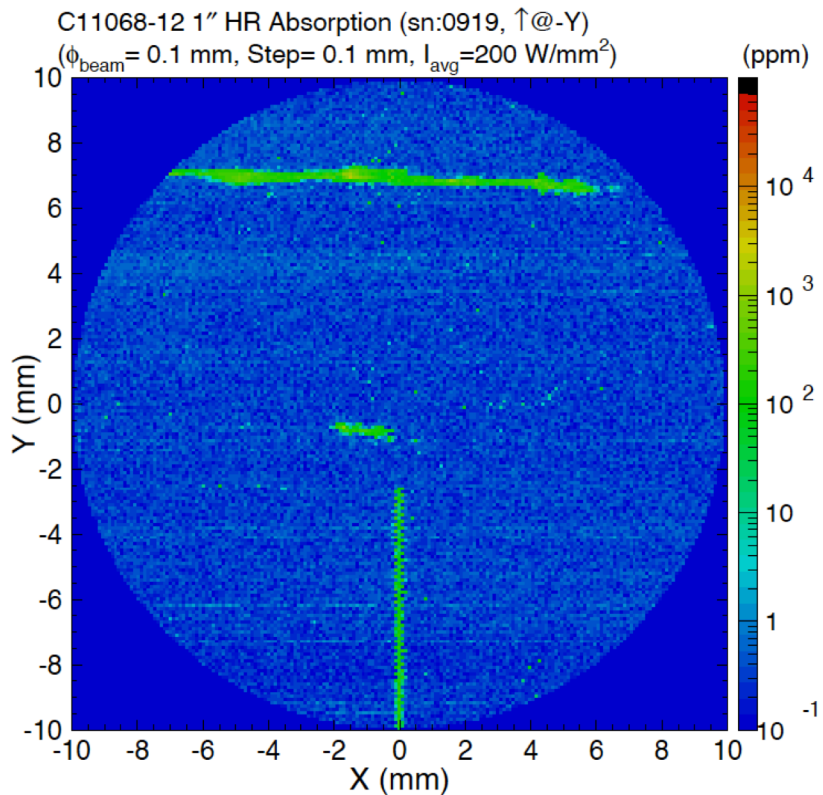
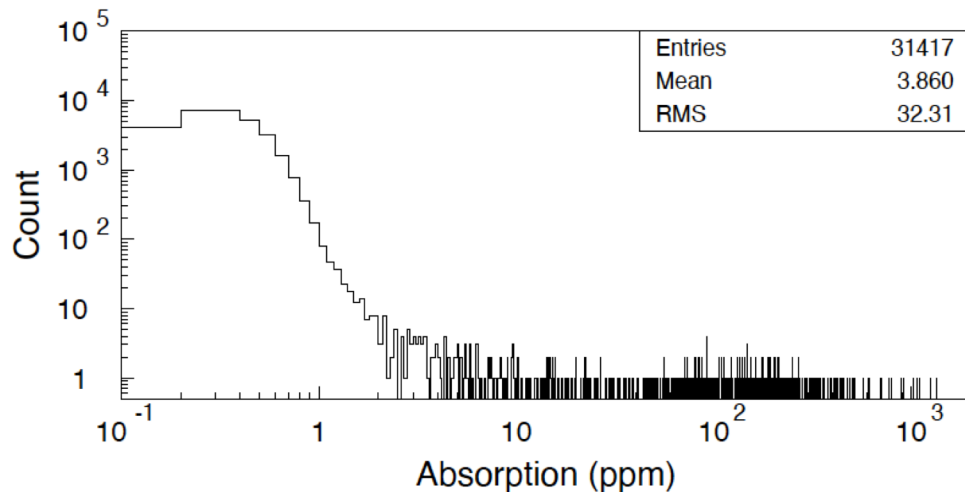
Absorption measurement after cleaning (and unintentional damage)

Accidental damage occurred after cleaning at (0,-y) when irradiated with 2000 w/mm^2 Not clear if there is still absorption, or if the signal comes from distortion

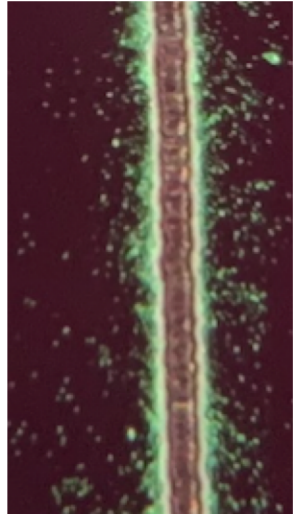
Images are at different magnifications

1. Acetone Soak in ultrasonic bath ~ 1 hour
 - a. No noticeable change
2. First Contact thinner in ultrasonic bath ~ 1 hour
 - a. No noticeable change

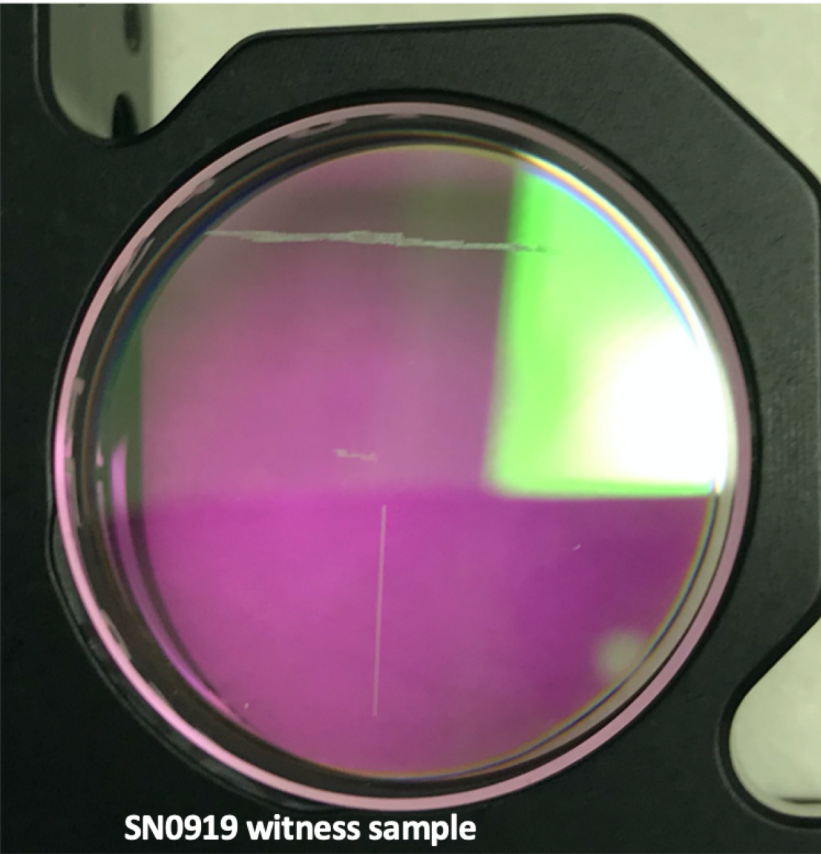
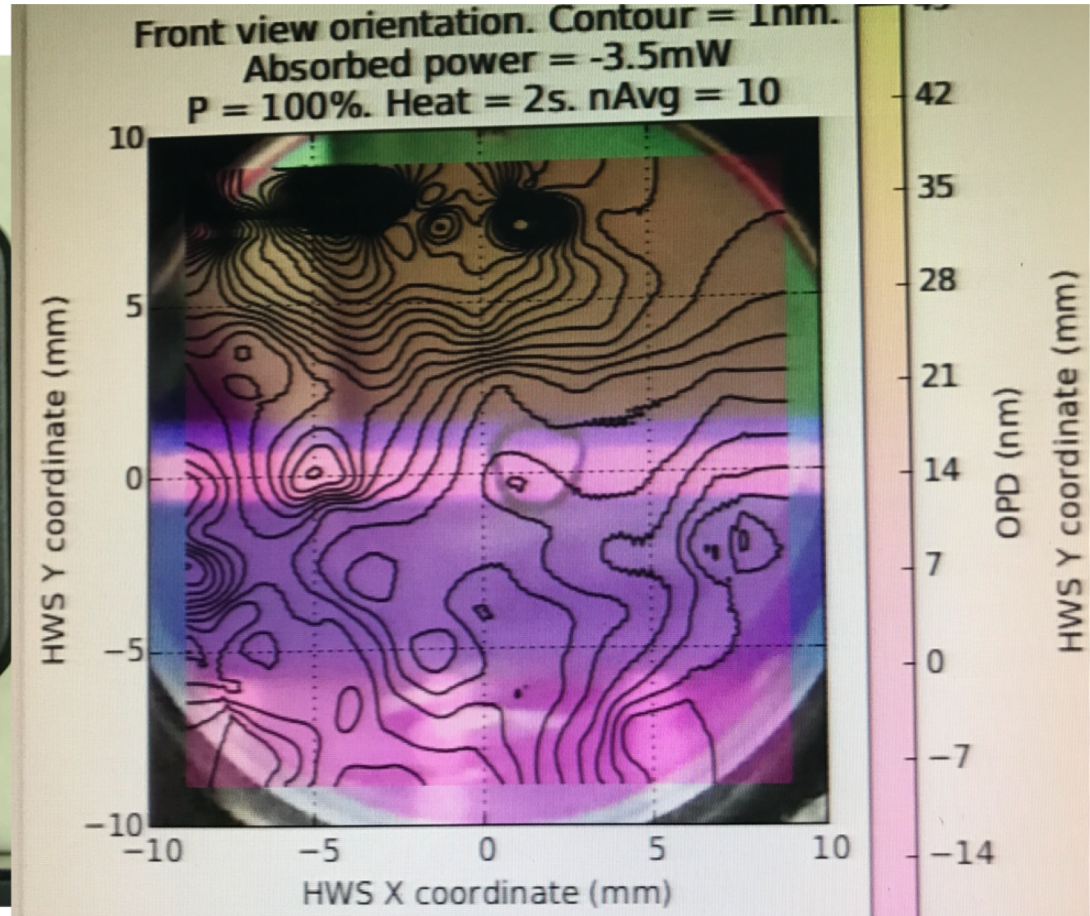
Front view orientation. Contour = 4nm.
Absorbed power = -3.0mW
P = 100%. Heat = 2s. nAvg = 10

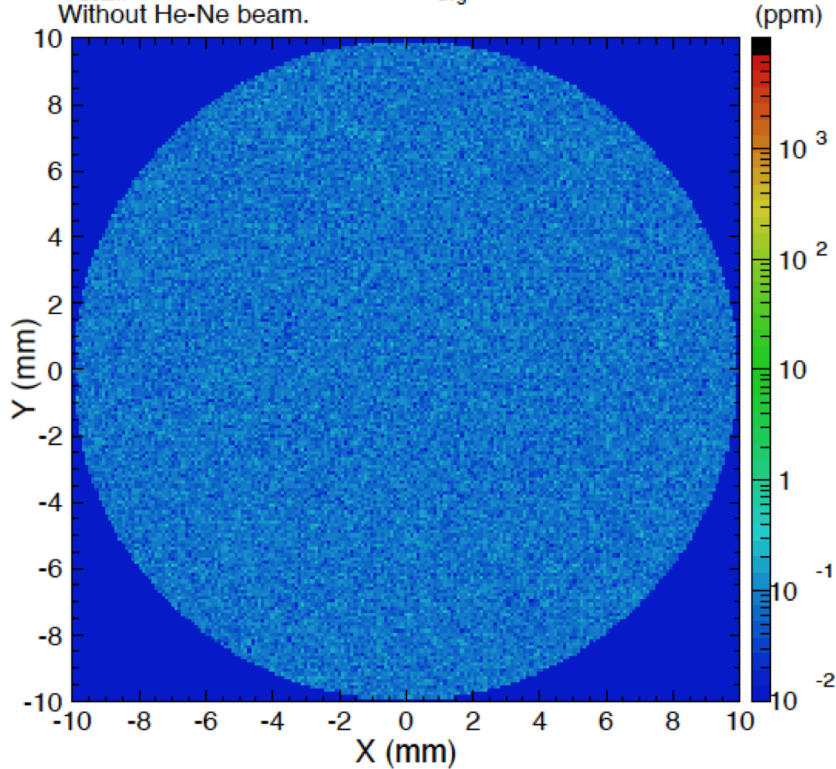
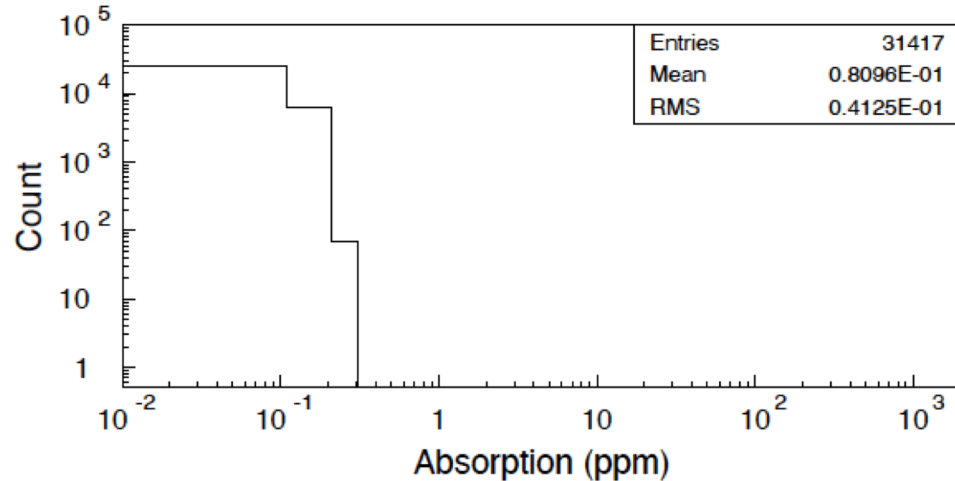
C11068-12 1" HR Absorption (sn:0919, ↑@-Y)
($\phi_{\text{beam}} = 0.1 \text{ mm}$, Step= 0.1 mm, $I_{\text{avg}} = 200 \text{ W/mm}^2$)
Without He-Ne beam.
