Point Absorber Update NSF Review June 2022

Addressing Charge 2.D

Absorber Summary

LIGO-G2200853

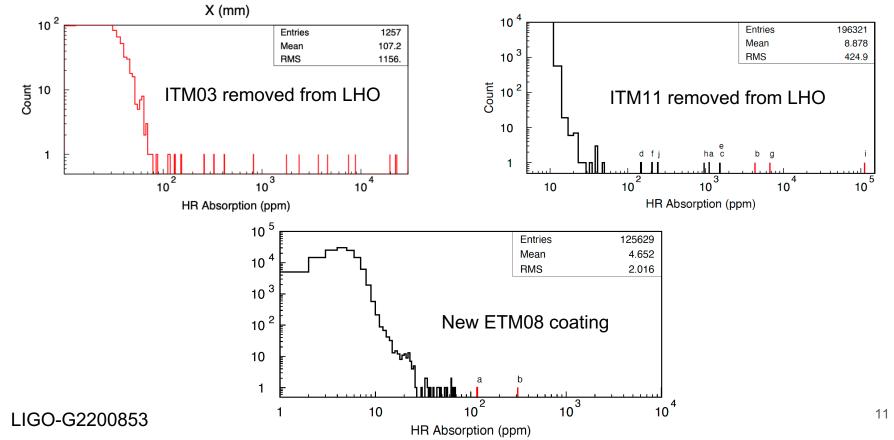
Compare Known Problem Absorbers to New Coating

- 2 PA found on RTS using gentle absorption on 80 mm ø
 - a. \emptyset 3.2 µm, r = 24 mm
 - b. \emptyset **5.4 µm**, r = 25 mm
- Max allowed "equivalent diameter" 12.6 µm
 - Assumes 100% absorption by defect
