ACOUSTIC MITIGATION
PROGRESS

LIGO-G030496-00-Z

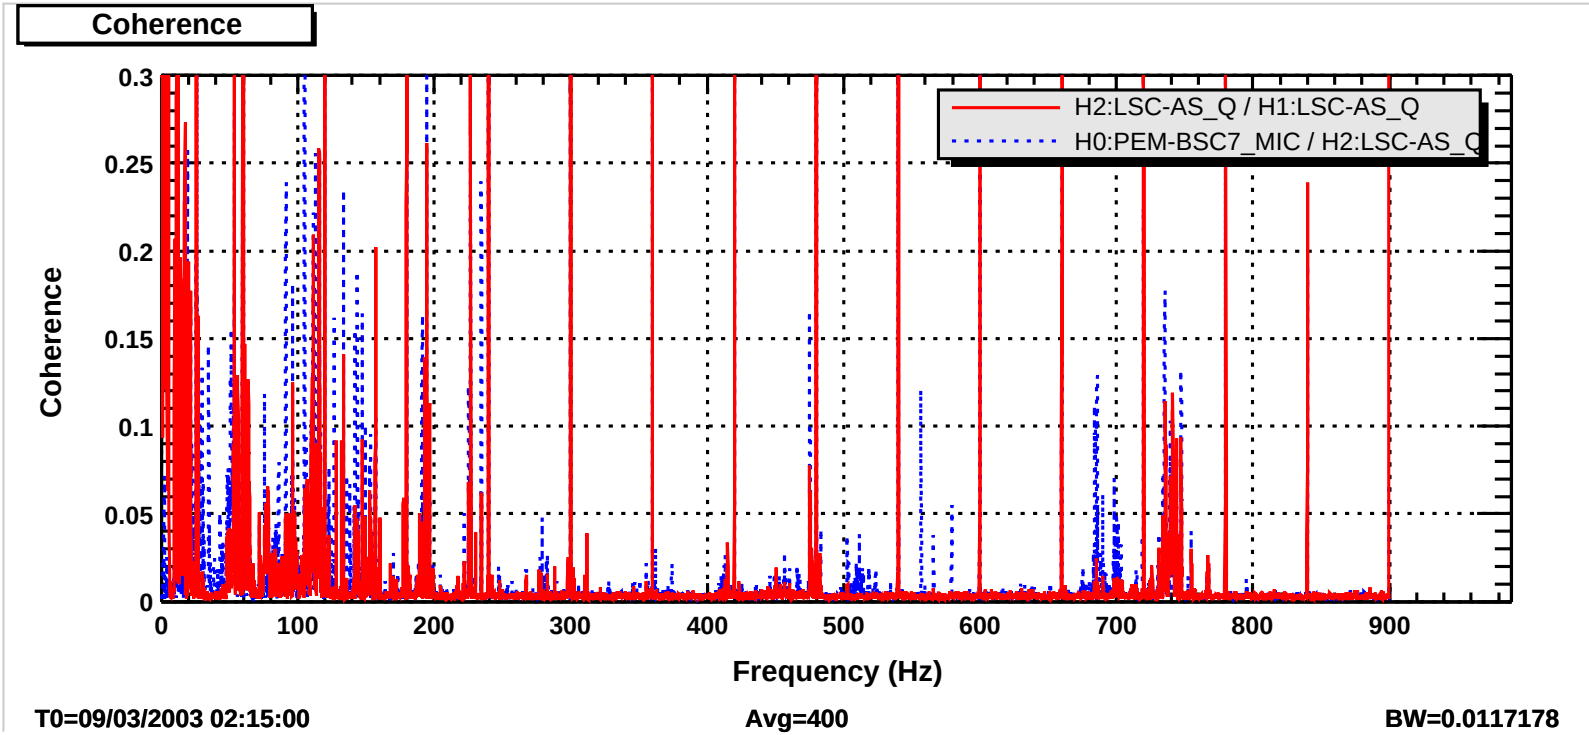
Red shows coherence between H1 and H2 AS_Q over 12h during S2

Blue shows coherence between microphone near 4k dark port and 2k AS_Q

Noise played through speaker during S2 indicated that all three interferometers were close to being limited over a broad frequency range by acoustic coupling

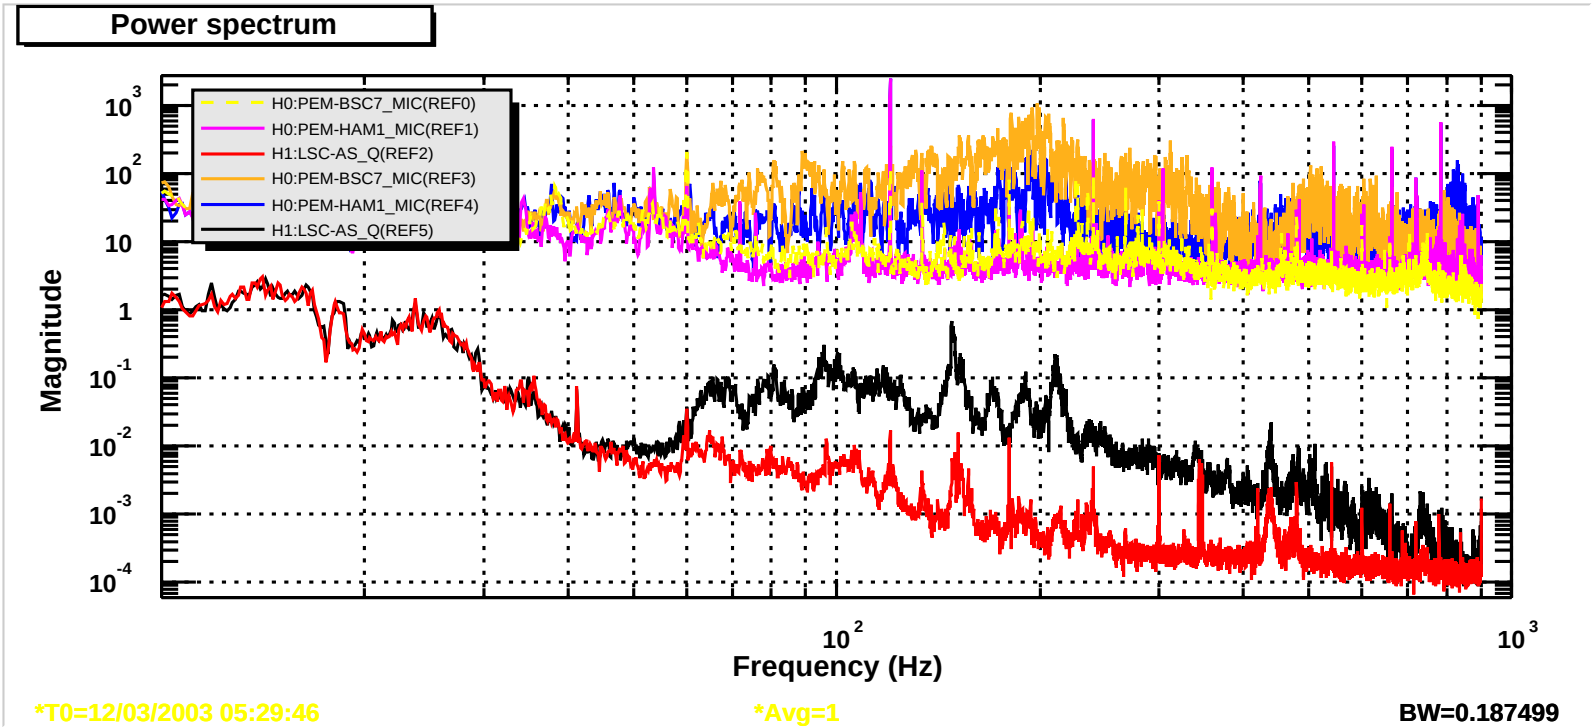
Black: AS_Q with noise; Red: normal; Orange: mic with noise; Yellow: normal

We would like to reduce acoustic-seismic contribution to noise by 100 to 1000

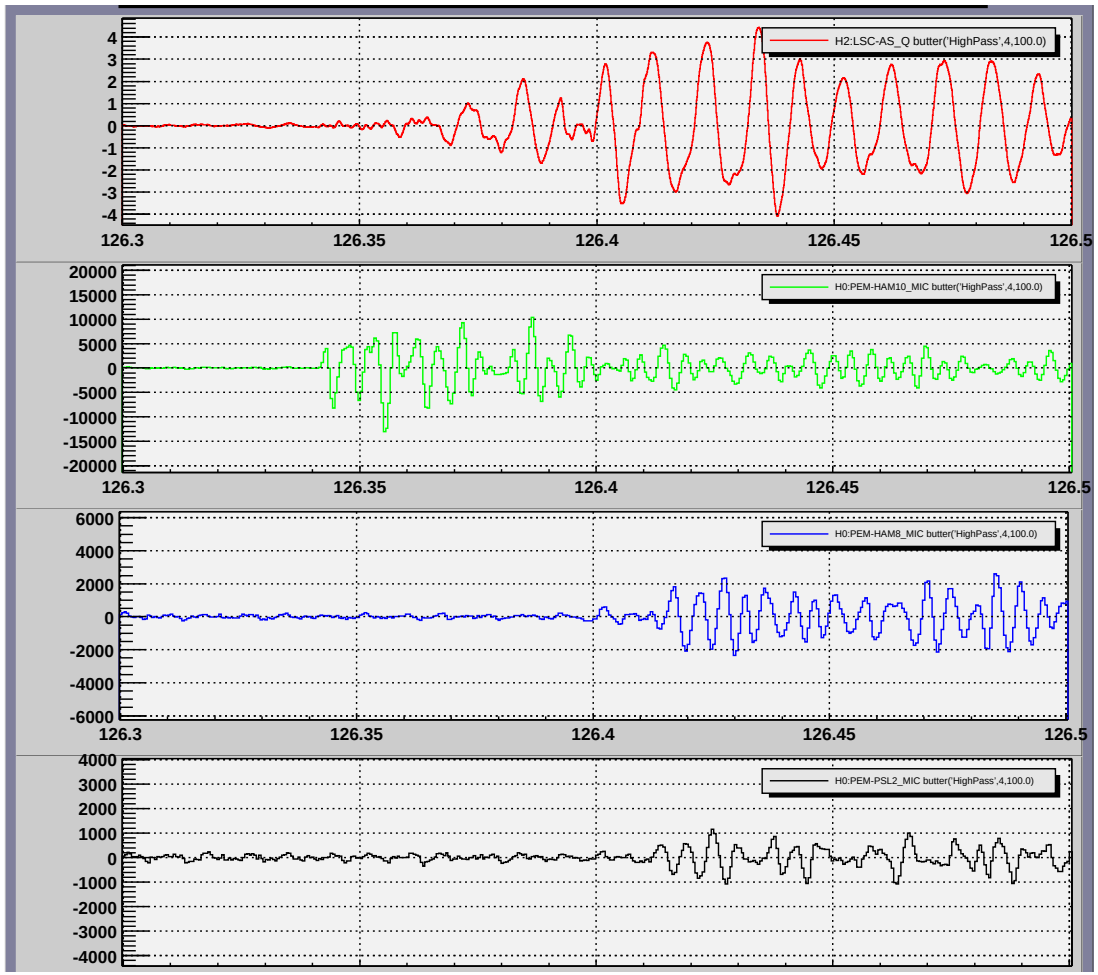
Burst propagation delays:

Predominant Coupling Sites : All 3 dark ports, LHO 4k PSL

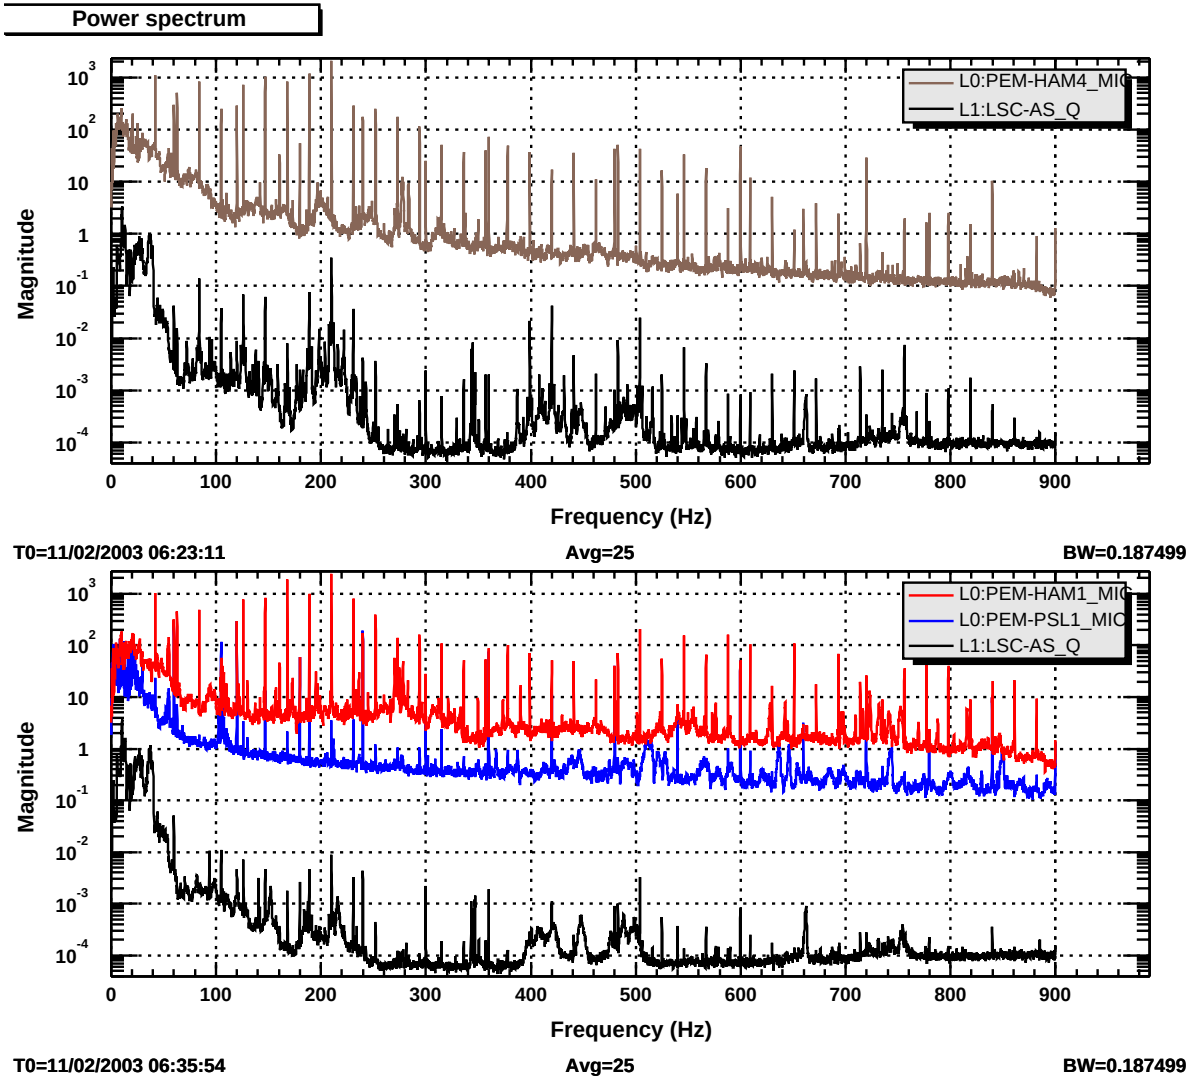
21 Hz sawtooth played near LLO ISCT4 (top), ISCT1 (bottom)

For S2 coupling at other tables is at least a factor of 10 lower than at dark ports.

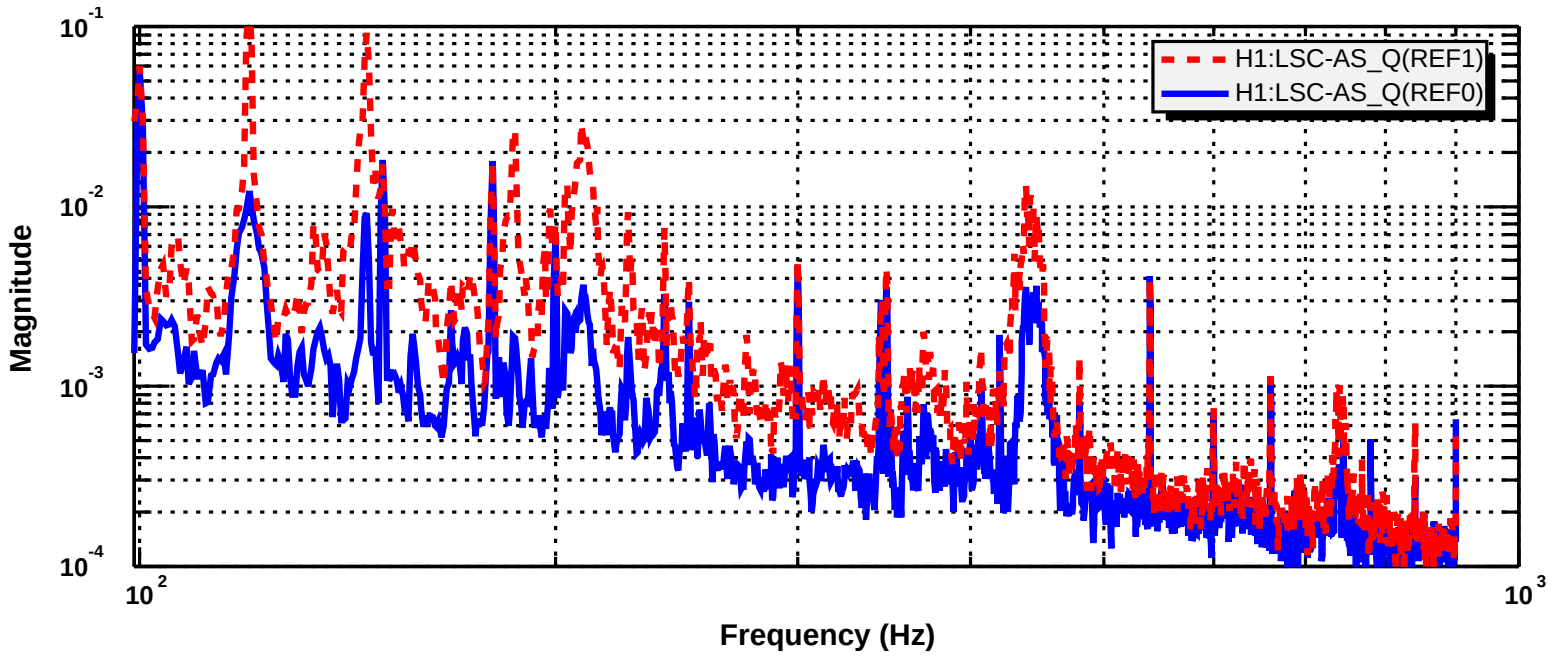
MAIN COUPLING MECHANISM:
clipping modulated by acoustic excitation.

Evidence: acoustically excitable peaks in GW channel gradually increase as an iris on the dark port table is closed (see periscope peak just above 200 Hz). Calibration lines at harmonics of 50 Hz do not increase.

Blue: Normal; Red: Iris increased clipping

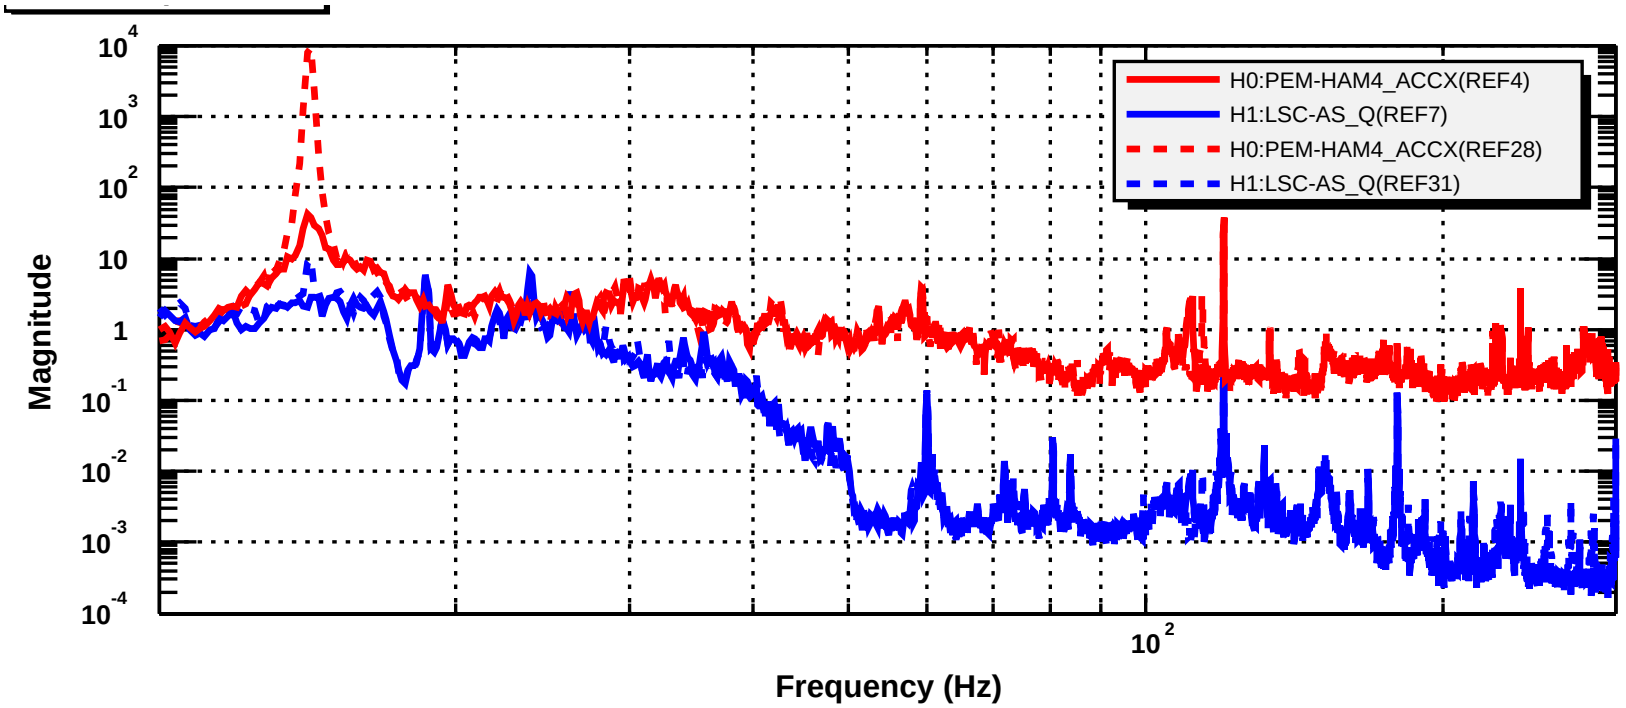
No evidence for parasitic interferometry noise from backscattering.

Red: Accelerometer on Dark Port Table; Blue: AS_Q

Solid: Normal; Dashed: Shaker shaking table at 14 Hz (sway resonance)

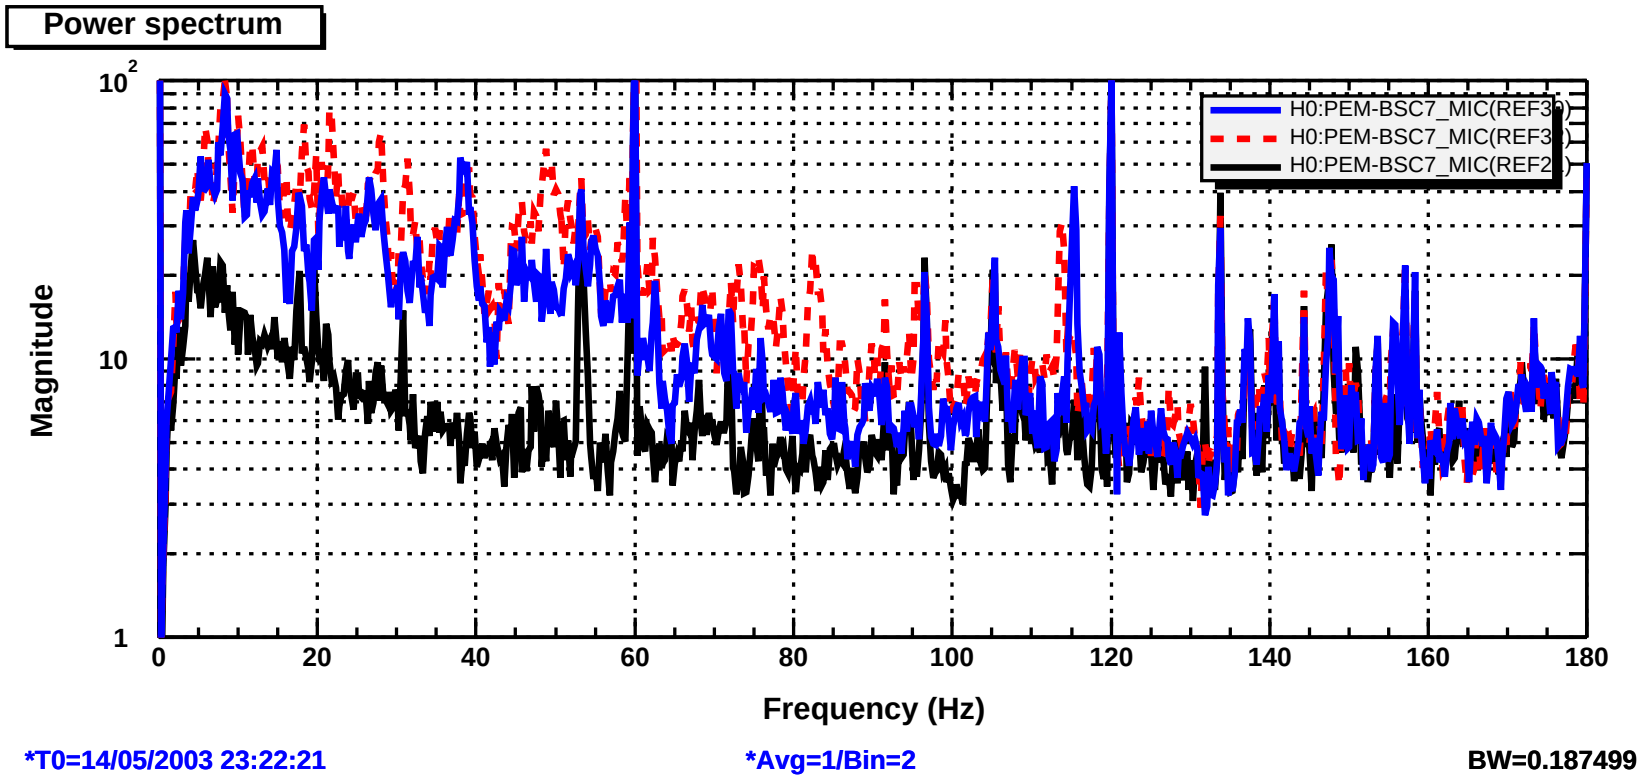
LOUDEST CONTINUOUS SOURCES:
HVAC below 100 Hz, electronics cabinets above.

Rattling ducts may contribute to HVAC noise

Black: HVAC off, LVEA mic; Blue: HVAC on; Red: hand rattling of single walled duct.

Damp sections of single walled ducts.

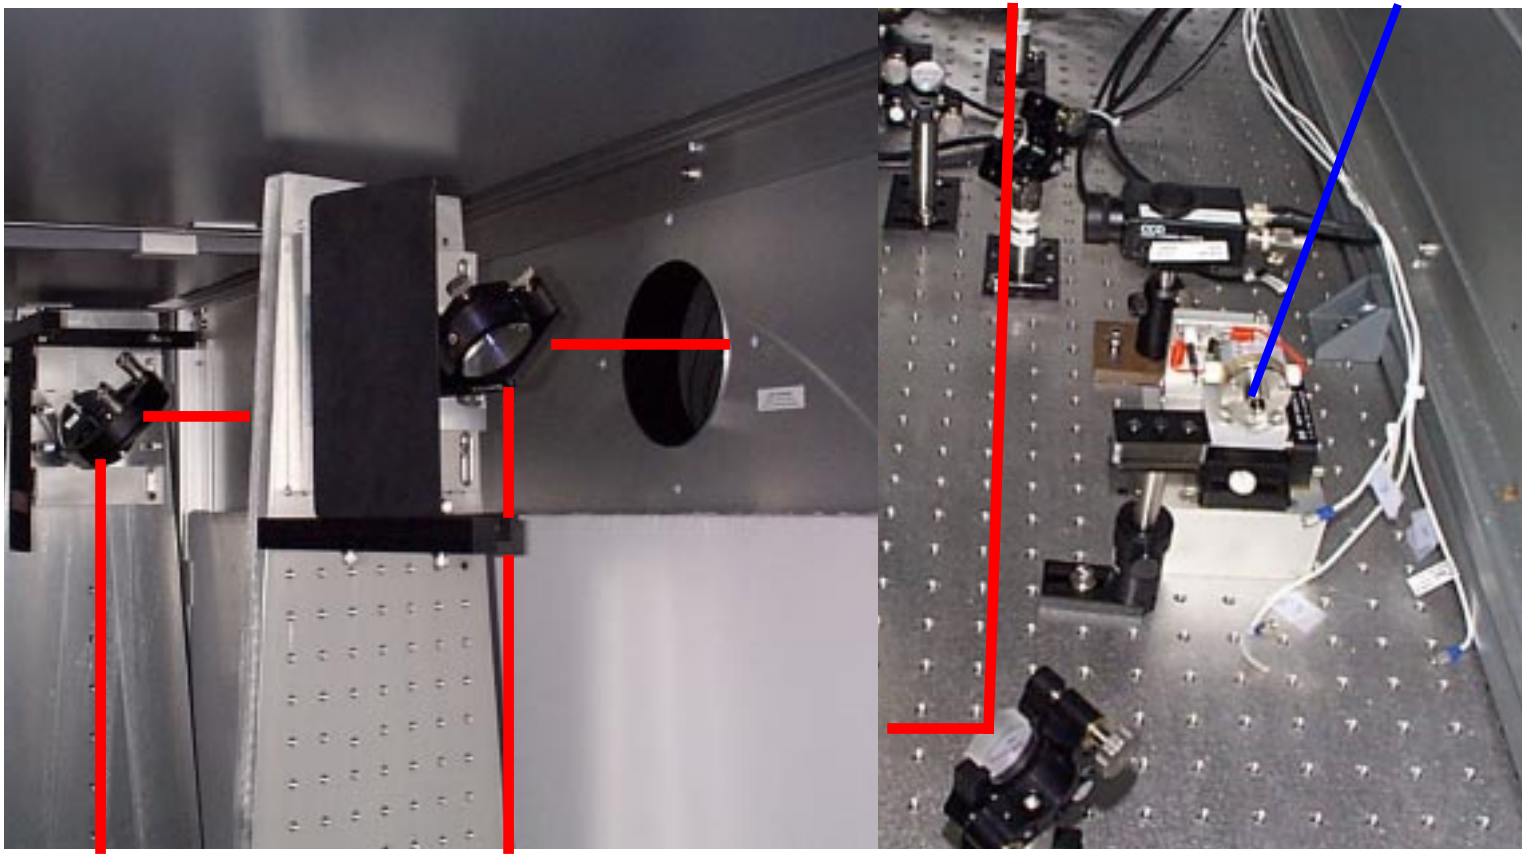
Old Mount New Mount New Path EO shutter sidelined

1) Replaced the top optic mount on the dark port periscope with a lighter one
2) Eliminated some small apertures since S2: EO shutter and associated polarizers

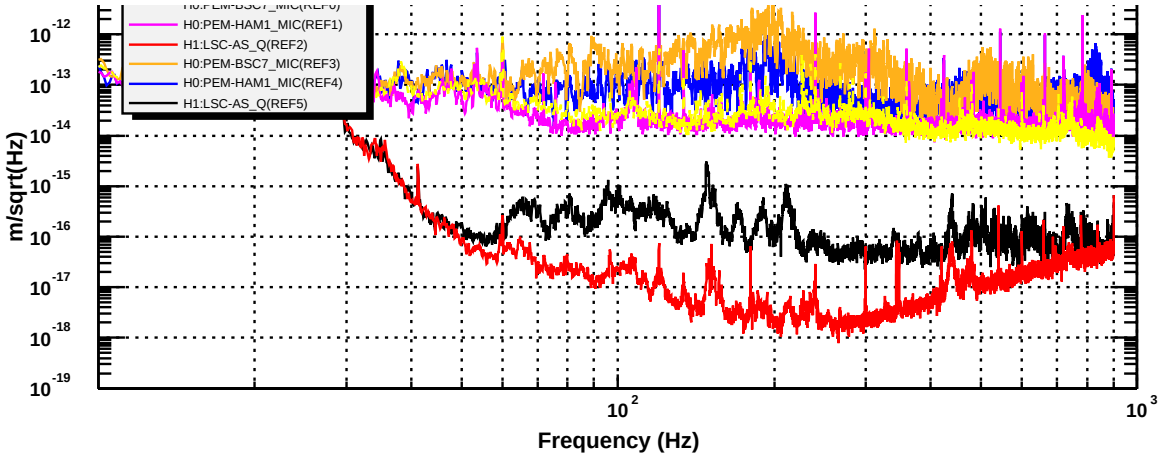
March 12

Red: AS_Q normal; Black: AS_Q with noise; Yellow & Orange: BSC7 mic

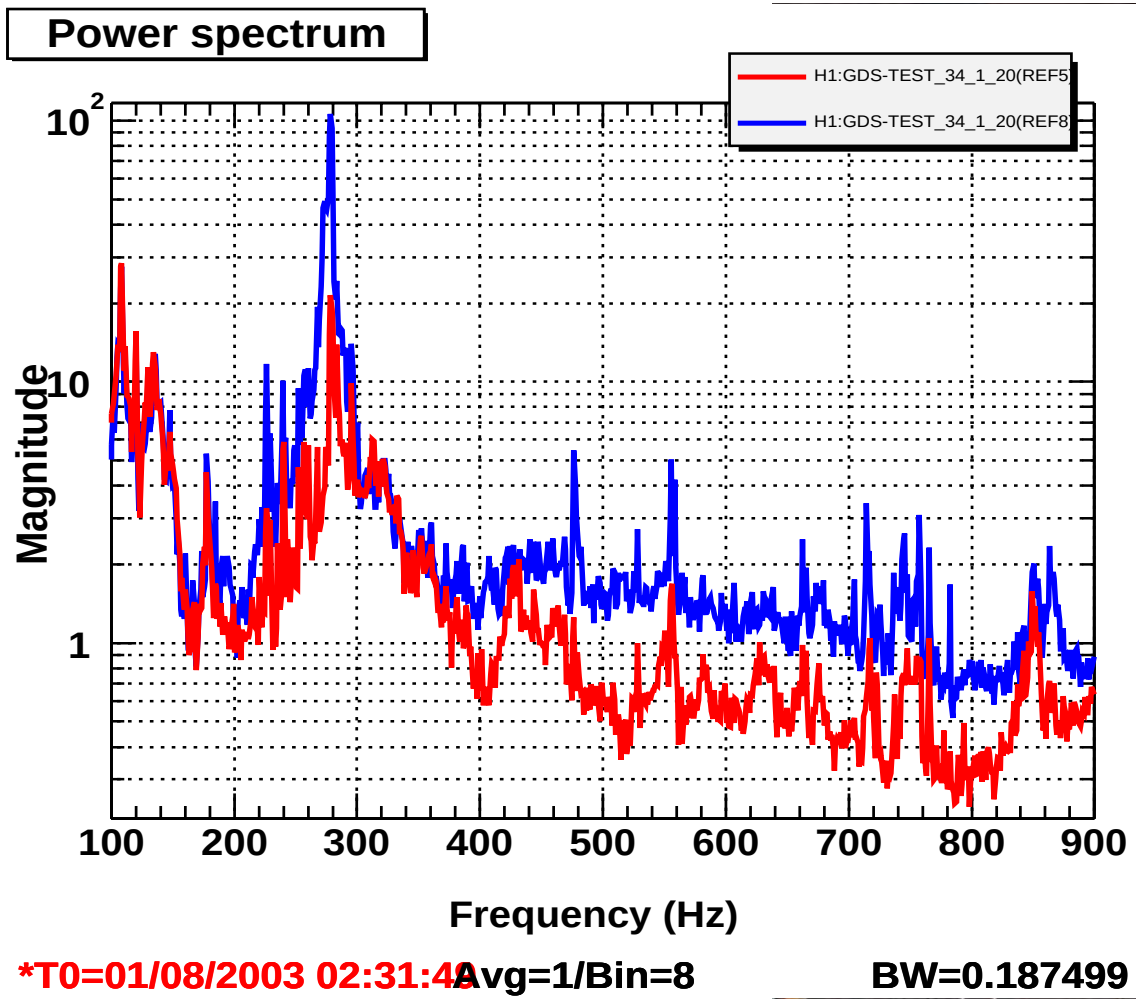
Accelerometer on periscope top; Blue: no damping Red: damping

TESTING OF NEW PERISCOPE DESIGN WITH DAMPING

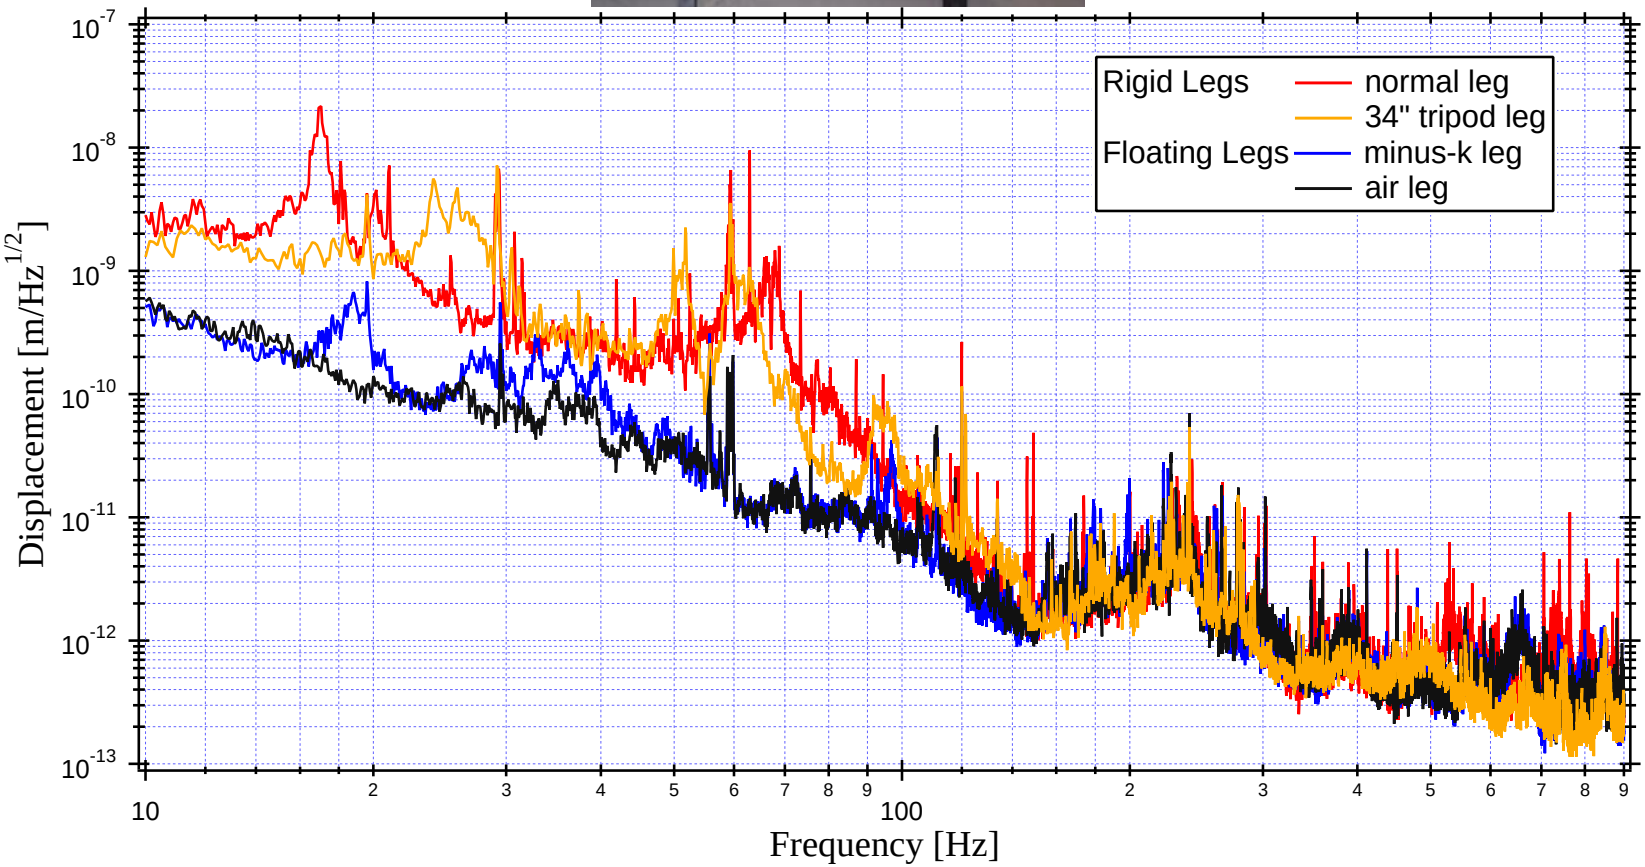
Sum in quadrature of 3 accelerometer axes

TESTS OF RIGID AND FLOATING TABLE LEGS

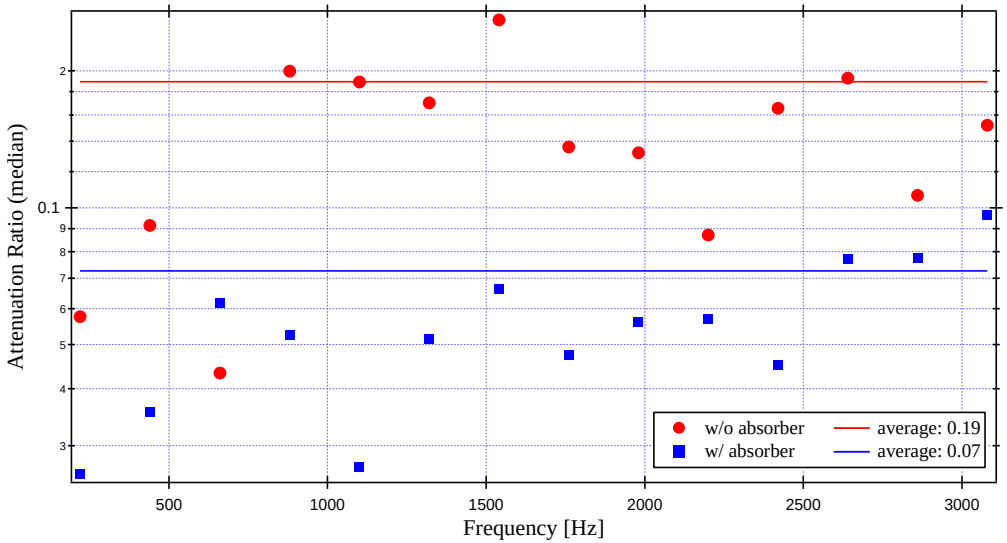
Enclosure: attenuation factor of about 10 at low f; with absorption kit, 20 to 30

DARK PORT ENCLOSURES WITH ABSORPTION KITS
