# Flat top beam interferometer to depress mirror thermal noise

- Juri AGRESTI
- Riccardo DESALVO
- Patrick GANAU
- Jean-Marie MACKOWSKI
- Jean-Luc MONTORIO
- Laurent PINARD
- Barbara SIMONI
- Phil WILLEMS
- Erika D'AMBROSIO
- Danièle FOREST
- Bernard LAGRANGE
- Christophe MICHEL
- Nazario MORGADO
- Alban REMILLIEUX
- Marco TARALLO
- LMA Lyon/EGO
- Caltech/LIGO

# Mexican Hat Mirror Production status (Alban)

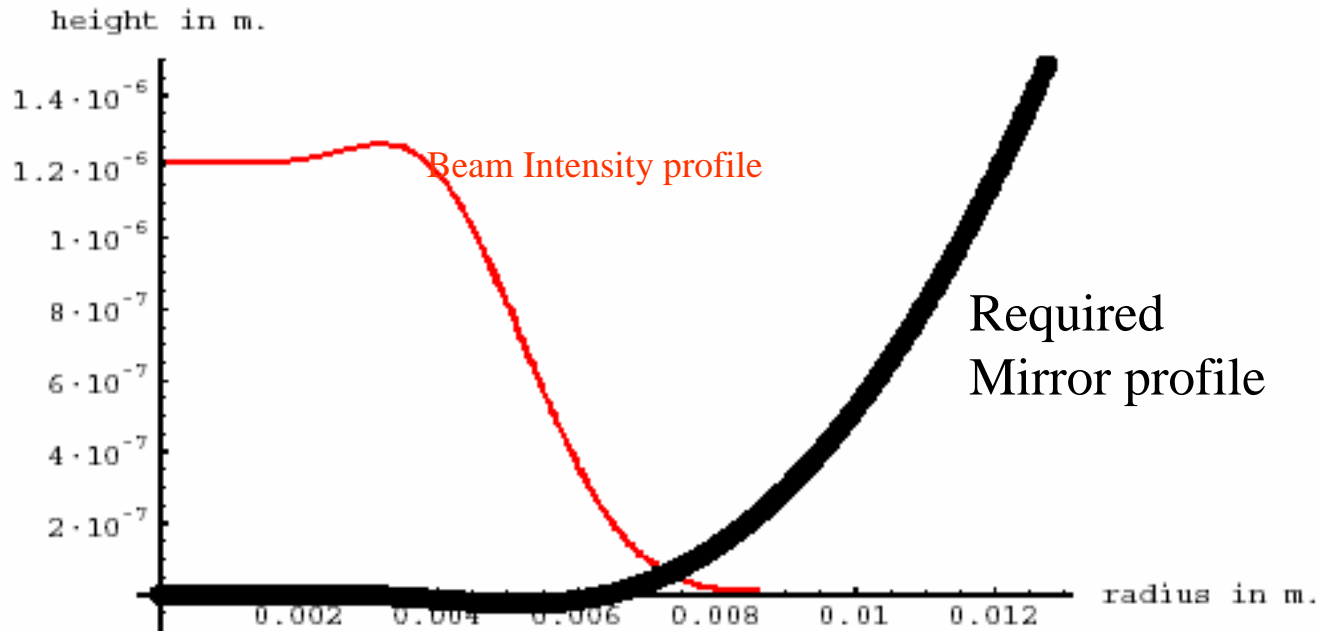
The beam intensity profile is flat and then falls off much faster than a Gaussian  
 The beam diameter at the mirror can be as large as 50% of the mirror diameter

25% of the mirror surface is sampled (up from 2.2%)

Much improved thermal noise performance

The mirror is not spherical! Manufactured with a special procedure

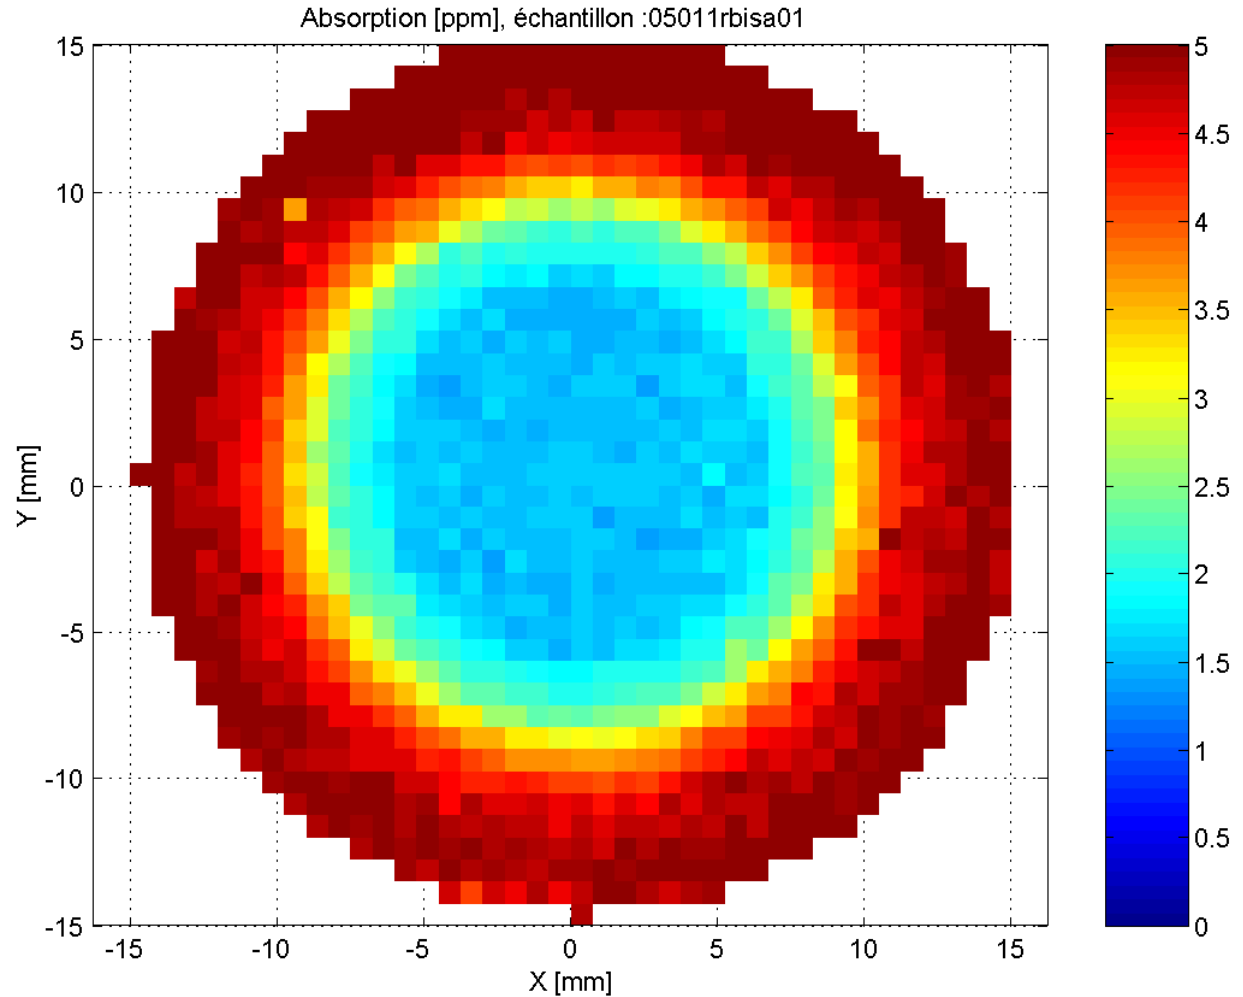
05011

Defect detection  
Before annealing

Unusually  
Large number of  
Defects generated

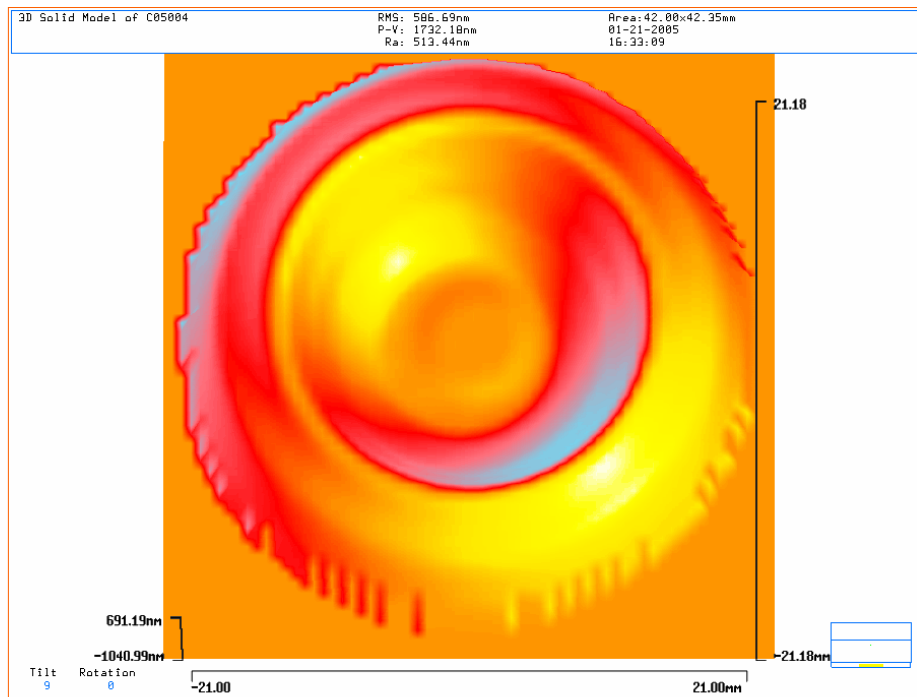
First corrective attempt on a 20 mm thick substrate:

Again  
Offset of 0.9 mm on X !  
and 0.7 mm on Y !

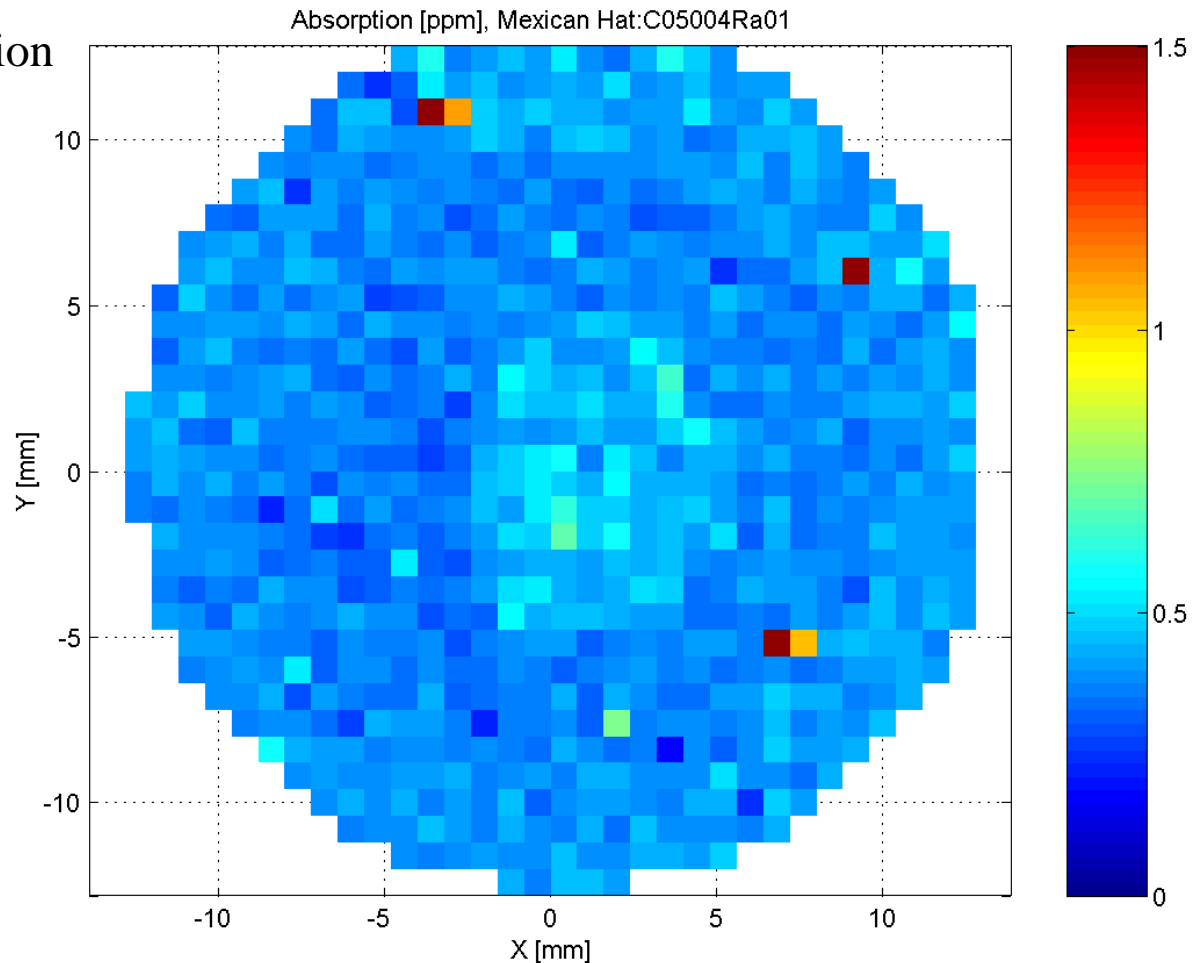
absorption map  
 on  $\varnothing$  26 mm : 0.5 ppm

At the center we guess a zone with corrective treatment with somewhat higher absorption (0.55 ppm).

Outside the central zone we have three absorption centers with 9, 16 and 26 ppm

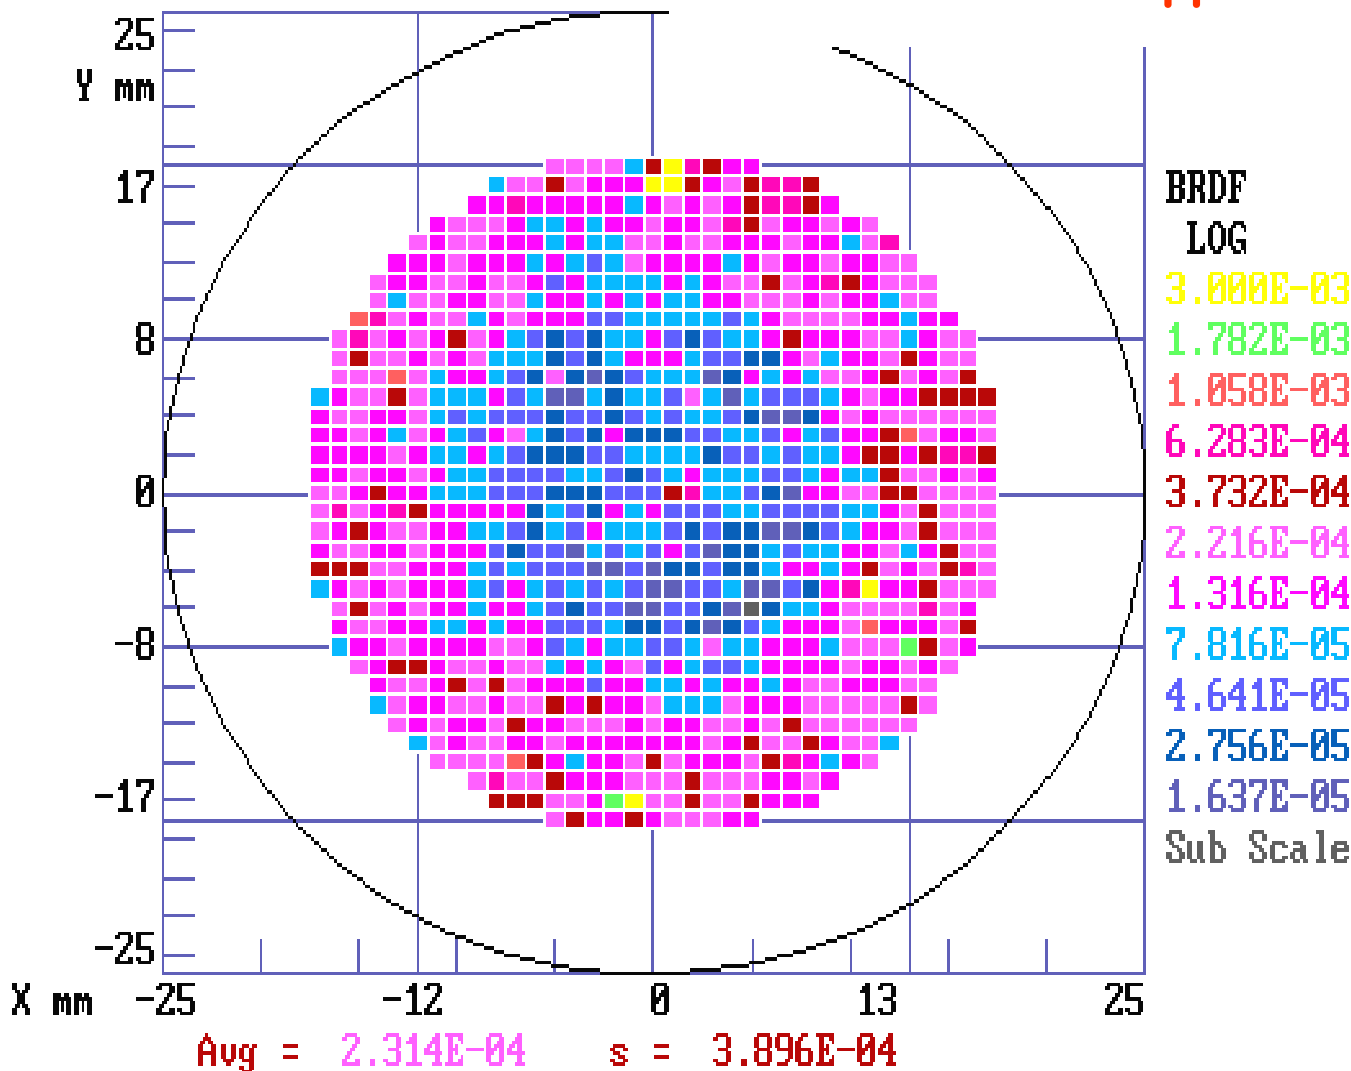
C05004.10R

Diffusion map (marker down)

on  $\varnothing$  36 mm : 150 ppm

on  $\varnothing$  20 mm : 50 ppm

- Absorption is good, 0.5 pmm
- The Transmission is around 1000 ppm, as specified.
- Diffusion is bad 50 ppm on 20 mm diameter  
(150 ppm on 36 mm diameter).
- Diffusion is much higher than usual (a few ppm).
- The quality of the silica deposited is not good,

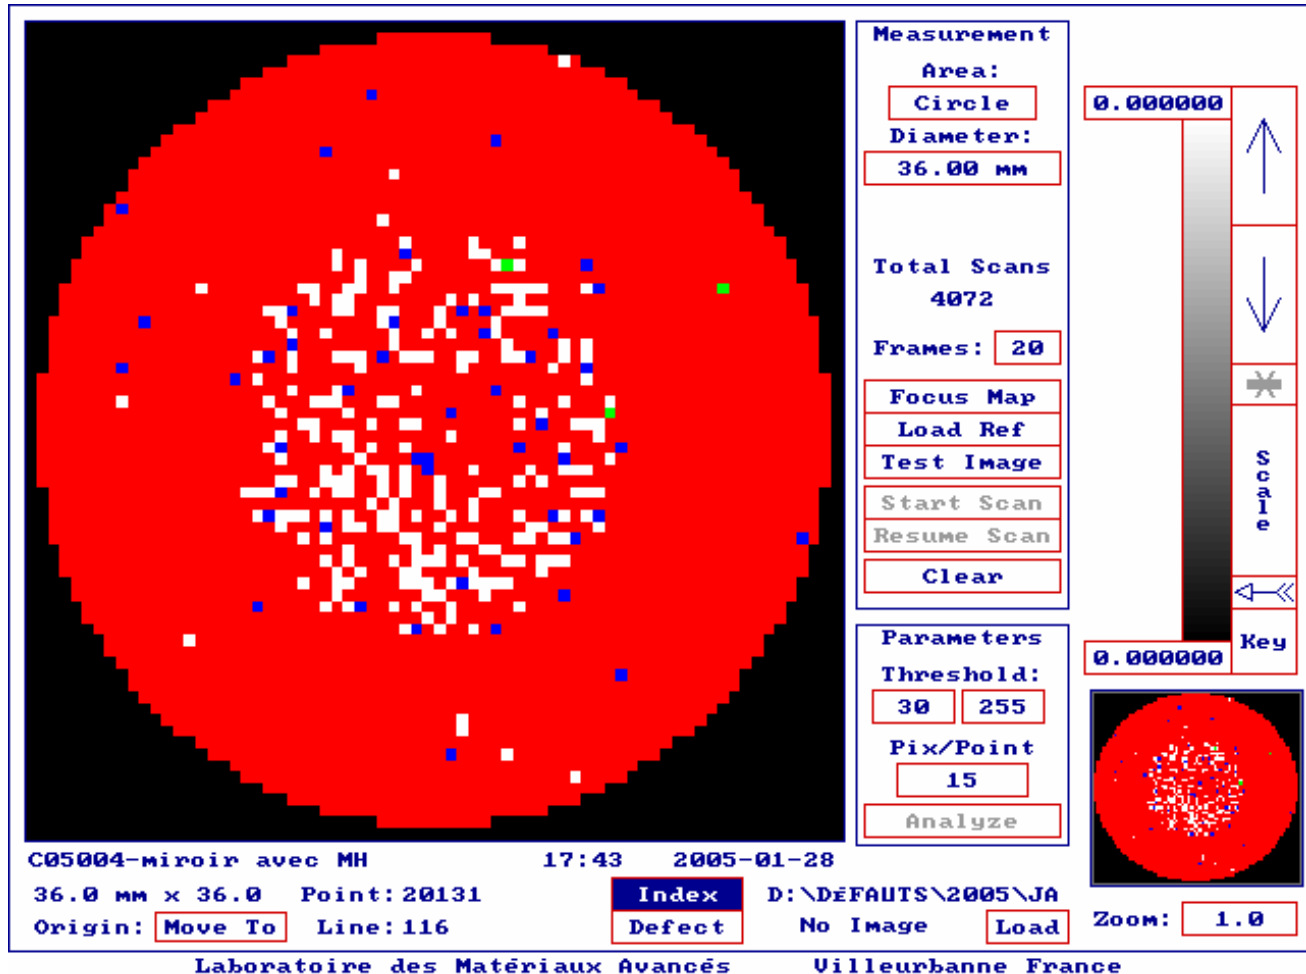
Defect detection  
 Again unusual  
 Defect  
 production

- The high diffusion and absorption losses are probably due to material ripped off the masks by the passing molecular beam thus generating nucleation centers
- Lots of time spent in solving this problem
- Sharp edge coated masks used in future
- Problem diminishing with larger sizes

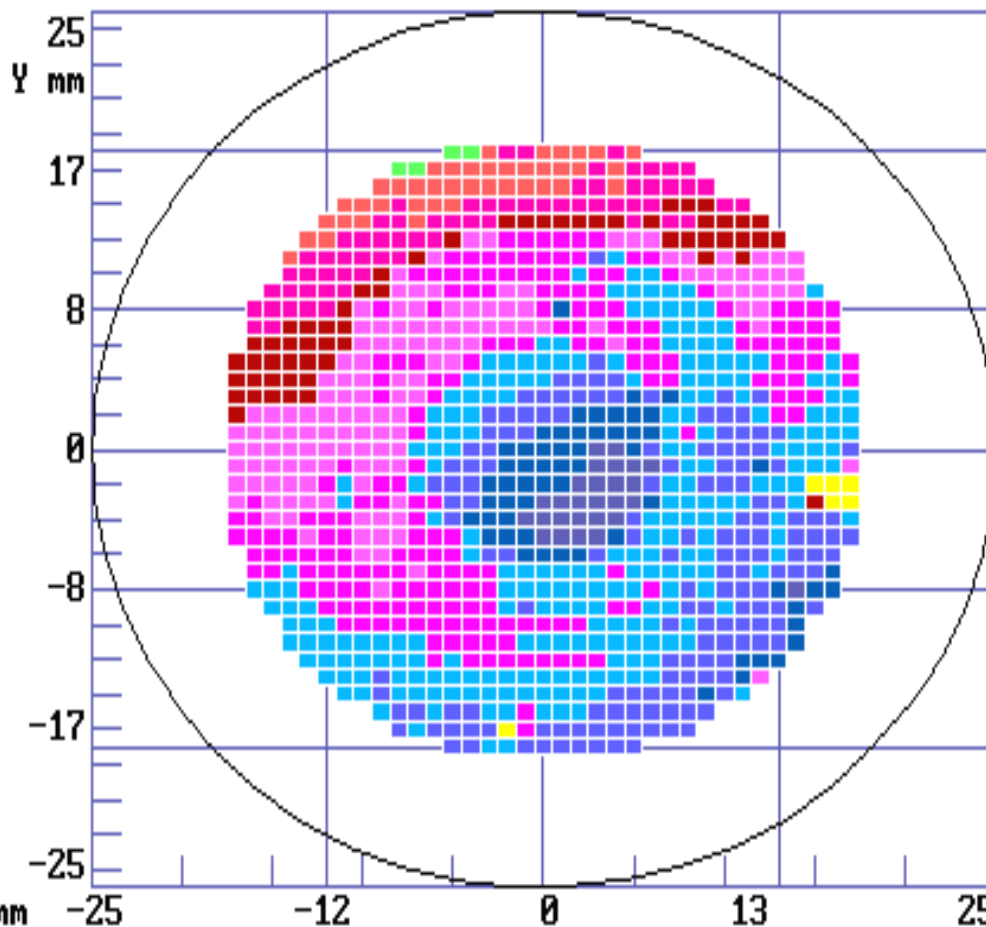
TC05004C.10R

Transmission map (2° incidence)

1009 ppm

The slope (50 ppm variation between the two edges) is due to a difference of thickness deposited during the deposition of the reflective coating (the mirror was not properly rotating during HR deposition).

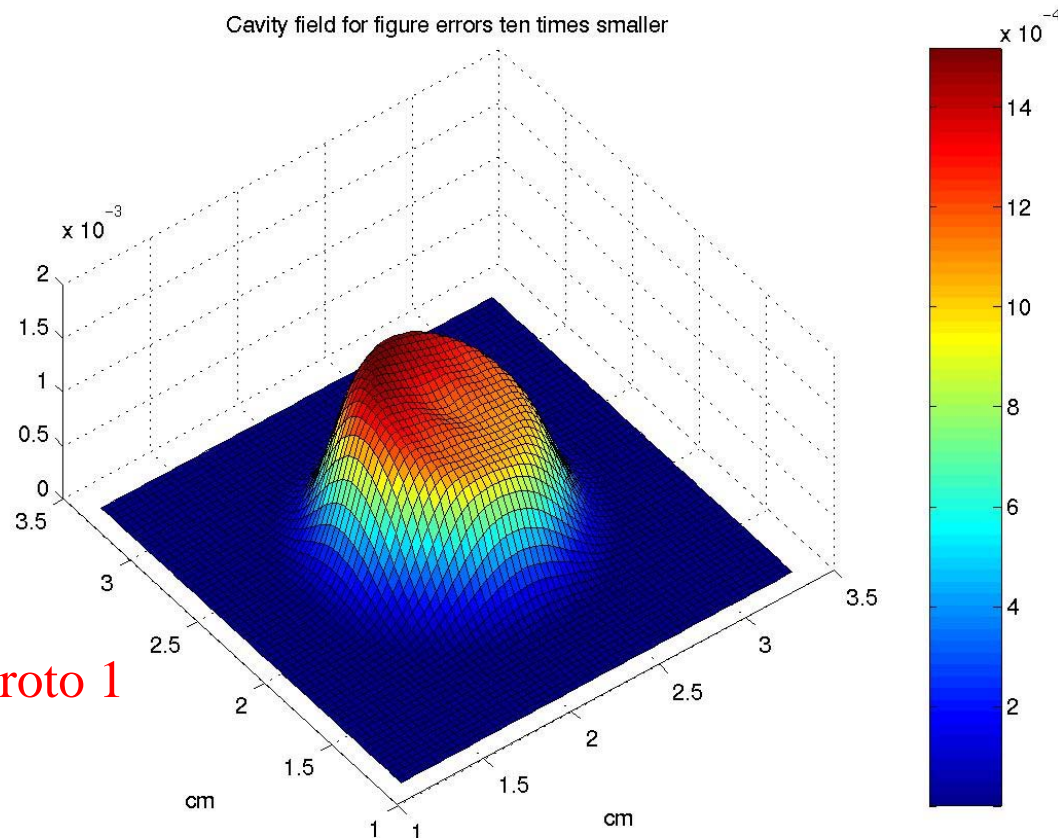
- Apply 10% of deviation on ideal mirror
- Simulate beam profile of “improved” mirror

“improved” proto 1

- Using perturbation theory to determine the ideal realignment
- Apply 10% of deviation on an ideal mirror
- Simulate beam profile of “improved” mirror
- Calculate correction tilt with perturbation theory, observe and optimize effect
- Apply 10x tilt on original mirror and calculate effect

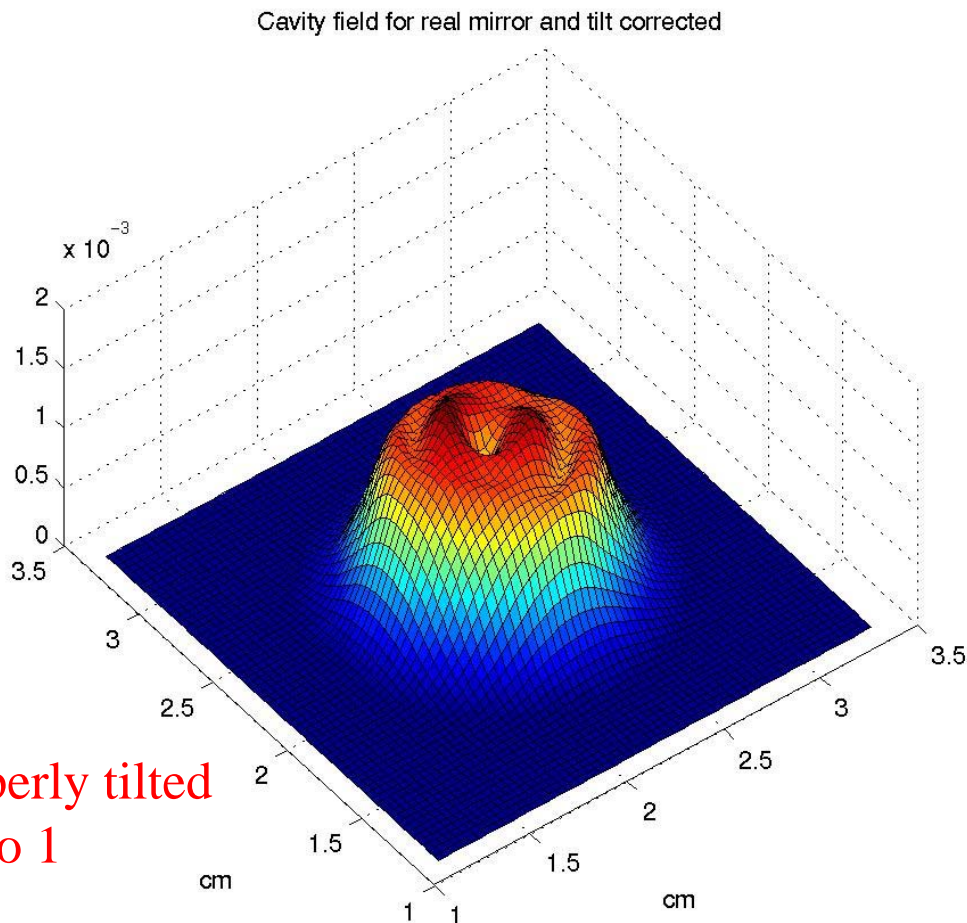
Apply 10x tilt on original mirror and calculate effect on beam

Variations from ideal beam profile

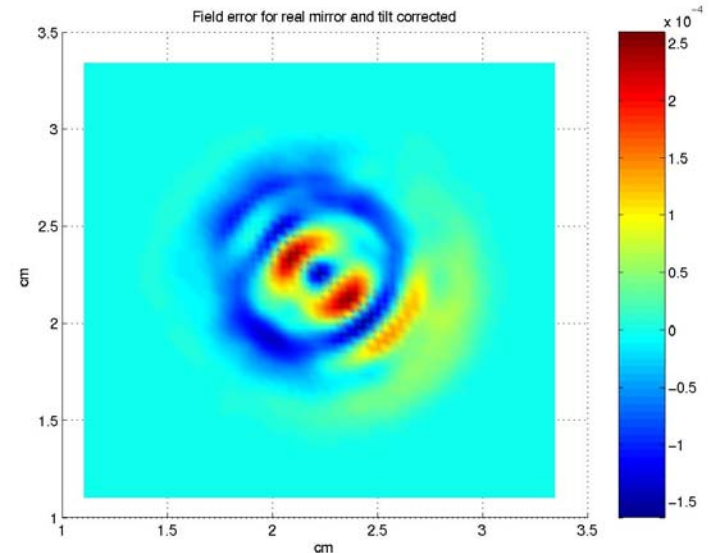
Properly tilted  
Proto 1

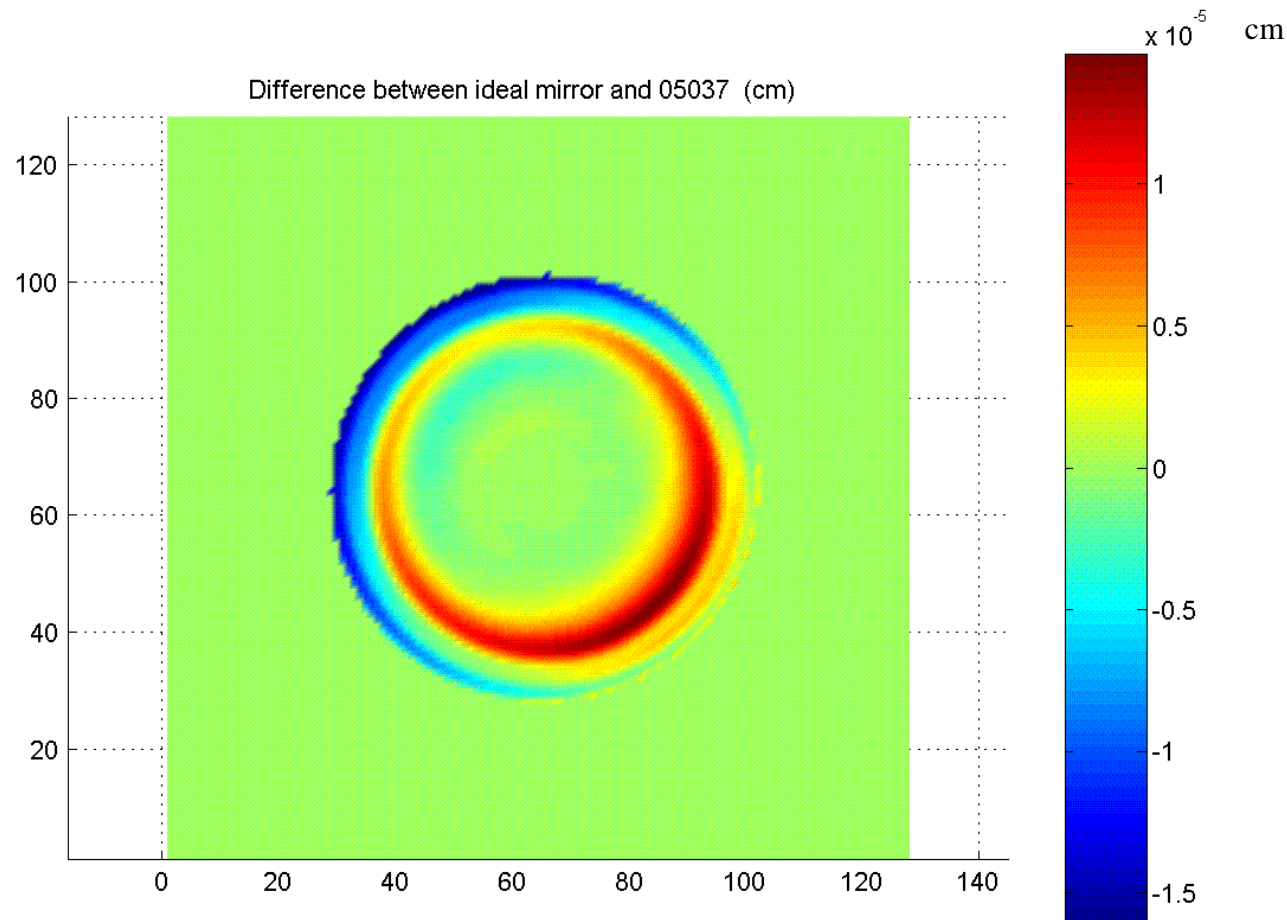
- Unfinished
- General coating only !  
no corrective coating yet !!!
- Deviations from ideal profile

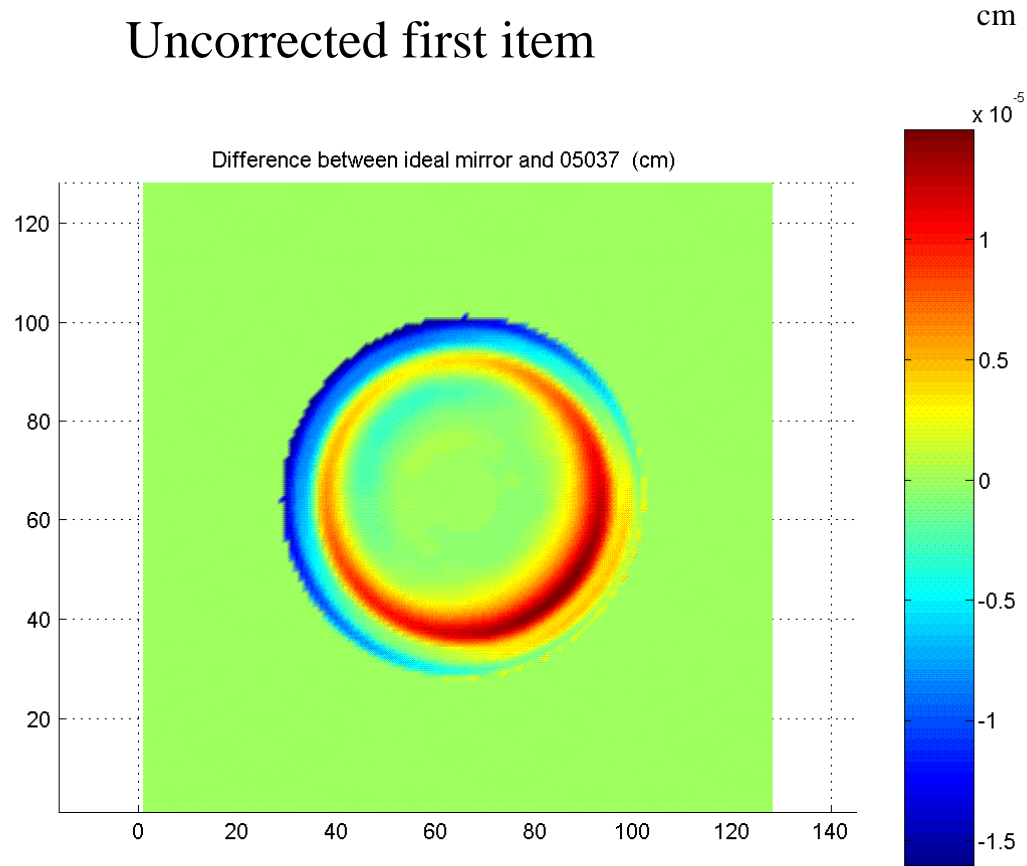
Uncorrected first item

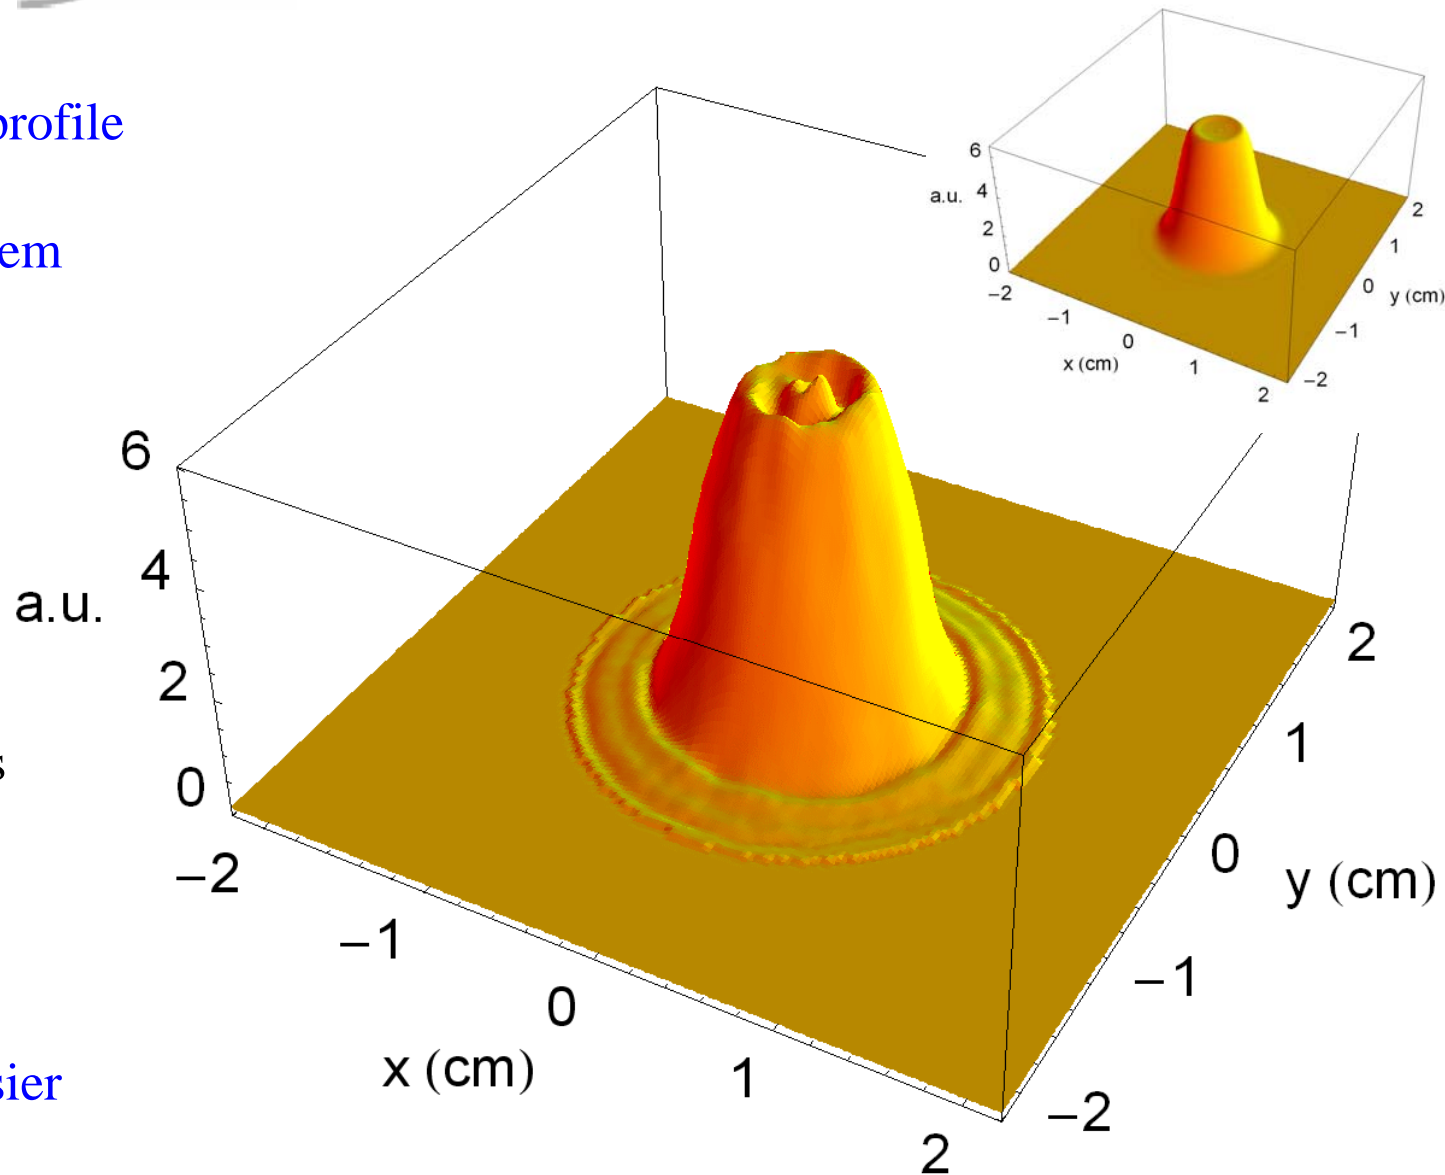
Calculated beam profile  
With unfinished  
First production item  
MH mirror

The corrective  
Coating steps  
Is expected to  
Further improve
