CDS Hardware Update

High Reliability Ultra-Fast Shutter (HRUF)

D2200426-v1

Update 11/22/23

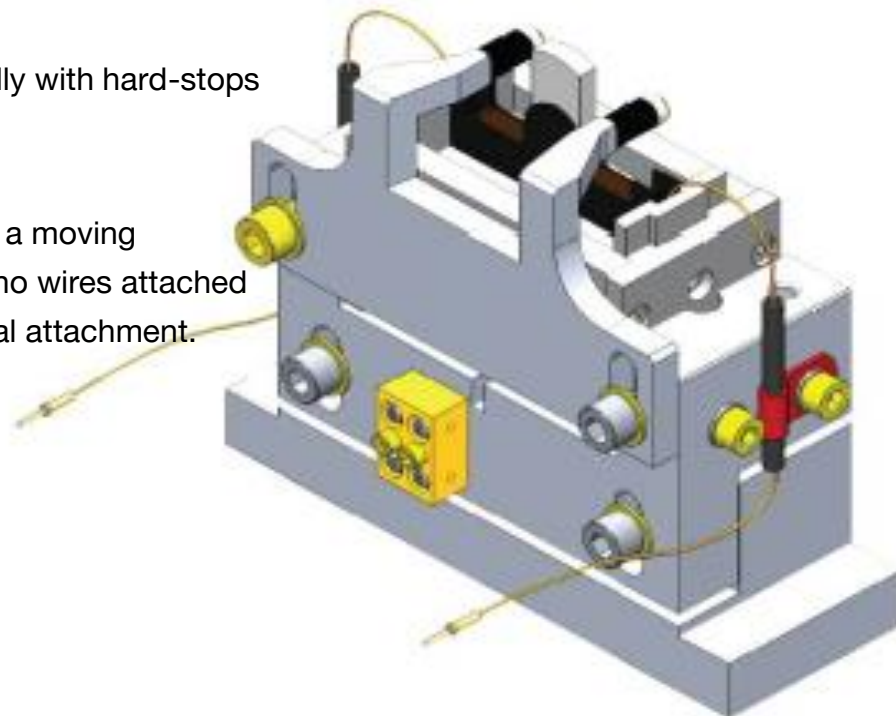
- Why do we have a Fast Shutter?
 - Optical energy stored in the LIGO arms during normal interferometer (IFO) operation is dumped into the antisymmetric (AS) port upon loss of lock. **The stored energy can be of order 50J**, which appears at the AS port as an optical transient lasting a few tens of milliseconds. In order to protect sensitive photodetectors in the AS port beampath from damage, a shutter is required to quickly block the laser beam upon a lock-loss event
- Current Fast Shutter design (D1003318)
 - Wires are attached to the moving parts
 - Work Hardening
 - Arresting of the shutter is done mechanically with hard-stops
 - Stress
 - Debris
 - Physical Shock (Stopping)
- New electro-magnetic ultra-fast shutter design of a moving payload consisting of magnets and a mirror with no wires attached
 - A non-moving coil requiring electrical attachment.
 - Self Arresting

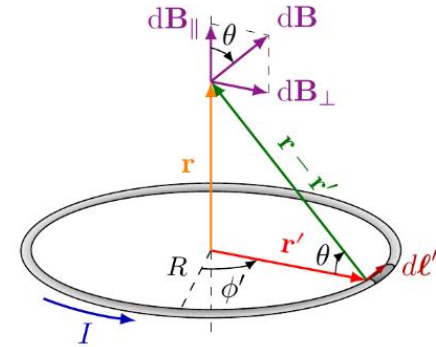
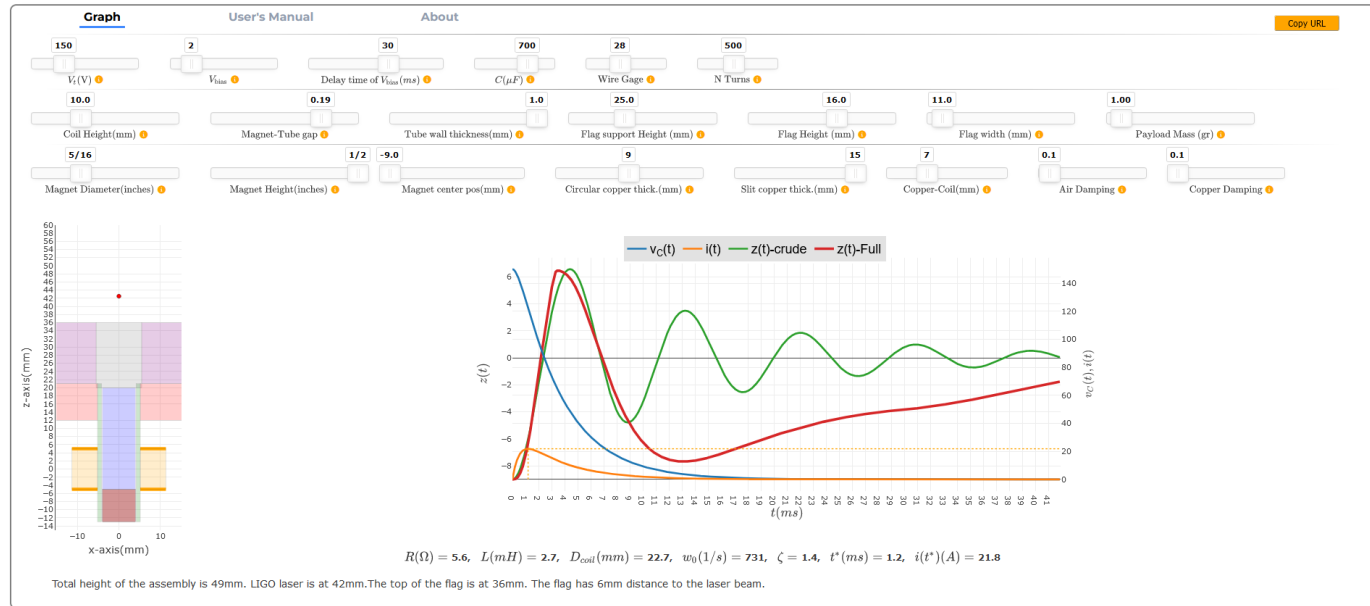
Real-Time Fast Shutter Simulator

- How do we make it better?
 - We first want to build a mathematical model of the system to understand the parameters we can tune to optimize the behavior. ([modeling](#) by Serkay Ölmez)

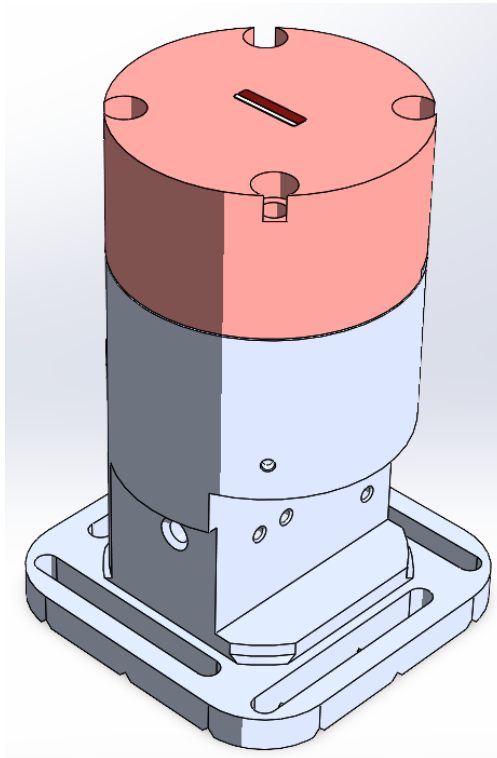
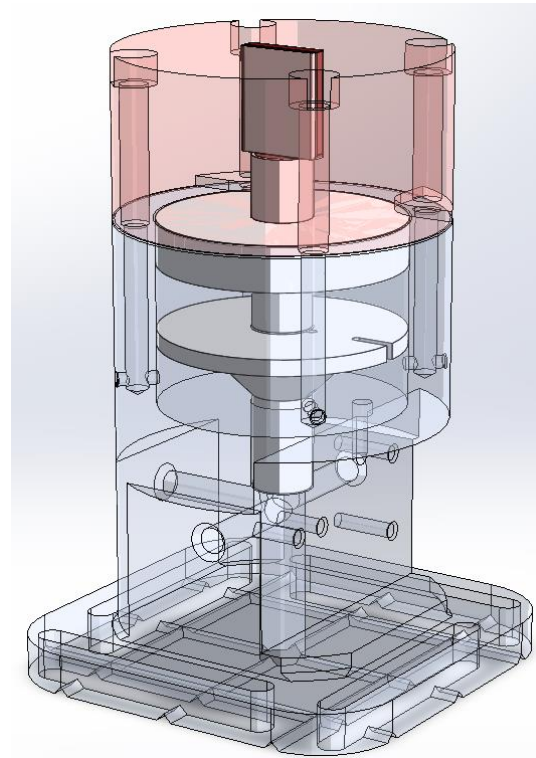
- A prototype was constructed and studied to create a moving shutter without the need for wires attached to the payload
- High-Reliability Ultra-Fast Mechanical Shutter (HRUF) Assy D2200426

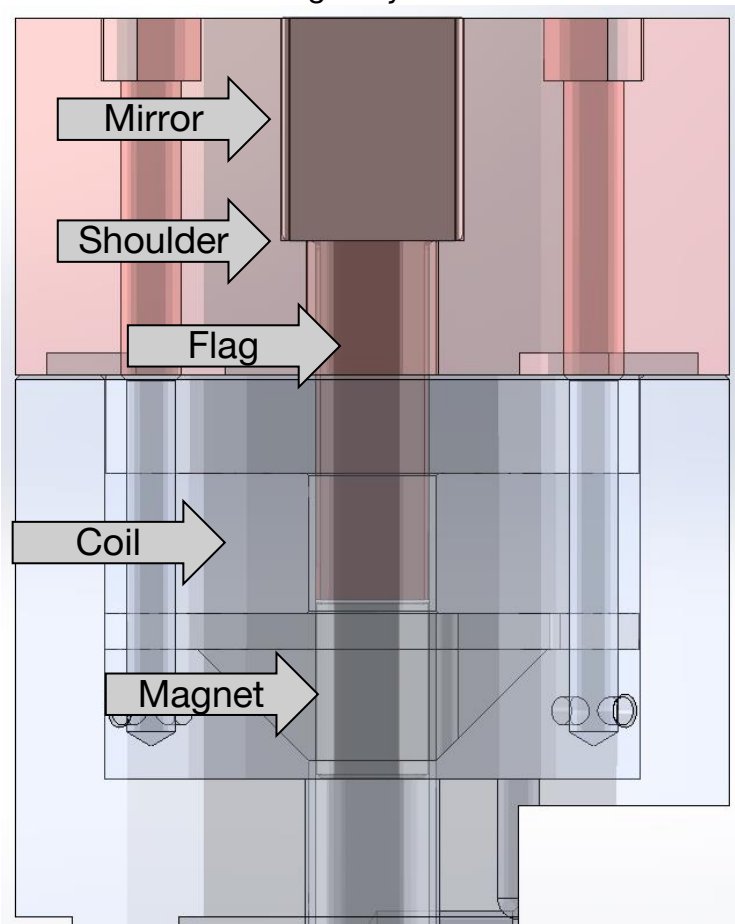
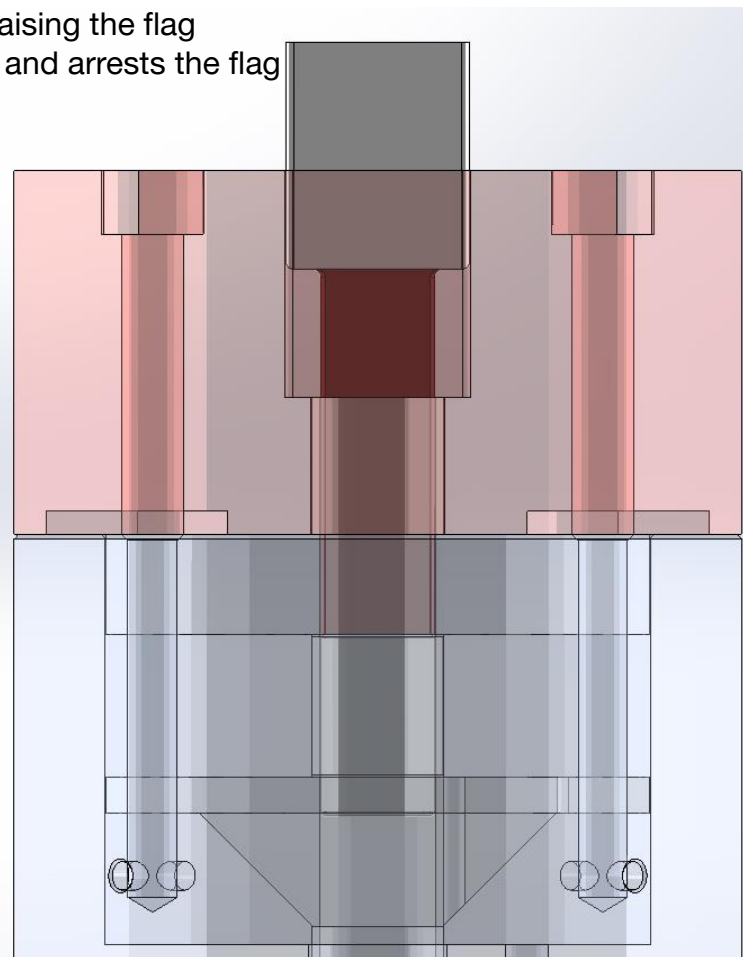
- How Does it Work?
 - Magnet and flag rest on the flag shoulder just inside the coil
 - When activated the magnet pulls up into the coil raising the flag
 - The magnetic field interacts with the copper plate and arrests the flag
 - A holding current keeps the flag raised
 - Falls back under gravity

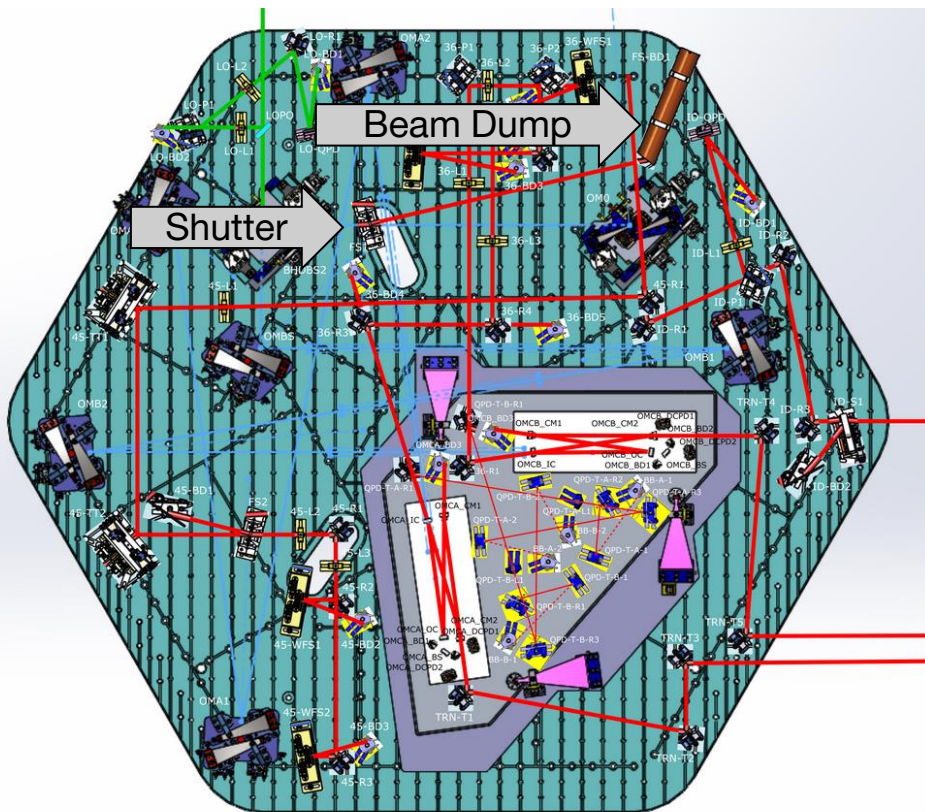
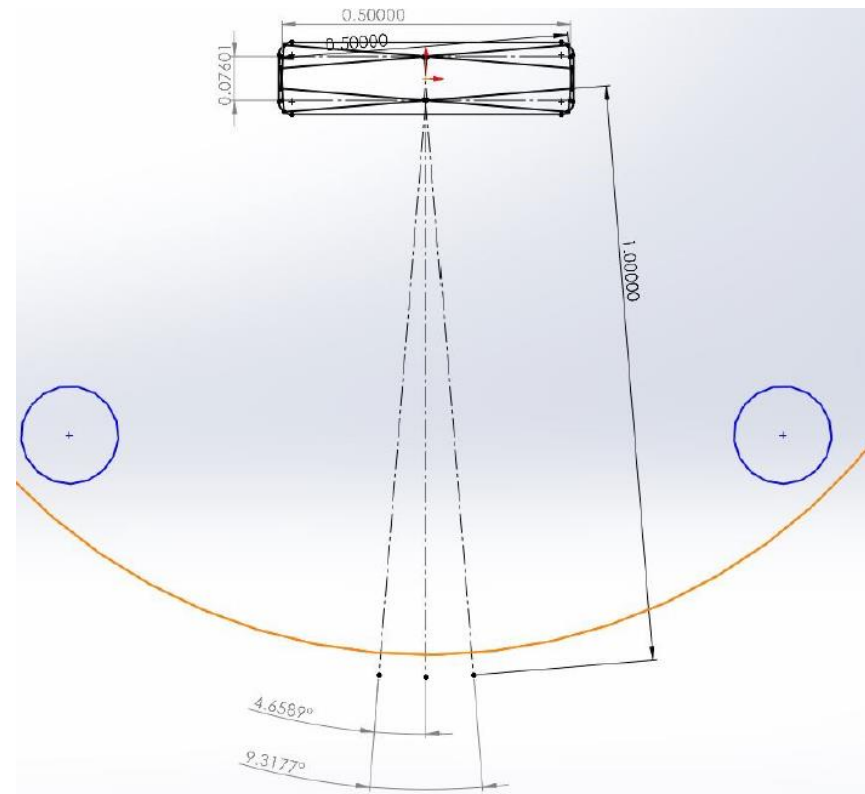
- What have the issues been?
 - The throw to the beam-dump is relatively long so any rotation of the FS mirror on deployment could swing and “paint” the chamber
 - Tolerances must be kept very tight while still allowing free movement of the flag

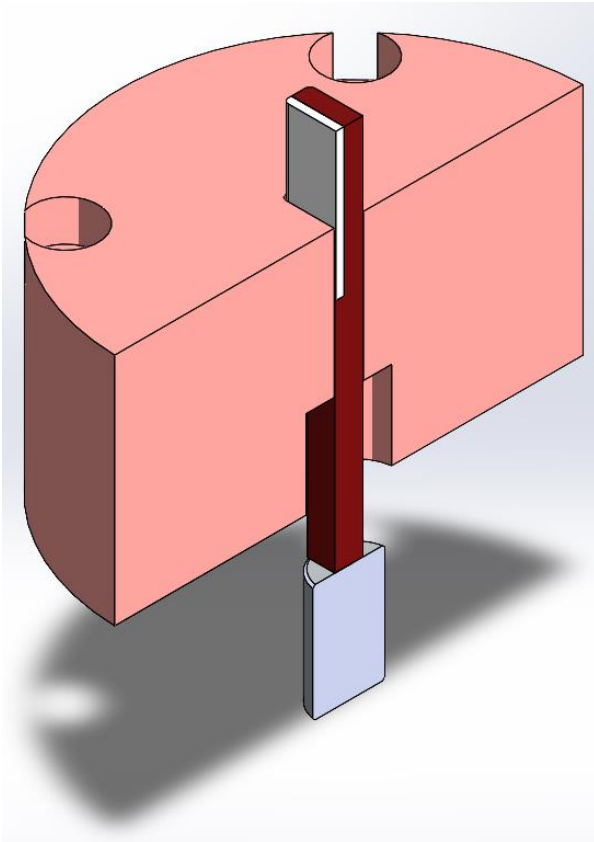
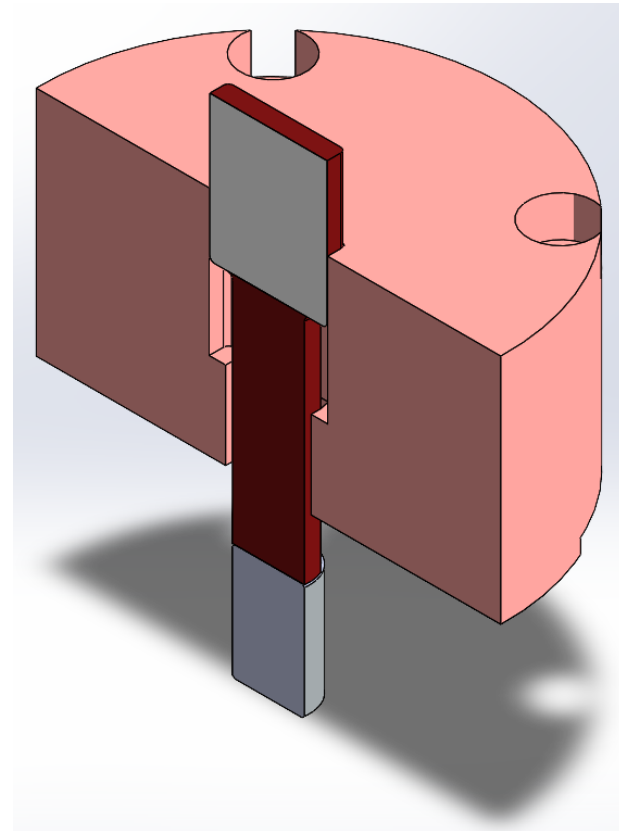
- What have the issues been?
 - How do you assemble it?
 - What order?
 - Magnet-to-Flag
 - Mirror-to-Flag
 - The magnet doesn't fit through the copper plate (square peg in a round hole)
 - The mirror cannot be attached when the flag is in the copper

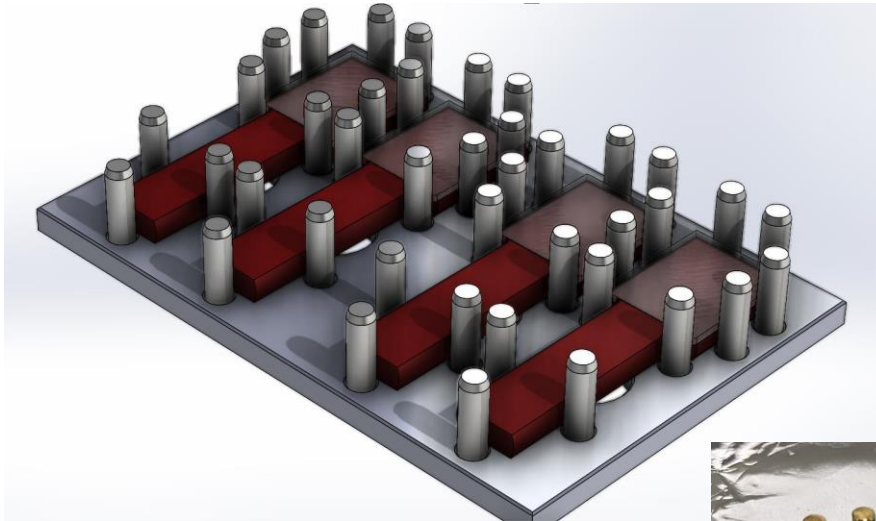
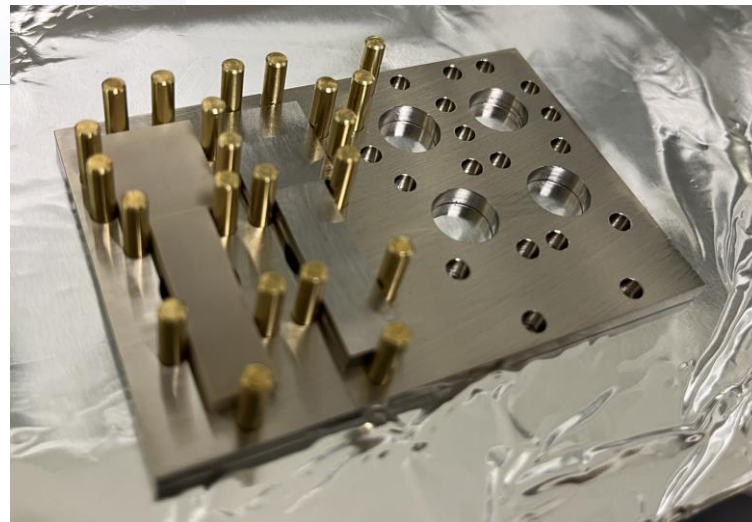
- What have the issues been?
 - The mirror cannot be attached when the flag is in the copper
- Mirror-to-Flag Fixture D2300217
 - Holds the flags still and positions the mirrors correctly for glue-up

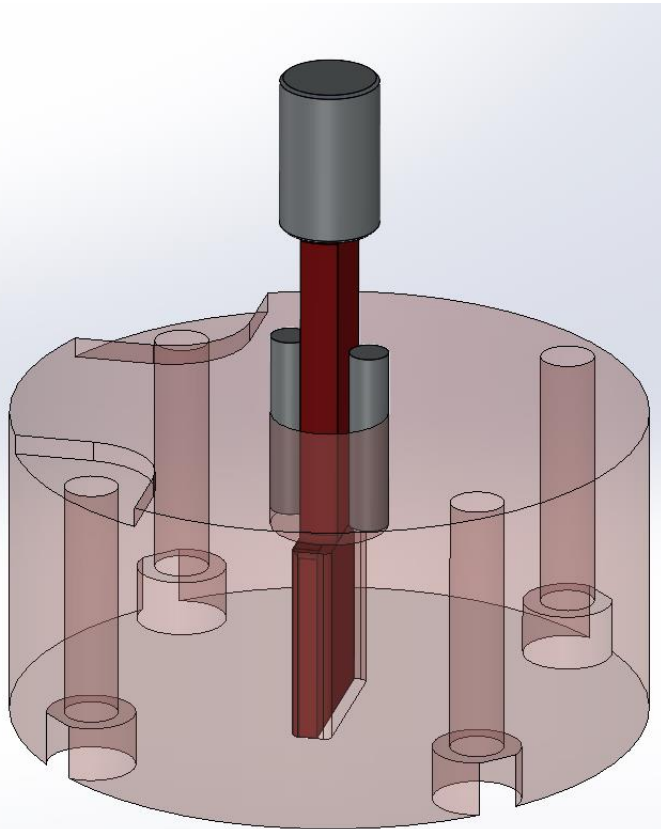
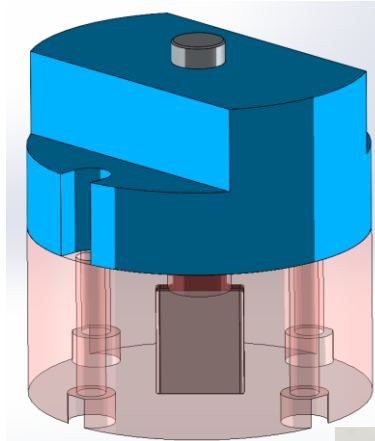
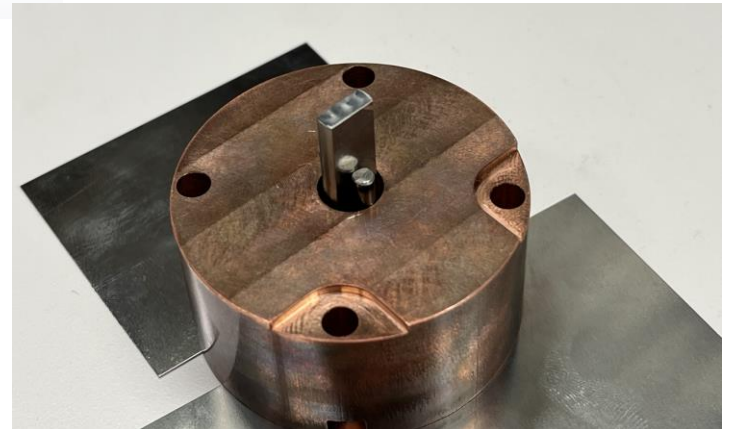
- First Attempt
 - We first attempted to glue a magnet-to-flag
 - The EP-30 Epoxy used was past expiration and did not properly cure
 - Precision pins were used to hold the flag relative to the copper and fixture but were still too magnetic and twisted during assembly

- 10/25/23
 - First epoxy test failed. Expired epoxy?
 - Parts sent to C&B for a proper Class B clean
 - 10/23 Parts back from C&B
 - 10/24 Test optic glued to flag
 - One PEEK and one Titanium
 - 10/27 Glue successful
 - Flag thickness possible issue
 - Flag redesigned
 - 11/7 New flags, M-to-F jigs arrived
 - Class B clean
 - 11/20 Glue -up failed
 - 11/22 Magnet-to-Flag glue-up curing

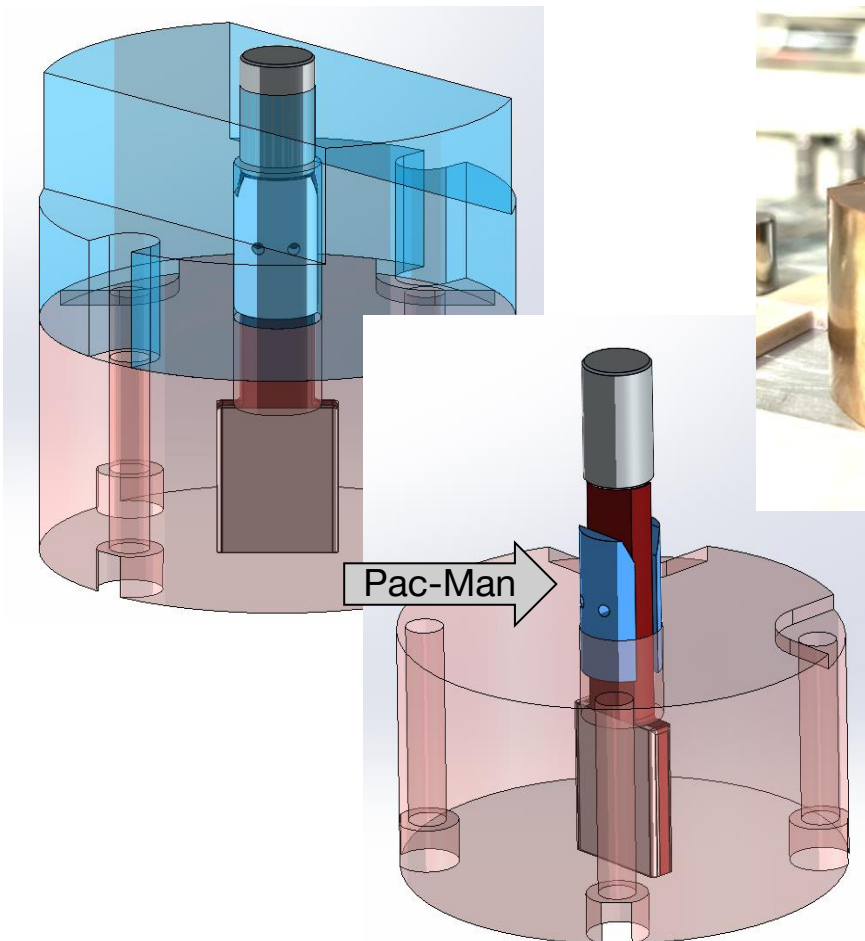
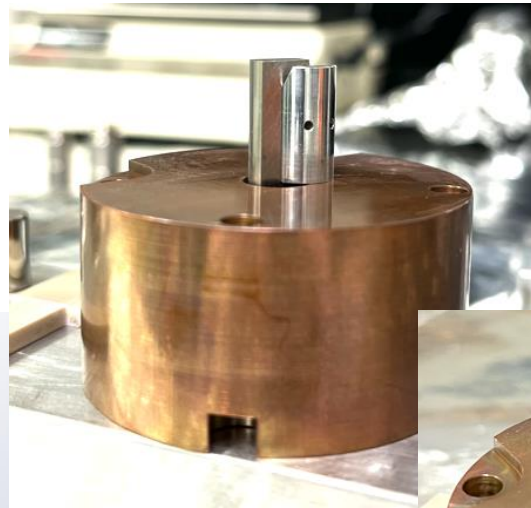
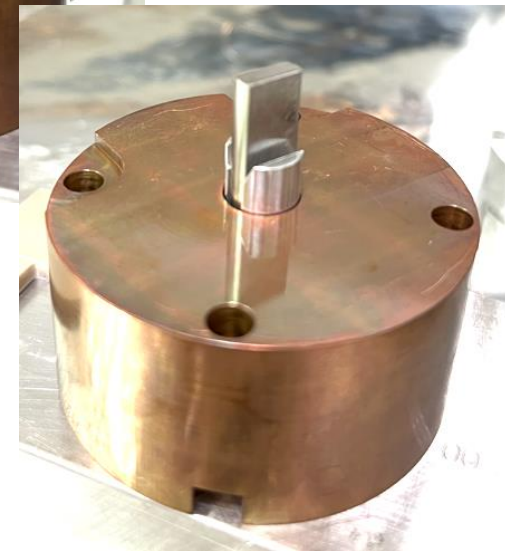
- Magnet-to-Flag Fixture D2300218
 - The “Pac-Man” was developed to hold the flag and copper relative to the fixture
 - Must be short enough to be removed when the magnet is glued, but long enough to bridge the transition of the pieces

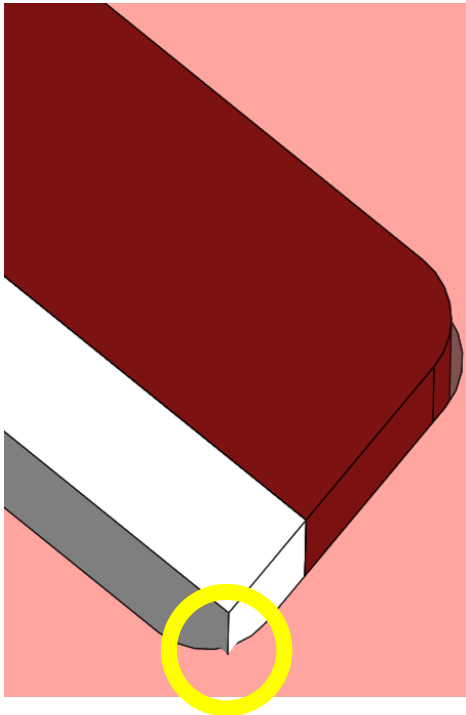
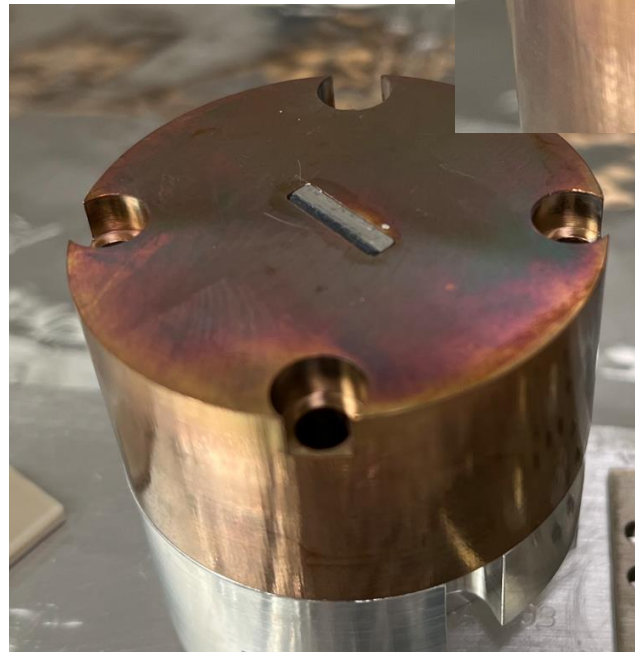
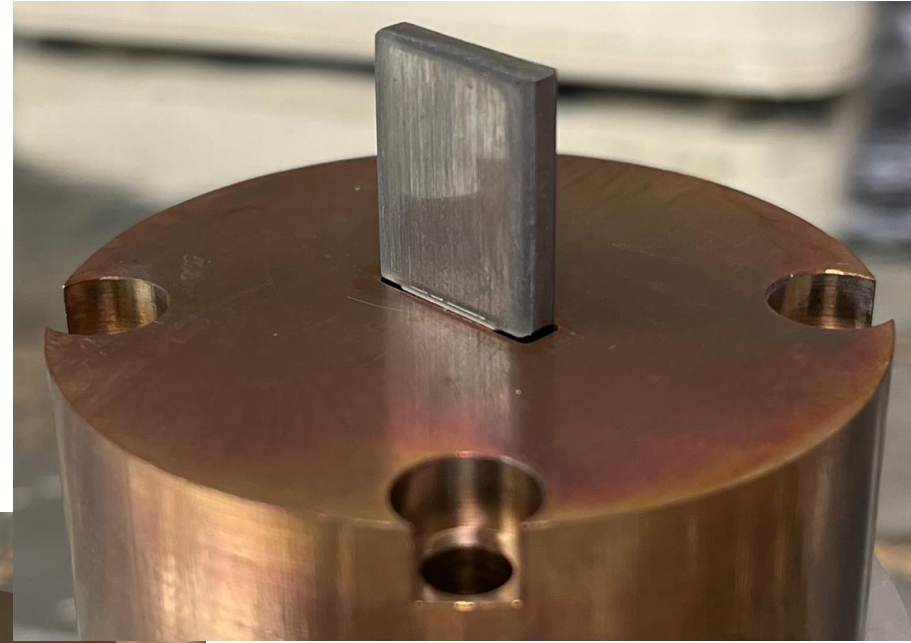
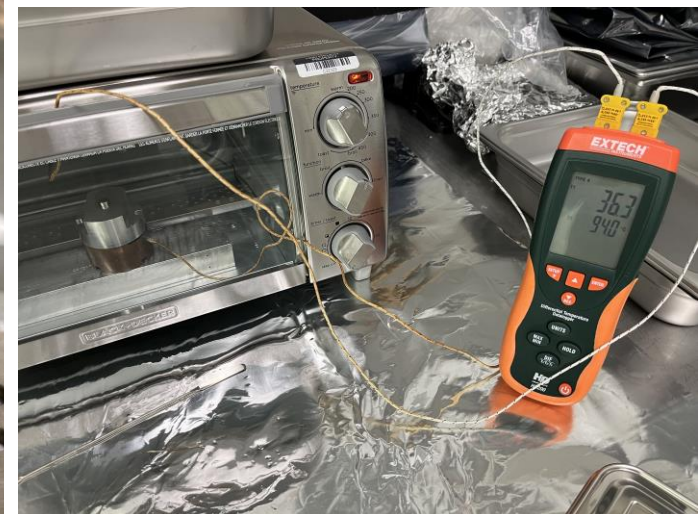
- Gluing the Mirror-to-Flag
 - Gluing successful
- Mirror Edges not beveled
 - Tolerance revenge!
 - Manual shaping of test optics
- The depth of the mirror on the flag with the epoxy is tight and does not always fall smoothly
- $v2 = 0.005''$ taken out the flag thickness at the mirror

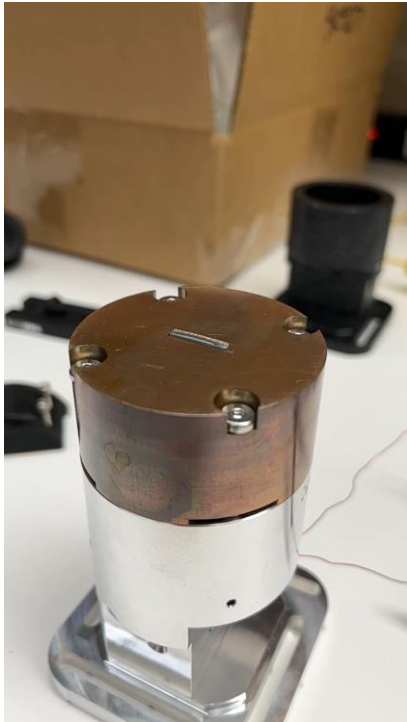
Slow-Mo(ish)

- Initial test firing
 - Does not fall back down
 - Does not seem to break
