LIGO- E1300930

**aLIGO HEPI L1 ITMY (BSC1) Assembly Validation Report**

E1300930

This document summarizes the tests done to validate the HEPI L1 ITMY (BSC1) assembly. As all L1 HEPI BSC, it had been installed since 2004 at Livingston. However, it had been grounded for the 2 to 3 years of aLIGO install. All electronics has been updated since, and more importantly, the position of the ITMY support tubes (i.e. the position of the 4 HEPI ITMY boots), but not the one of the housings, were adjusted to accommodate the position needed for aLIGO alignment. Note that when HEPI was first released, we subsequently found out that there was some constant rubbing between the boot and the housing, due to some of the moves done for Initial Alignment. The boot assembly was adjusted to provide clearance. Those adjustments were completed in July 2013.

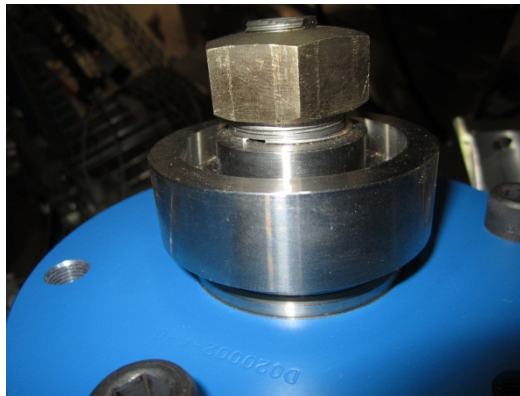
For the BSC HEPI springs, check the assembly per D030320-v4. See LLO aLOG 7162 for more details.

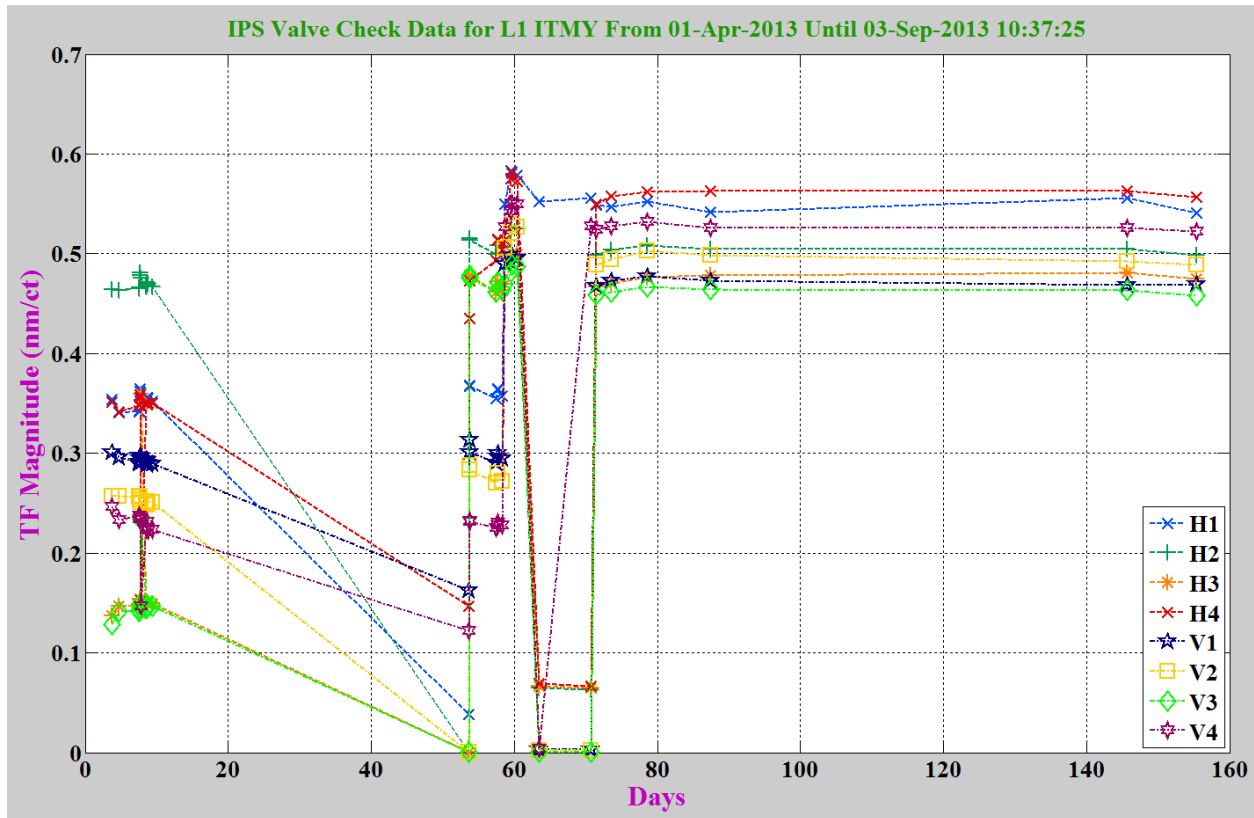
Issues/difficulties/comments regarding this test:

The one before last H1 point was a measurement issue, valve and L4C are ok.

- All corners should behave consistently (usually displacement > 0.4 nm/ct)
